ACCIDENT

Aircraft Type and Registration:	Zenair CH 601HD Zodiac, G-CBDT	
No & Type of Engines:	1 Rotax 912ULS piston engine	
Year of Manufacture:	2002	
Date & Time (UTC):	5 May 2011 at about 1600 hrs	
Location:	A private airstrip 19 nm southeast of Penrith, Cumbria	
Type of Flight:	Private	
Persons on Board:	Crew - 1	Passengers - None
Injuries:	Crew - 1 (Fatal)	Passengers - N/A
Nature of Damage:	Aircraft destroyed	
Commander's Licence:	National Private Pilot's Licence	
Commander's Age:	63 years	
Commander's Flying Experience:	591 hours (of which 93 were on type) Last 90 days - 11 hours Last 28 days - 6 hours	
Information Source:	AAIB Field Investigation

Synopsis

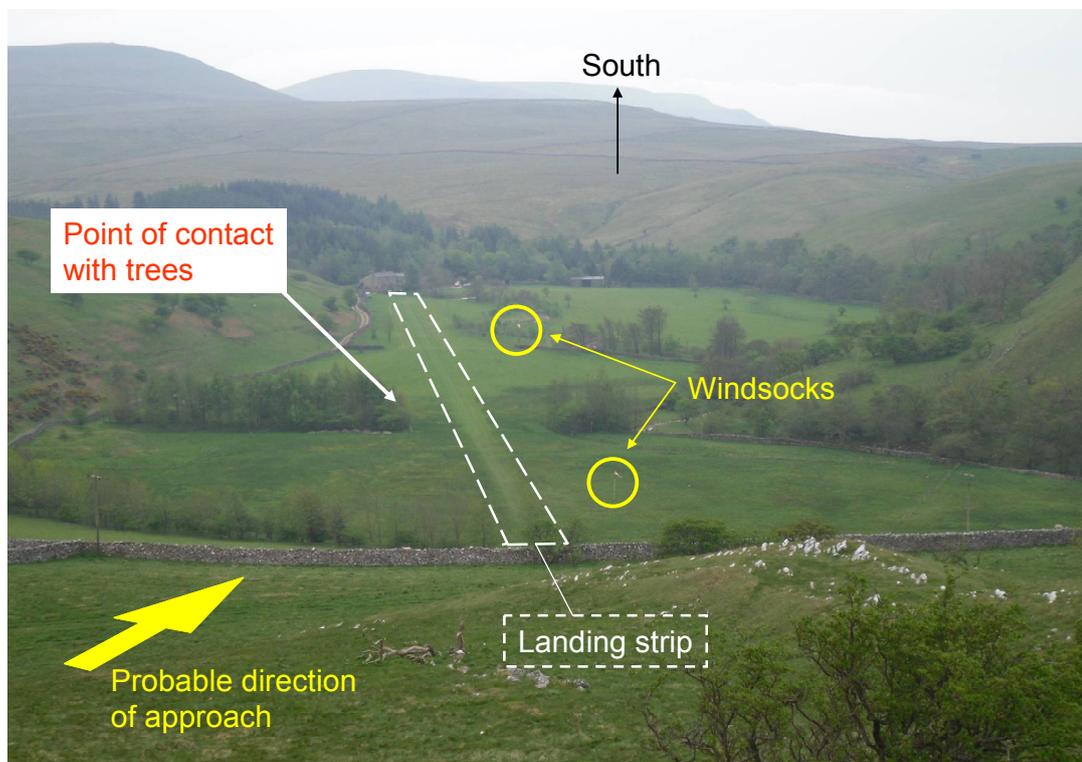
Figure 2

460 m long with a prepared central strip 5 m wide. It was surrounded on all sides by higher ground, which reached about 1,100 ft amsl immediately to the north and about 1,400 ft amsl within 0.5 nm in the sector from the north-east, through south, to the west. Thus, the airstrip sat in a small valley (Figure 2). The highest ground in the vicinity was at 2,170 ft amsl, 1.7 nm to the south-east.

View of the airstrip from high ground to the north

The Met Office provided a report on the likely conditions at the airstrip on the afternoon of the accident, which would have been heavily influenced by the local topography. The gradient wind (at 2,000 ft amsl) was estimated to have been from 170° at 15 to 20 kt, with a theoretical wind at airstrip level (about 1,000 ft amsl) of 160° at 15 kt. However, the surface wind at airstrip level would have been subject to much greater variation, due to topography, than the 2,000 ft wind, giving the potential for significant windshear between the airstrip and about 2,000 ft, with variations likely in wind speed and direction. The topography and wind direction would suggest that the surface wind and 2,000 ft wind would have been relatively closely aligned at the upwind (southerly) end of the airstrip, while blocking

and funnelling effects of the topography would be likely to have produced a marked variation in wind direction at the approach and touchdown (northerly) end of the strip.
