## Boeing 737-81Q, G-XLAD

<b>AAIB Bulletin No: 5/2004</b>	<b>Ref: EW/C2002/12/04</b>	<b>Category: 1.1</b>
<b>Aircraft Type and Registration:</b>	Boeing 737-81Q, G-XLAD	
<b>No &amp; Type of Engines:</b>	2 CFM56-7B26 turbofan engines	
<b>Year of Manufacture:</b>	2000	
<b>Date &amp; Time (UTC):</b>	23 December 2002 at 0030 hrs	
<b>Location:</b>	Gatwick Airport, West Sussex	
<b>Persons on Board:</b>	Crew - 8	Passengers - None
<b>Injuries:</b>	Crew - None	Passengers - N/A
<b>Nature of Damage:</b>	None	
<b>Commander's Licence:</b>	Airline Transport Pilot's Licence	
<b>Commander's Age:</b>	37 years	
<b>Commander's Flying Experience:</b>	4,980 (of which 2,950 were on type)	
	Last 90 days - 216 hours	
	Last 28 days - 85 hours	
<b>Information Source:</b>	AAIB Field Investigation

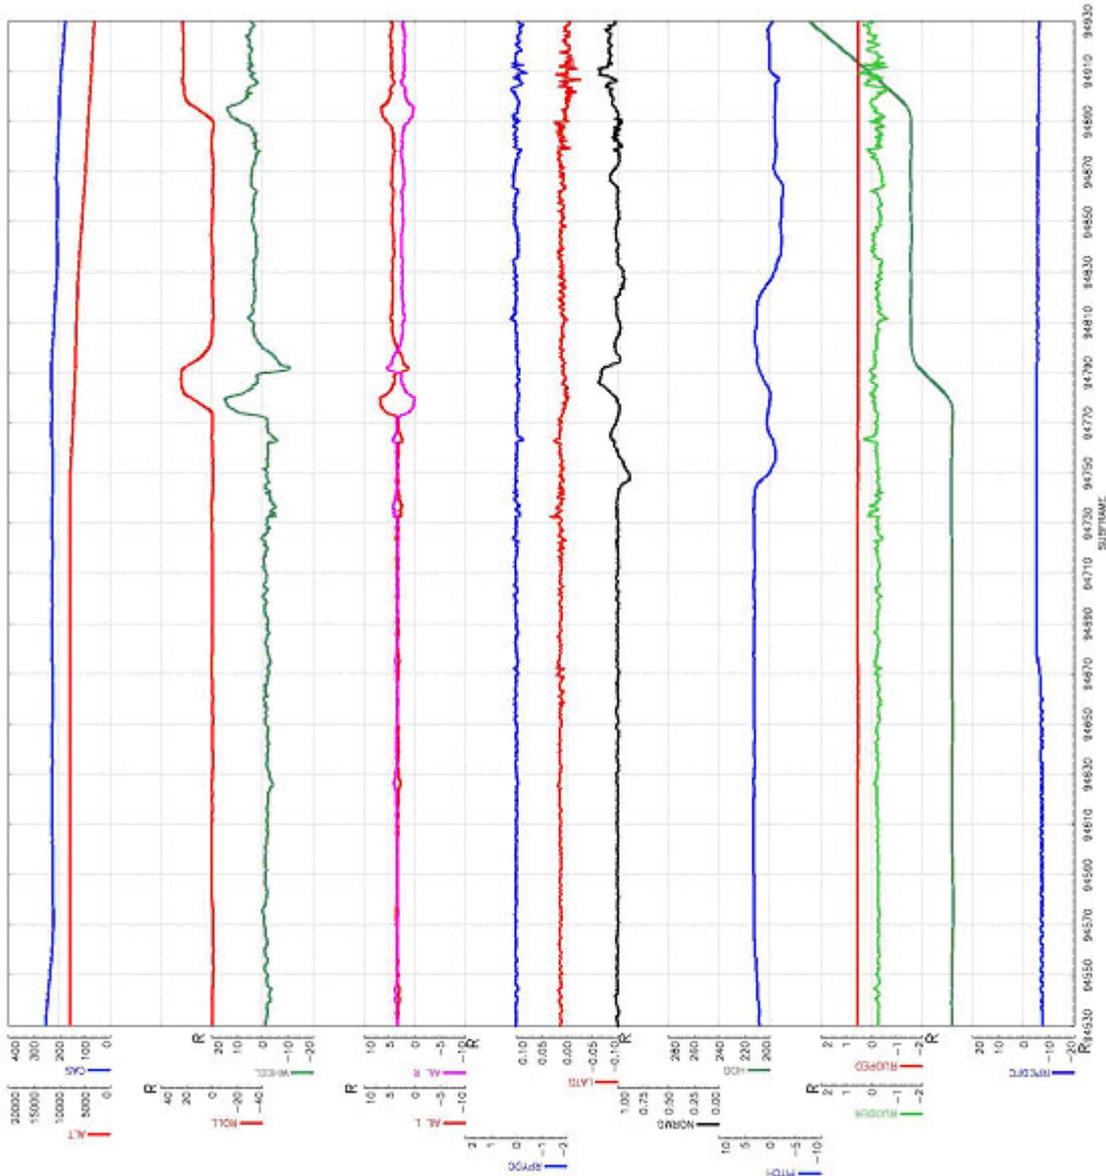
Figure 5

It can be seen that, in contrast to the Brussels-Gatwick sector, the rudder pedal and rudder pedal force remain essentially neutral, and the rudder responds normally to inputs from the yaw damper. Similarly, the approach and landing at Brussels (Figure 6), which covers the same period of flight as Figure 3, has no apparent rudder pedal inputs until the aircraft has touched down.
