Aircraft Type and Registration:	Piper PA-23-250 Aztec, N54211	
No & Type of Engines:	2 Lycoming TIO-540 piston engines	
Year of Manufacture:	1974	
Date & Time (UTC):	5 February 2005 at 1310 hrs	
Location:	Elstree Aerodrome, Hertfordshire	
Type of Flight:	Private	
Persons on Board:	Crew - 1	Passengers - 1
Injuries:	Crew - None	Passengers - None
Nature of Damage:	Damage to nose cone, nose underside and nose gear doors	
Commander's Licence:	Private Pilot's Licence	
Commander's Age:	41 years	
Commander's Flying Experience:	999 hours (of which 13 were on type) Last 90 days - 10 hours Last 28 days - 3 hours	
Information Source:	Aircraft Accident Report Form submitted by the pilot and further enquiries by the AAIB

Synopsis

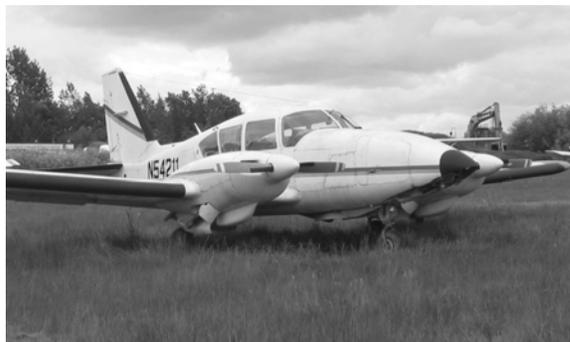
The nose landing gear would not lock down in flight due to an unidentified technical defect involving a loss of hydraulic fluid from the nose landing gear system. Upon landing the nose gear collapsed resulting in damage to the aircraft's nose. During the recovery operation the main landing gear collapsed resulting in further damage to the aircraft. At the time of compiling this report (May 2005) the aircraft had not been raised on jacks to identify the source of the hydraulic leak or to carry out repairs.

An inspector from the AAIB examined the aircraft and did not find any evidence of a mechanical fault with the main landing gear or the nose gear. Hydraulic fluid was found congealed around the nose gear door and on the belly of the aircraft aft of the nose gear bay. The nose landing gear actuator and hydraulic lines were not accessible for inspection with the aircraft on the ground. The

aircraft needed to be jacked up to determine the source of the hydraulic fluid but this was not possible at the time of inspection.

The nose landing gear retracted on landing because it was not locked down. No mechanical fault of the nose gear was found that would have prevented it from locking down and therefore it was a loss of actuating power that prevented the nose gear from locking down in flight. The nose gear extends forwards in flight, against the slipstream, and therefore more actuating force is required to extend the nose gear than to extend the main gear which extend aft. The evidence of congealed hydraulic fluid on the belly of the aircraft aft of the nose gear bay indicated that it was a loss of hydraulic fluid in flight that resulted in the loss of actuating force. The source of the hydraulic fluid leak could not be determined at the time of inspection. It is possible that the aircraft's low usage over the past two years may have contributed to the deterioration of a component within the hydraulic system.

The main gear collapsed during recovery of the aircraft because, as the nose gear actuator was being manually extended, the displaced hydraulic fluid caused the main gear actuators to move in the retract direction which caused the downlocks on the main gear drag links to unlock. Fortunately no one was injured but more damage resulted to the aircraft from the recovery operation than from the landing itself. This incident demonstrated how important it is to fully understand an aircraft's landing gear system before attempting a recovery.
