CEA DR400/2+2, G-BAGS

AAIB Bulletin No: 3/2001

Ref: EW/G2000/09/02 - Category: 1.3

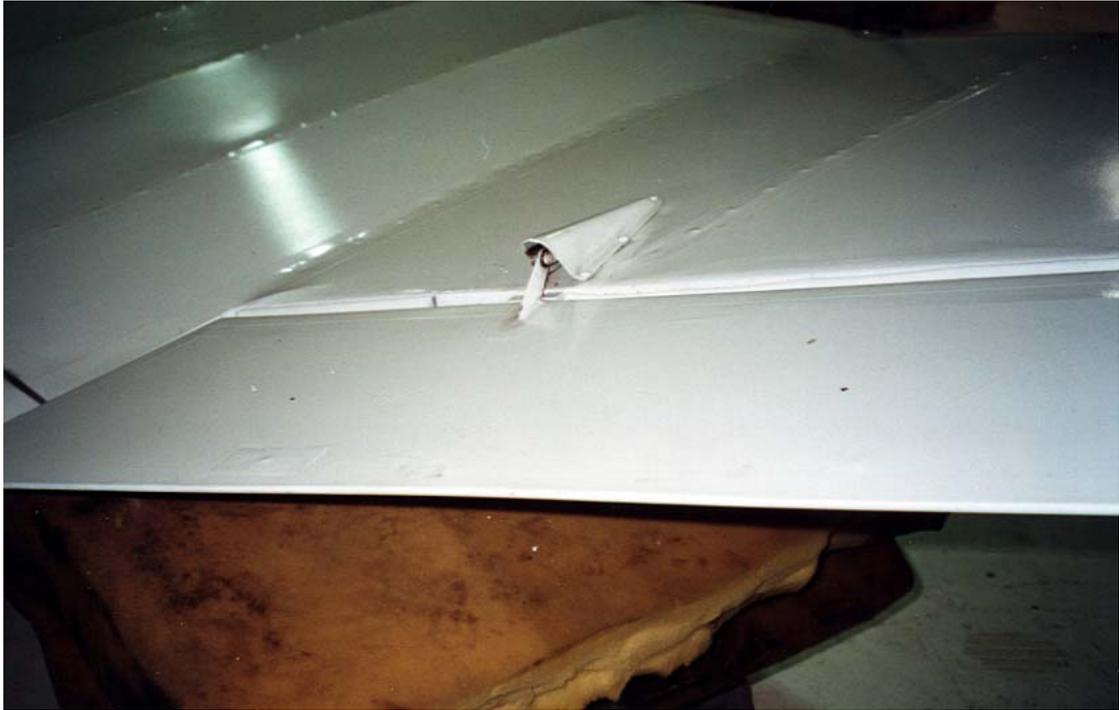
Figure 1. View of right hand aileron and wing

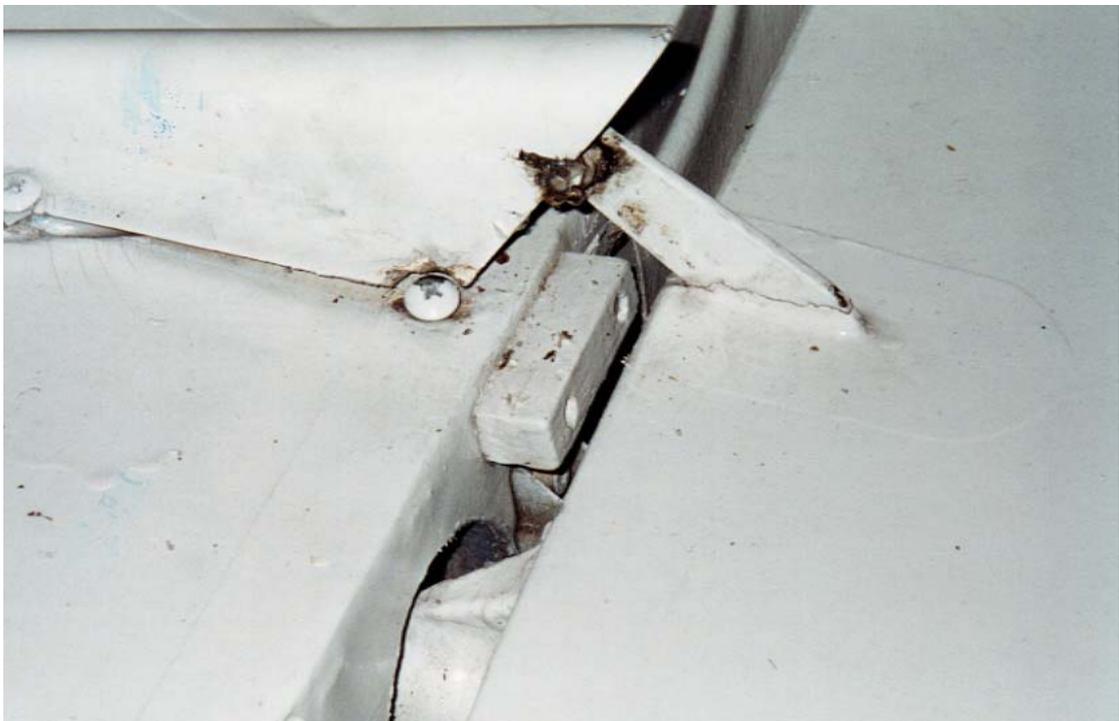
The field in which the aircraft had landed was owned by another of the pilot's neighbours who facilitated recovery of the aircraft, by an aircraft engineering company, to accommodation on his farm. During this process it was noted that the ailerons apparently functioned normally. However, it was later noted that there was evidence of fouling between a bolt connecting the right hand aileron horn to its associated operating rod in the wing, and a glassfibre shroud attached to the wing where the operating rod emerged from it. This can be seen in the photographs at Figures 1 and 2. Contact between the bolt and the shroud occurred with the aileron in a near - neutral position and was such that upward movement was impeded, which appeared to correspond with the reported control symptoms. The shroud was attached to the wing upper surface screws which passed through a flange around its base. It was noted that the rear of the shroud was only partially secured because the rear inboard corner of the flange had broken off under the head of the screw.

However, a member of the aircraft recovery organisation (which had not been associated with the maintenance of the aircraft) subsequently stated that he had caused this damage whilst he was investigating the flying controls for potential restrictions after this incident. Although the aileron system was inspected, no other reason for the restriction was found. Notwithstanding this, the commander noted that he had felt inhibited from applying excessive force after encountering the restriction, for fear of breaking a control cable. It was thus possible that an in-flight contact occurred between the bolt and the shroud, with little discernible damage resulting to the latter; the observed damage to the shroud flange could therefore have been caused during the subsequent investigation, as described by the member of the recovery team.

FIGURE 2. Evidence of contact between bolt tail and inboard edge of shroud.

Note broken corner of shroud under screw head.
