AIB Bulletin

No: 8/85

Aircraft type and registration: Bell 222 G-METB (heavy helicopter, public transport)

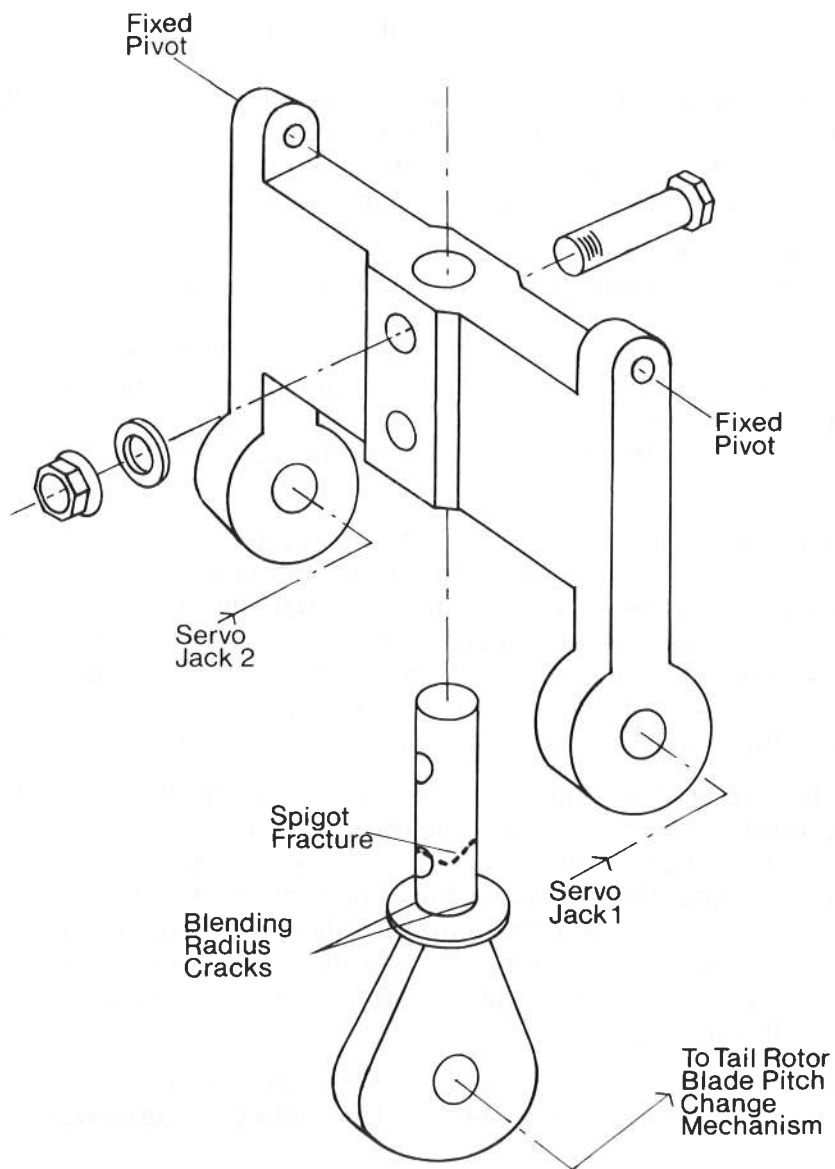
Fig.1

Yaw pedal movement on the Bell 222 is transmitted to the pitch change arms of the tail rotor blades via a rod and bellcrank lever linkage. A hydraulic servo jack is interposed in series in the linkage partway along the run to provide reduced pedal forces and prevent transient tail rotor loads feeding back to the pedals. The aircraft was designed with a single jack, but for British Validation of the FAA Type Certificate dual parallel jacks supplied from two separate hydraulic sources were required, as pedal forces in the event of jack failure were considered excessive. This also necessitated a different design of lever to connect the two jack output rams to the linkage (Fig 1). The central arm of the lever incorporates a spigot of 0.562 inches nominal diameter which fits into a socket in the main part of the lever, with a design clearance of

0.0003—0.0013 inches. Both parts are of aluminium alloy. The spigot is installed with an epoxy based adhesive and retained by two 0.25 inches diameter bolts. The lever is supplied by the aircraft manufacturer as an assembly.

Examination of G-METB revealed that the central arm of this combining lever had failed, completely disconnecting the tail rotor from the rudder pedals. The failure comprised fracture of the spigot at the point where it was penetrated by the lower retaining bolt hole, following propagation of fatigue cracking across almost the whole spigot cross-section from origins at the four corners of the bolt hole. Fatigue cracking was also found at the forward and aft side of the arm in the blending radius between the spigot and flange.

Spigot material properties were consistent with the design specified material, spigot and socket dimensions were within design limits, and chemical analysis confirmed the presence on the spigot of epoxy adhesive deposits. Few traces of adhesive were found on the lower parts of the spigot or socket surfaces, but an even film could clearly not be expected to remain after a cylindrical spigot had been introduced into a tight clearance socket, and there was no reason to suspect that G-METB's linkage was unusual in this respect. The evidence clearly indicated that the spigot had been rocking in the socket in a fore and aft sense during part of the fatigue fracture progression.
