# AIB Bulletin

# 10/85

**Ref: EW/C914**

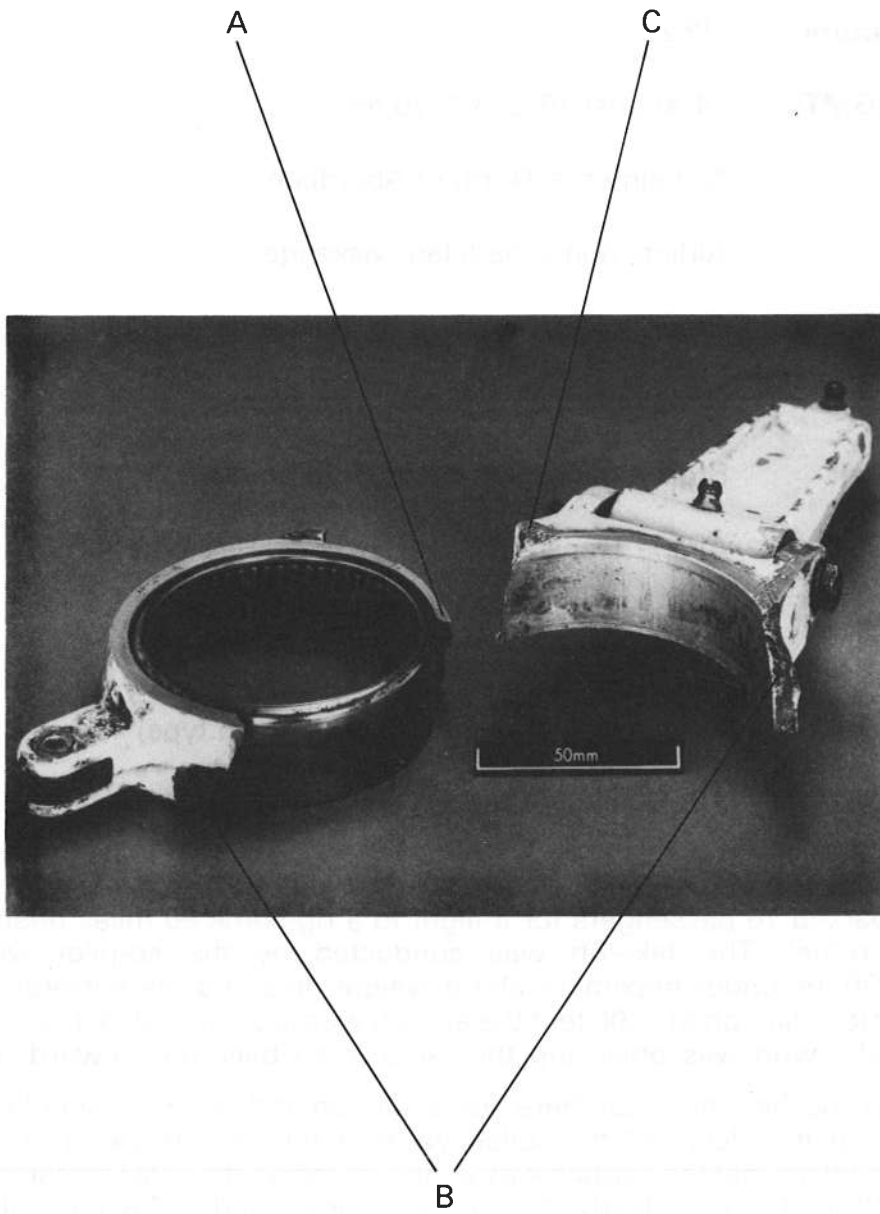
Fig 1

Examination of the aircraft showed that the steering collar (fig 1) on the nose gear had failed. This collar transmits the pilot's steering commands to the upper arm (fig 1, to right) of the torque link scissors assembly; failure of the steering collar would allow the lower strut to descend and the nosewheel to castor.

Metalurgical examination of the two fractures indicated that the initial fracture had occurred at A, in the area of reduced cross-section, and that the final failure occurred at area B. The initial fracture shows some evidence of a small area of fatigue originating in an area of rough surface finish on an inside radius (point C).

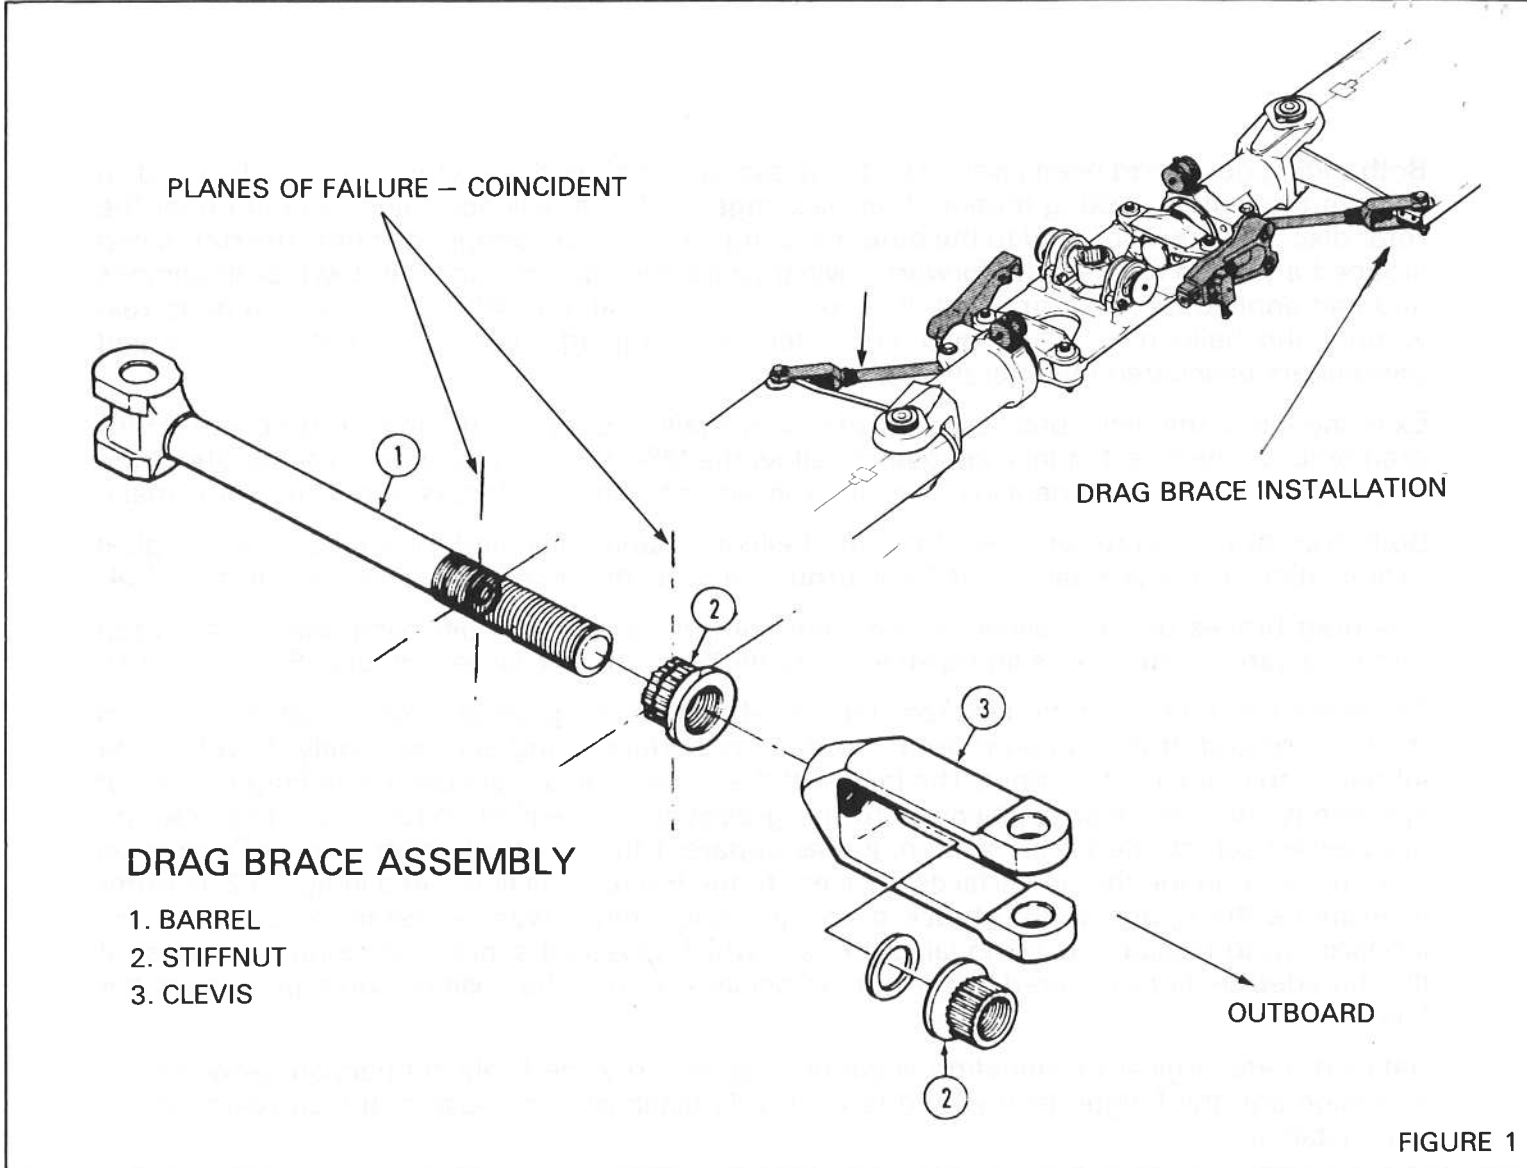
FIGURE 1

The drag braces on the helicopter are each comprised of two main components; a forged threaded barrel, and a clevis fitting attached to the barrel by two large stiffnuts. (Refer figure 1).

The brace had failed by fatigue across the barrel section at a position approximately  $1\frac{1}{2}$ " from the inboard end of the thread runout, the fracture surface being approximately  $\frac{1}{2}$ " within the inboard end of the inner stiffnut. The failure of the nut was also associated with fatigue, the nut apparently having been subjected to progressively increased loading as the fracture progressed across the barrel section. It was apparent that relatively high levels of corrosion were present on the thread surfaces adjacent to the fracture, as illustrated in figure 2. In order to examine the opposite drag brace from this helicopter, it was necessary to cut open the inboard nut to facilitate its removal, a process which revealed similar corrosion over most of the threaded sections covered by the nut, particularly around the position corresponding to the failure.

Both the barrel and stiffnuts are made from high tensile alloy steel, cadmium plated for corrosion protection. However, the stiffnuts are only effective as such due to deformation of the thread, accomplished during manufacture, by a degree of crimping of the end of the nut at three positions spaced  $120^\circ$  apart.

The possibility that damage was occasioned to the protective treatment of the threaded sections as the stiffnuts were screwed along the barrel, by these areas of relatively high contact pressure, is presently being investigated. Additionally the localised stress concentrations due to this feature of the stiffnut and operation of the helicopter in a mildly corrosive environment, ie over water, are being examined as possible contributory factors in the failure mechanism.

As a result of this failure and the subsequent discovery of corrosion/cracks on some other aircraft, the Civil Aviation Authority have placed additional restrictions on the life of this component and the design of the assembly is being reviewed.
