INCIDENT

Aircraft Type and Registration:	Piper PA-34-200T Seneca II, G-BSHA	
No & Type of Engines:	2 Continental TSIO-360-EB1 piston engines	
Year of Manufacture:	1976	
Date & Time (UTC):	5 March 1993 at 0701 hrs	
Location:	Blackbushe Airport, Surrey	
Type of Flight:	Aerial Work	
Persons on Board:	Crew - 2	Passengers - None
Injuries:	Crew - None	Passengers - N/A
Nature of Damage:	Both propellers significantly damaged, aircraft boarding step scraped and engines shock-loaded	
Commander's Licence:	Basic Commercial Pilot's Licence with Instrument rating	
Commander's Age:	32 years	
Commander's Flying Experience:	2,200 hours (of which 130 were on type) Last 90 days - 56 hours Last 28 days - 18 hours	
Information Source:	Aircraft Accident Report Form submitted by the pilot, together with examination of door mechanism by AAIB engineering Inspector and subsequent discussions with operators and pilot

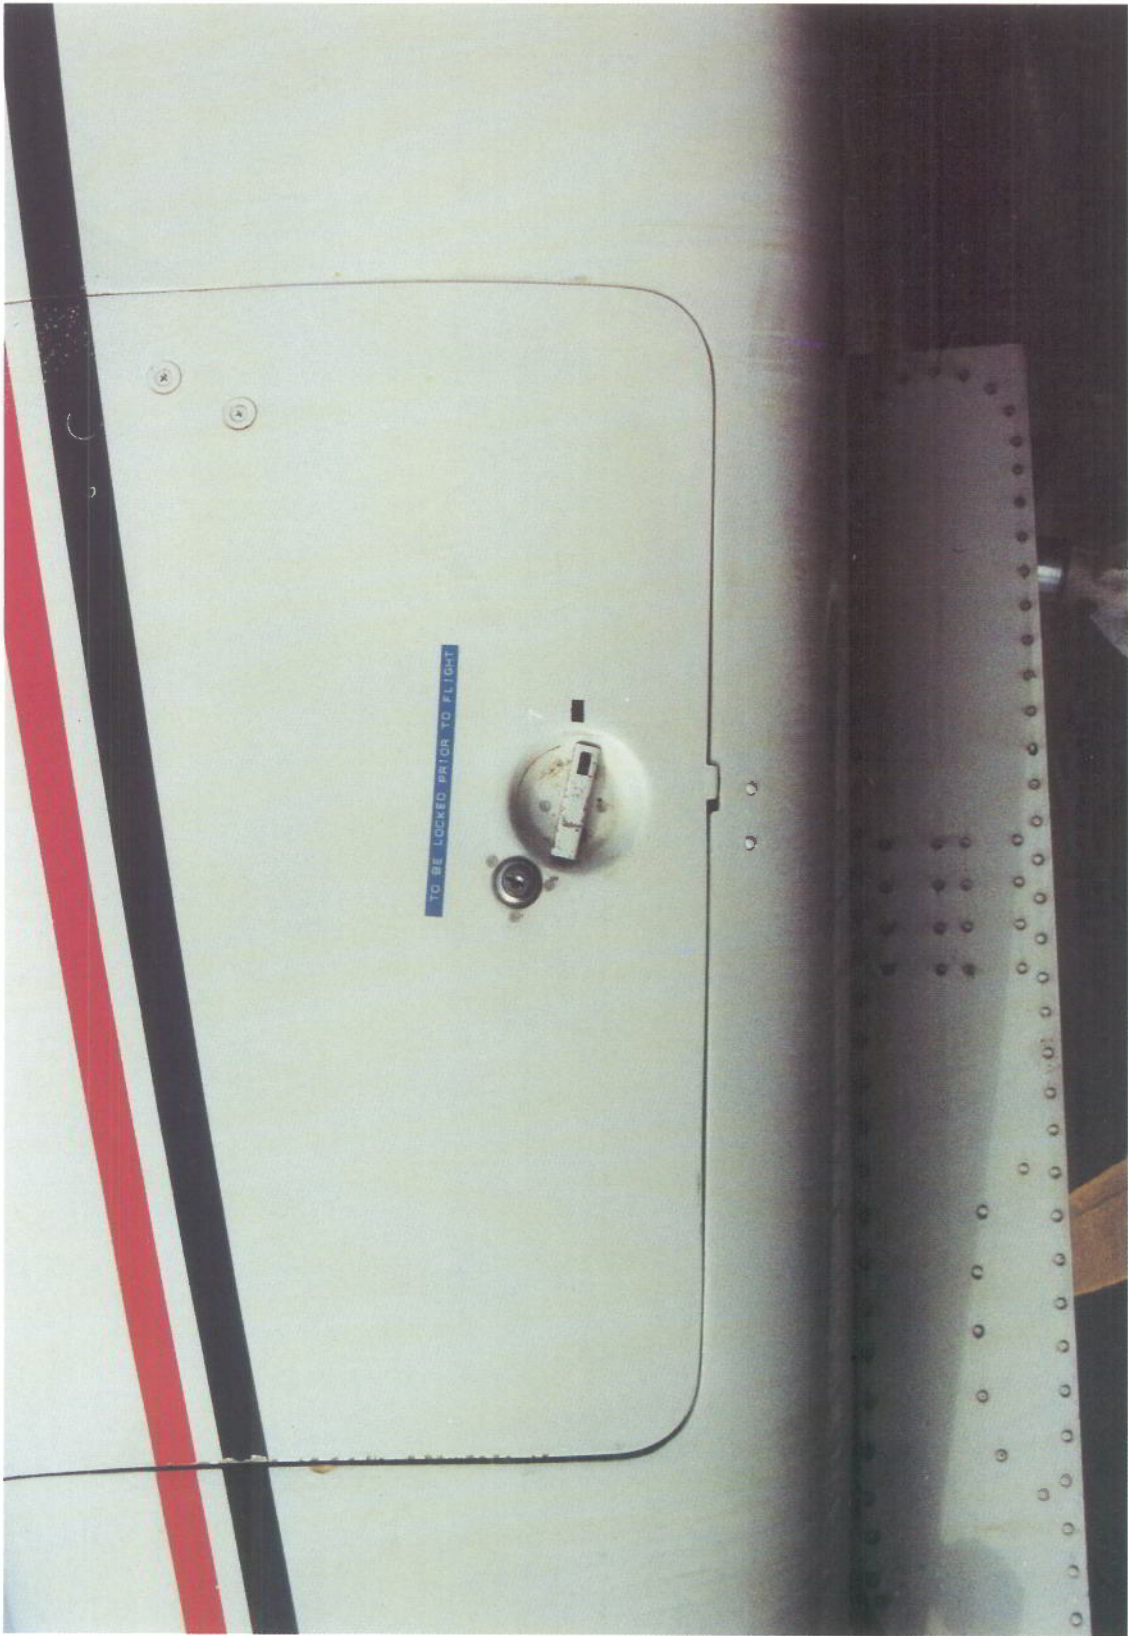
FIGURE 1

Examination of the door locking mechanism on this aircraft revealed that the key could be removed from the lock barrel whilst in any rotary position and hence it performed no interlocking function in alerting operators to a door unsafe condition. Further examination of the baggage door latching arrangements showed that when the mechanism was in the fully latched condition, the handle was rotated to such a position that its painted alignment mark was significantly beyond the corresponding painted mark on the door (See Figure 1).

- 93-46** The CAA should require periodic checks of the latching mechanism to ensure that the external markings align accurately when the door mechanism is correctly latched.
(Issued 21 July 1993)

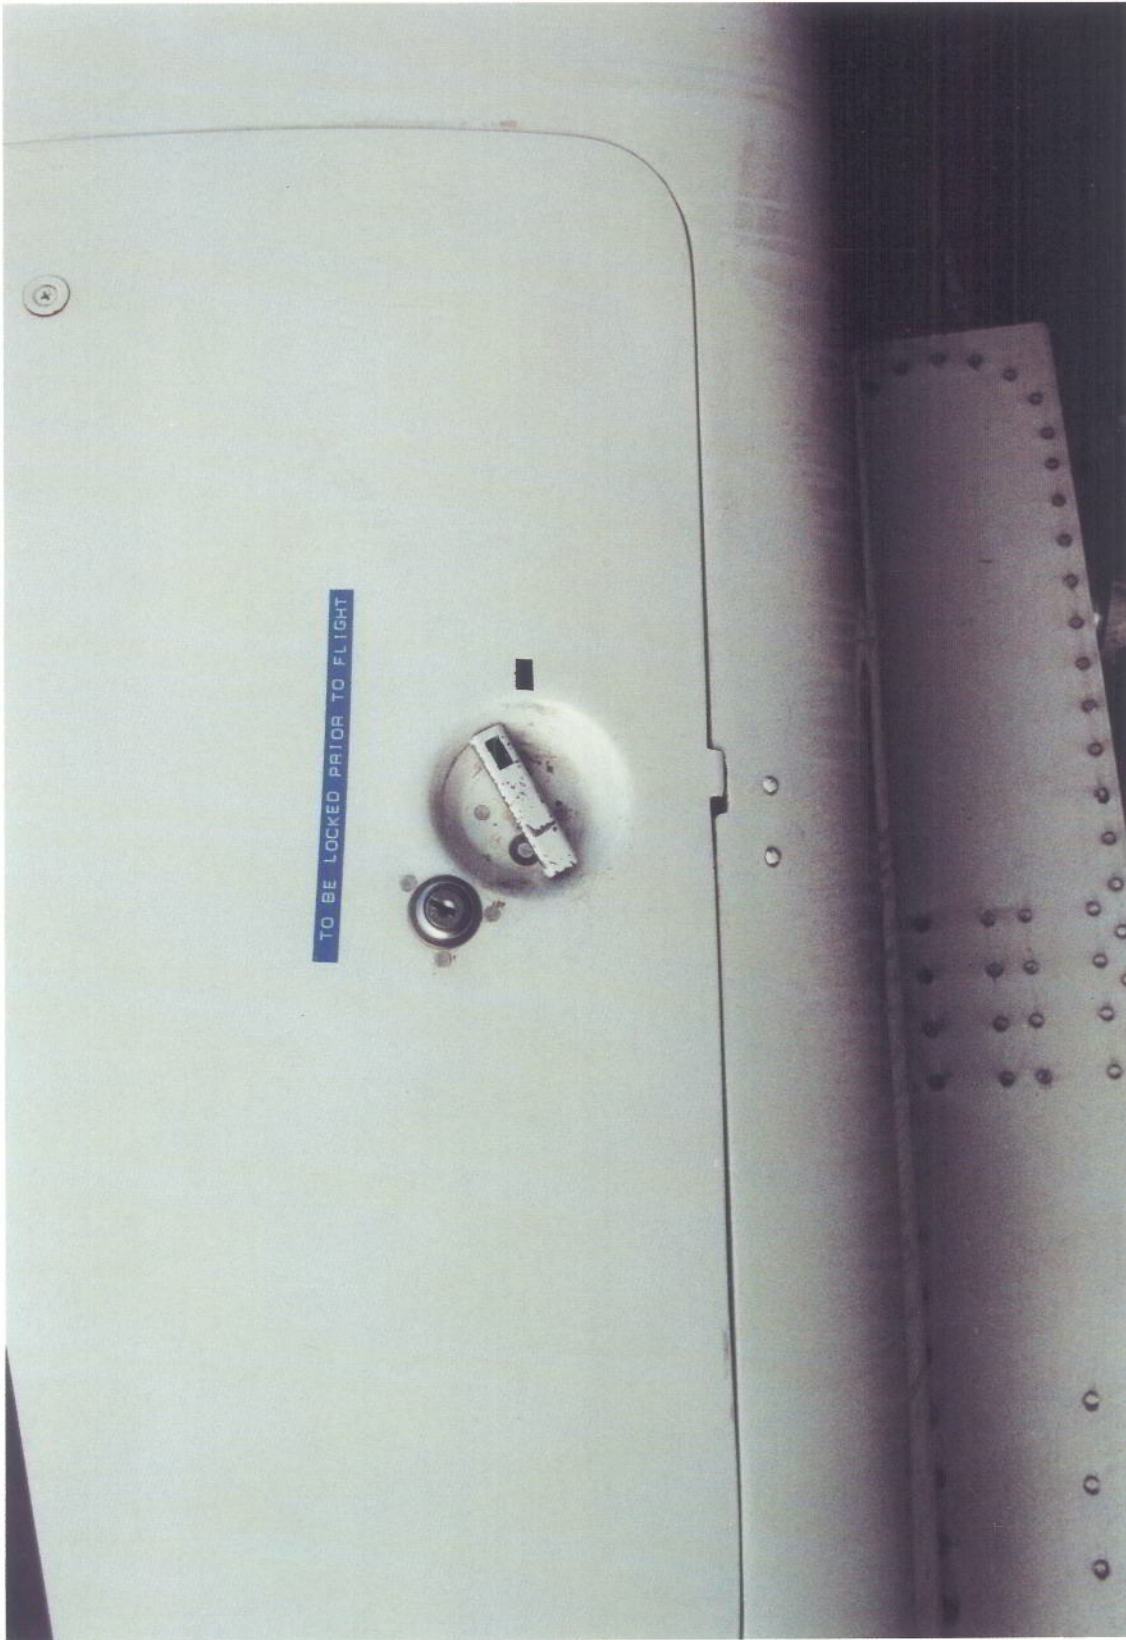
FIGURE 2

Examination and testing of the latch system revealed that this mechanism was 'on centres' when the handle was positioned as shown in Figure 2. In this condition the door appeared to be latched, but a sharp blow administered by hand to the centre of the door caused it to unlatch and pop open. With the handle positioned any further in the closed direction, such a blow would cause it to rotate to the fully

latched position. Thus, the door appeared to be latched when the handle was out of alignment by only approximately twice the angular distance by which it was in error with the latch fully engaged, albeit in the opposite direction of travel.

- 93-45** The CAA should require the implementation of SB 872 on a repetitive basis in order to ensure that the interlocking of the lock and latching arrangements remain effective.
(Issued 21 July 1993)
