Aircraft Type and Registration:	Piper PA-34-200T Seneca, G-BHYG	
No & Type of Engines:	2 Continental Motors TSIO-360-EB piston engines	
Year of Manufacture:	1980	
Date & Time (UTC):	11 February 2005 at 0747 hrs	
Location:	1.5 miles north-east of Oxford (Kidlington) Airport, Oxon	
Type of Flight:	Training	
Persons on Board:	Crew - 3	Passengers - None
Injuries:	Crew - None	Passengers - N/A
Nature of Damage:	Front baggage bay door detached, damage to left propeller	
Commander's Licence:	Airline Transport Pilot's Licence	
Commander's Age:	49 years	
Commander's Flying Experience:	3,600 hours (200 hours on type) Last 90 days - 70 hours Last 28 days - 30 hours	
Information Source:	Aircraft Accident Report Form submitted by the pilot

Damage to aircraft

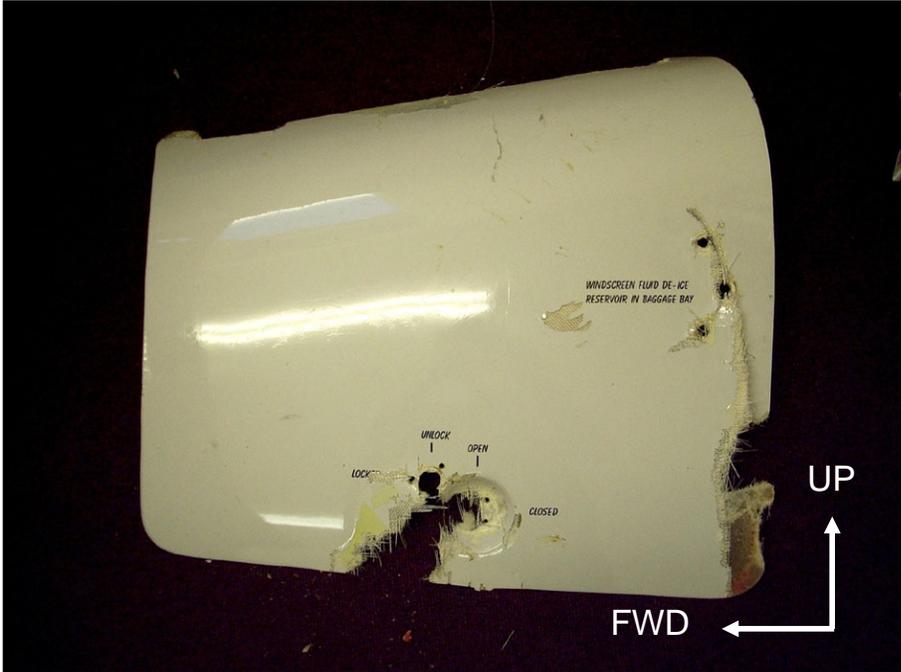
Figure 1

On inspection, the left propeller was found to be badly damaged, having struck the departing door and the door seal was wrapped around the OAT probe. The remains of the door were recovered from a nearby golf course (Figure 1), with the latch spring still attached, but the lock, shoot bolts and other

latch components were missing, these probably having been knocked off on contact with the propeller. According to the engineer who inspected the aircraft, there was no evidence of distress to the door frame or the latch components on the aircraft. Following the incident, the nose baggage bay door key, with its high-visibility fob, was found inside the aircraft where it is normally stowed.

Given that the instructor saw the handle in the unlatched position when the door came open in flight, and the lack of distress to the door frame or latch components on the aircraft, it is probable that the door was not latched prior to flight. This implies that it must have been possible to either withdraw the key from the lock with it in the unlocked position, or that it was possible to turn the key to the locked position, with the door handle in the unlatched position. However, as the lock was not recovered, it was not possible to confirm either scenario.

Damaged Nose Baggage Bay Door

The operator is modifying its PA-34 fleet to paint more visible alignment marks adjacent to the door handle, to make it easier to confirm that the door is latched. The fleet is also to be inspected for

proper functioning of the nose baggage bay door key/latch interlock function. The operator's PA-34 maintenance schedule will also be expanded to include this as a recurring inspection on the '100-hour' Check. A communication has already been issued to all instructors and students within the flying training organisation to make them aware of the implications of lock/key wear and the need to confirm that the nose baggage bay door is correctly latched prior to flight.
