BULLETIN RE-ISSUED

INCIDENT

Aircraft Type and Registration:	Airbus A319-131, G-DBCI
No & Type of Engines:	2 International Aero Engines V2522-A5 turbofan engines
Year of Manufacture:	2006
Date & Time (UTC):	18 April 2007 at 0944 hrs
Location:	Amsterdam Schiphol Airport, The Netherlands
Type of Flight:	Commercial Air Transport (Passenger)
Persons on Board:	Crew - 5 Passengers - 112
Injuries:	Crew - None Passengers - None
Nature of Damage:	None
Commander's Licence:	Airline Transport Pilot's Licence
Commander's Age:	53 years
Commander's Flying Experience:	11,123 hours (of which 3,493 were on type) Last 90 days - 132 hours Last 28 days - 44 hours
Information Source:	AAIB Field Investigation

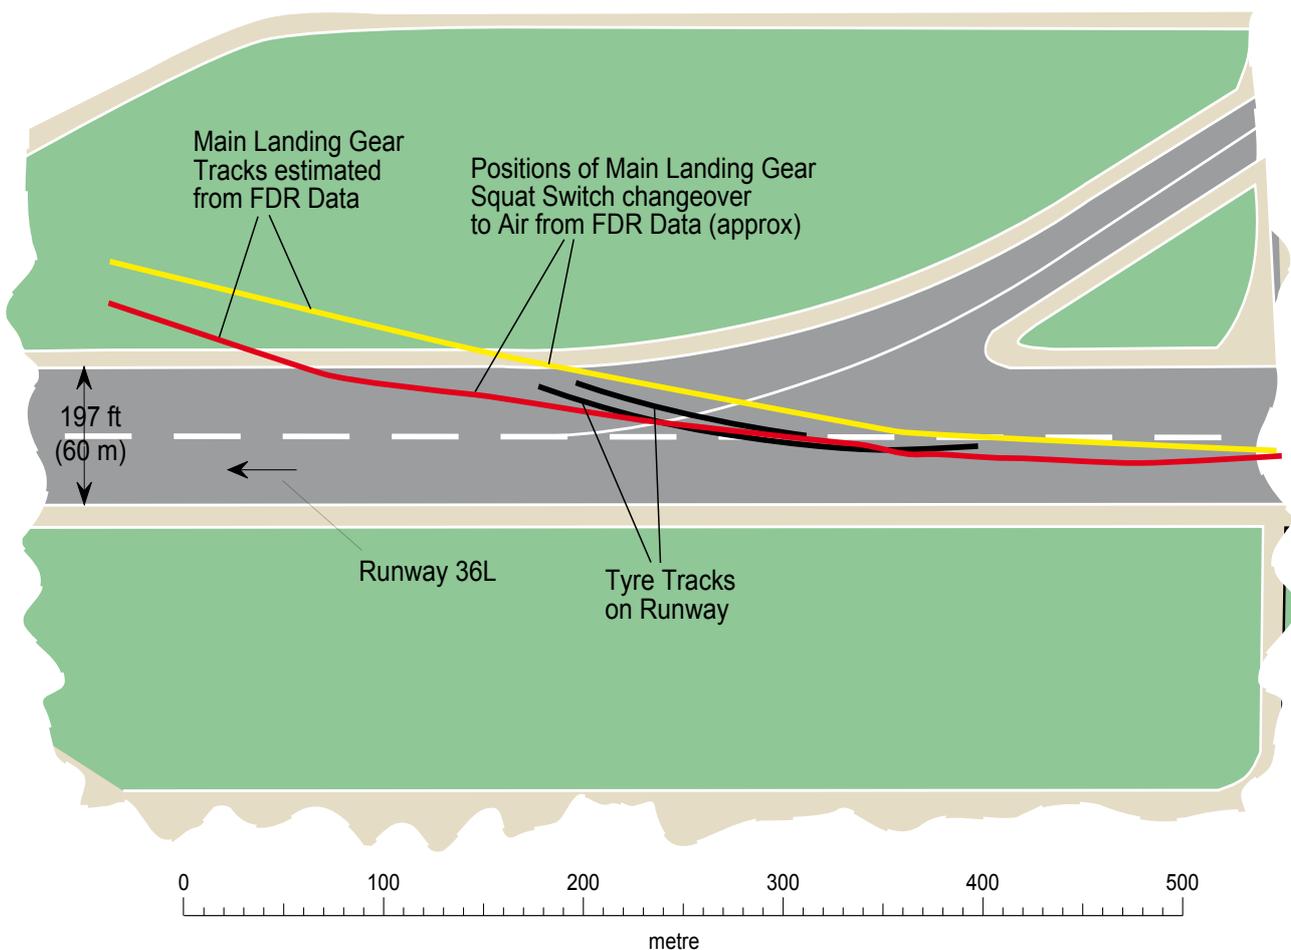
Figure 3

Inspection of Runway 36L at Amsterdam by the Dutch authorities shortly after the incident identified two pairs of tyre track marks that appeared likely to be associated with G-DBCI's takeoff ground roll deviation. The Dutch Safety Board supplied photographs of the marks and their approximate dimensions and AAIB subsequently examined the runway. The marks were found to consist of pronounced black rubber deposits on the light-coloured asphalt surface of the runway. Their lateral spacing corresponded to the A319 main landing gear wheeltrack and their position (Figure 3) corresponded closely to the aircraft track estimated from FDR data. It was therefore concluded that G-DBCI's mainwheel tyres had made the marks during the takeoff ground run.

The track marks from the left main wheel tyres commenced approximately 1,035 m from the start of Runway 36L, adjacent to a turnoff (V2 turnoff) from the reciprocal Runway 18R, with the aircraft near to the centreline. The marks indicated a brief slight turn to the left, followed by a sustained right turn, during which track marks from the right mainwheel tyres became evident. After turning approximately 20° right of the runway heading, both the left and right track marks ceased, at points respectively 9 m and 6 m from the runway edge. No signs were found to indicate that any of the tyres had run on the runway shoulder or the grass surround.

Plan View of Runway Tyre Marks and Main Landing Gear Tracks estimated from FDR Data

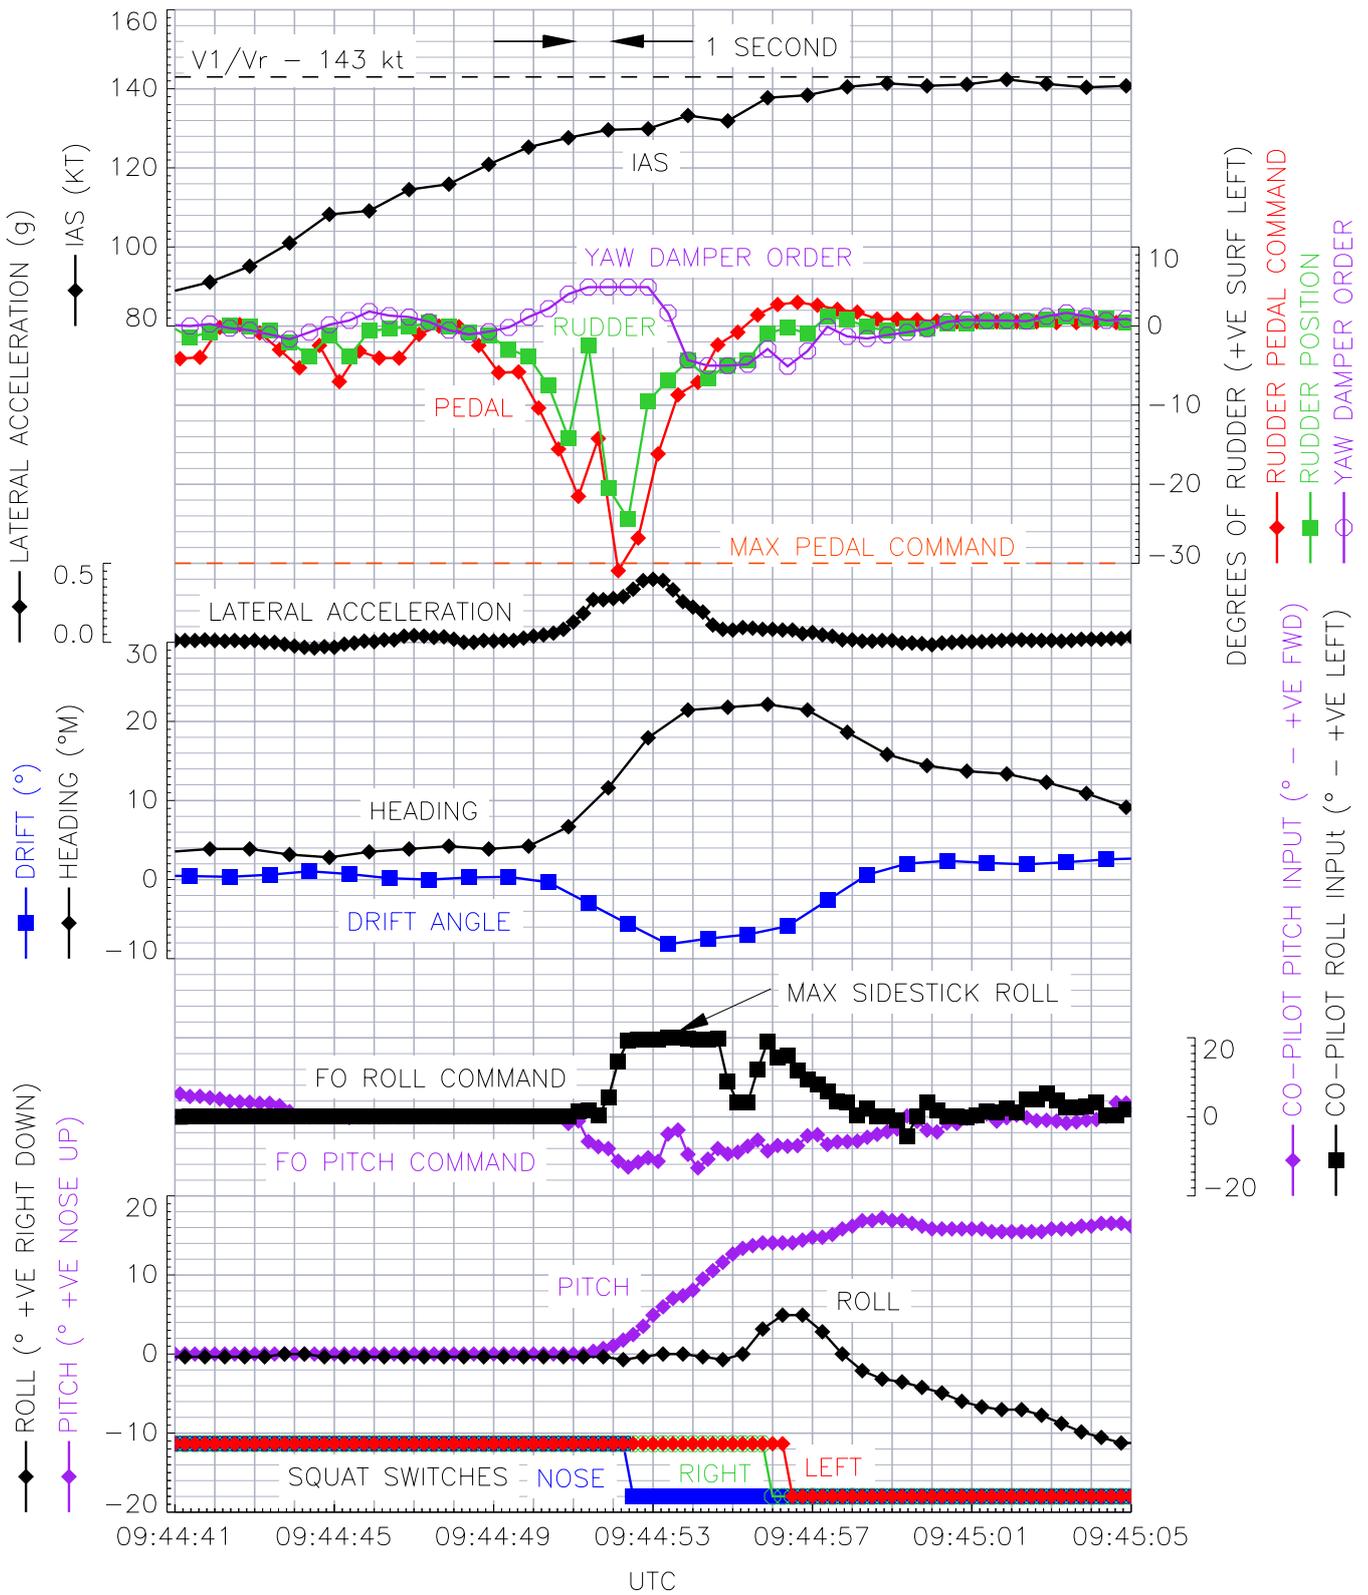
Figure 4

FDR Parameters showing control inputs and aircraft motion.
(Incident to G-DBCI on 18 April 2007)

At 0944:48 hrs, with an IAS of 116 kt, another right pedal input was initiated. Two seconds later, whereas previous inputs had started to return towards neutral, the right pedal input continued increasing and the heading increased through 005°M. A further second later the data shows a brief peak in pedal input at approximately 72% of full deflection. At this point the IAS was 128 kt and increasing, aircraft heading was passing through 007°M and recorded drift angle was increasing through 3°.

The co-pilot's sidestick showed the start of a pitch up command. Half a second later, the commander's sidestick registered a brief roll left input and the co-pilot's sidestick started to move towards a full left roll input. There was a one sample reduction in pedal input and rudder deflection. This was followed, half a second later, by a 31° yaw right command from the pedals (effectively a maximum 30° right rudder surface command) and an opposing 5° left rudder command from the yaw damper. This combination resulted in a recorded rudder surface deflection of 24° to the right.

At an IAS of 130 kt, with heading increasing through 015°M and with full roll left command applied, the aircraft had started to rotate, increasing through a pitch attitude of 2° nose up. This airspeed equates to $V_R - 13$ kt.

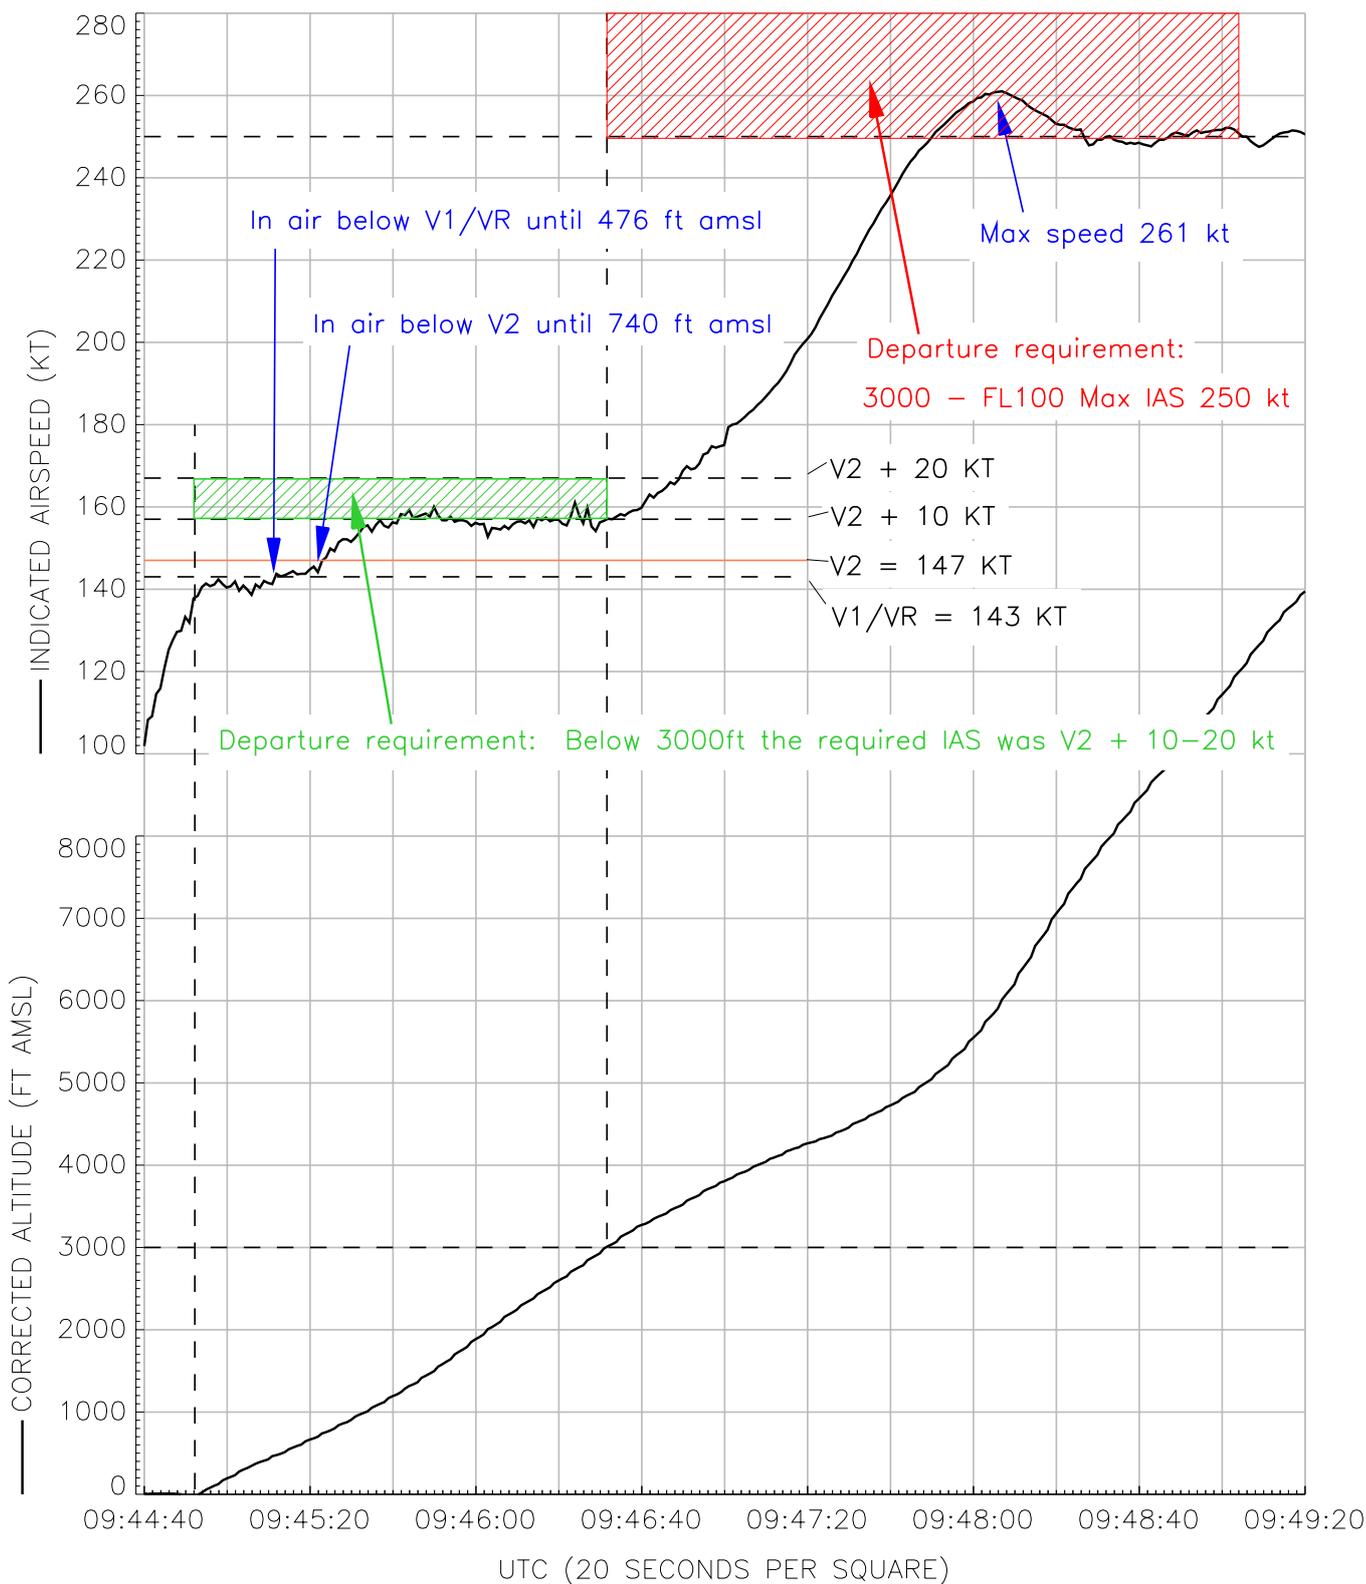
Figure 5

FDR parameters showing recorded airspeed relative to required airspeed after takeoff
(Incident to G-DBCI on 18 April 2007)

it continued to follow the SID, accelerating slowly to the SRS target speed of $V_2+10\text{kt}$ by 1,100 feet amsl. The time taken for the aircraft to accelerate to V_2 , the takeoff safety speed, was undesirable, bearing in mind that it is the speed that should be achieved by the screen height (35 feet agl) if an engine failure occurs at V_1 .
