No: 8/92 Ref: EW/C92/4/9 Category: 1a

Aircraft Type and Registration: Airbus A300B4-103, SX-BEG

Location: Stand F15, London Heathrow Airport

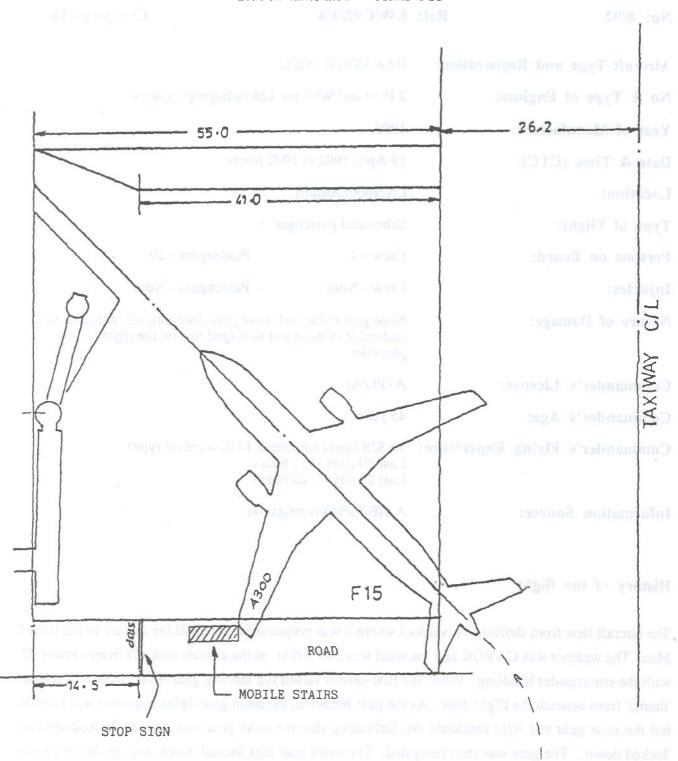
After landing, the aircraft was instructed to proceed to Gate F15 via the outer taxiway. F15 is the outermost stand of a cul-de-sac parking area at Terminal 2 (see attached diagram). The handling agents had detailed a driver to position a set of self propelled stairs adjacent to F15 in preparation for passenger disembarkation. The driver collected the steps from the far end of the cul-de-sac and drove onto F15 before attempting to reverse over the stop line at the edge of the aircraft manoeuvring area. Meanwhile however, a refuelling vehicle had parked across the stop line and the two vehicles collided. The driver got out of his vehicle to check for damage and having assured himself that there was none, he drove forward several metres and parked in the position shown on the diagram. The driver stated that the apron markings led him to believe that he was parked on a road and not on the aircraft manoeuvring area although he did state that he knew that he should have been behind the stop line. He therefore raised the steps to the sill height of an A300 in anticipation of the arrival of the aircraft.
