**AAIB Bulletin No:** 2/93

**Ref:** EW/G92/11/11

**Aircraft Type and Registration:** Piper PA-38-112 Tomahawk, G-BSVW

**Nature of Damage:** Damage to propeller, engine and lower cowling

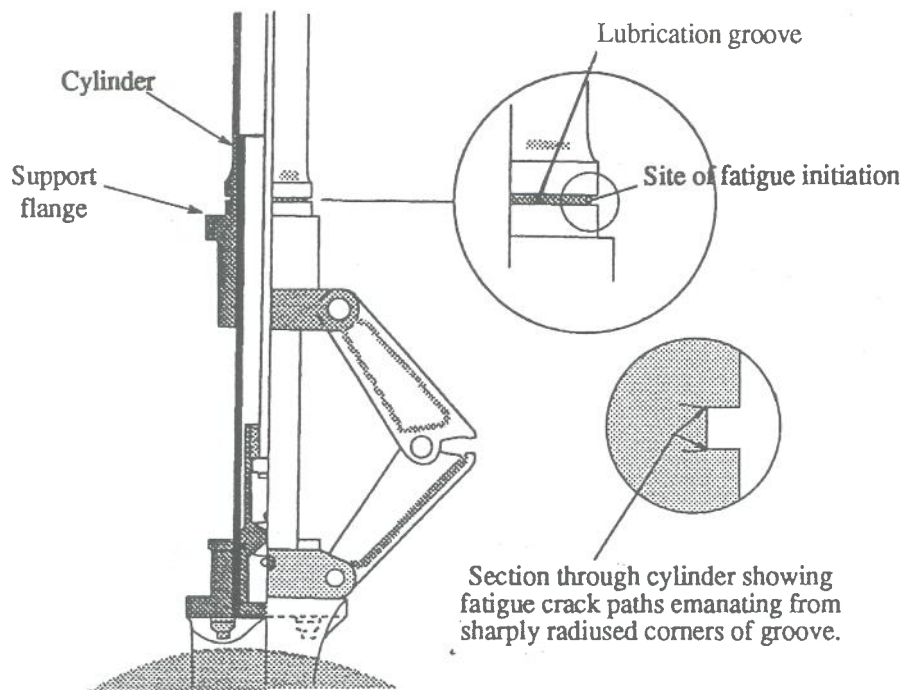
**Half Section of PA38  
(Tomahawk) Nose Leg**

It was apparent that the cylinder had failed at the position of a 2.2mm wide, 1.4mm deep, lubrication groove at its bottom end (see attached diagram). Examination of the fracture surfaces revealed the presence of fatigue cracking emanating from multiple origins in the bottom corner of the groove around

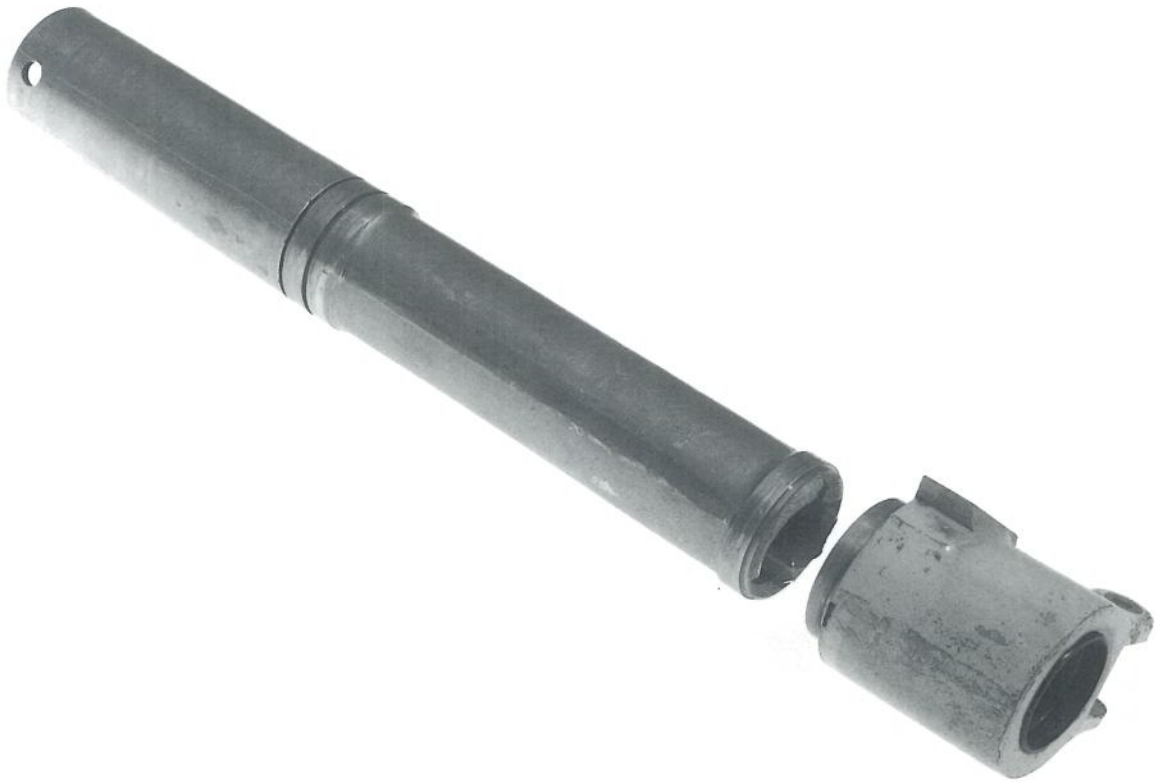
General view of fractured nose leg from G-BSVW

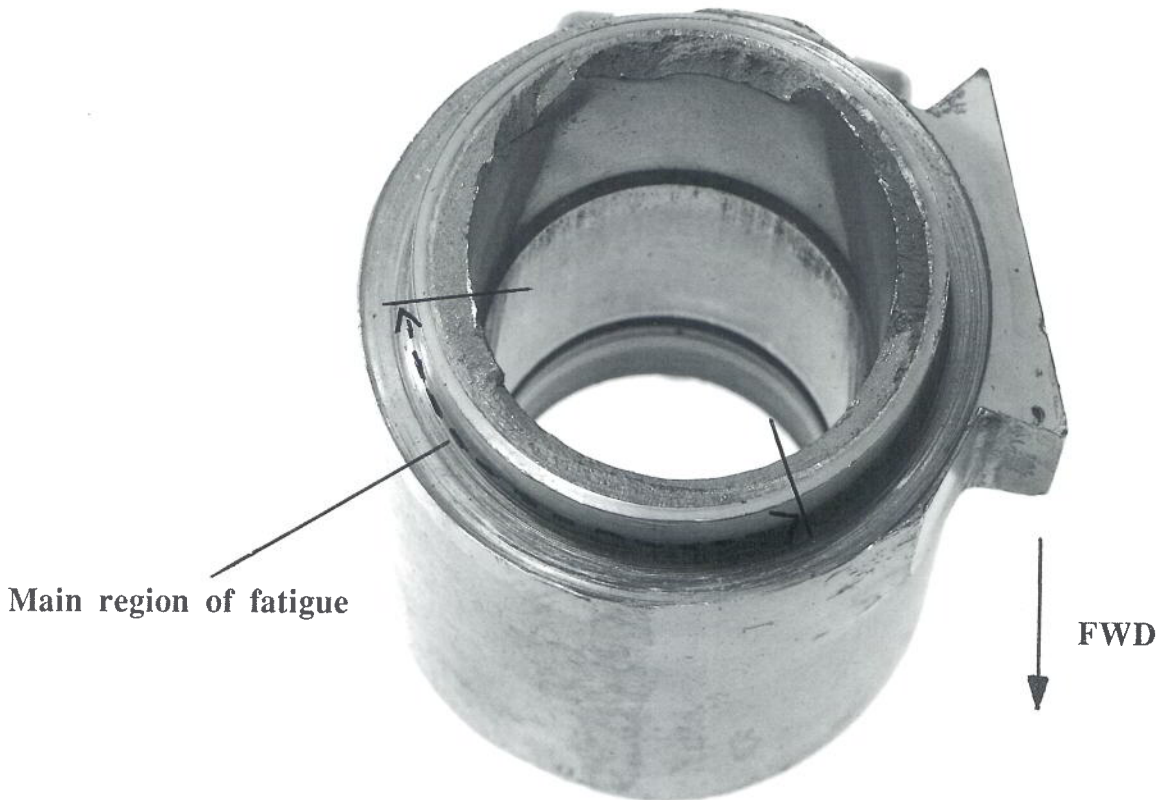
the entire circumference. The main region of the fatigue was at the front of the cylinder, where it had penetrated to a depth of approximately 3.5mm; the penetration around the remainder of the circumference was approximately 0.5mm. In addition, there was evidence of circumferential cracking in the top corner of the groove. There was no evidence of corrosion attack or mechanical damage that could have influenced the failure. Thus the alleged heavy landing resulting in the damaged engine mount is unlikely to have contributed to the failure. It was considered that the absence of any blending radii in the groove would have resulted in high localised stresses, leading to fatigue initiation.

View of fracture face on lower portion of the leg
