ACCIDENT

Aircraft Type and Registration:	Beech B58 Baron, G-OSDI	
No & Type of Engines:	2 Continental Motors Corp IO-520-CB piston engines	
Year of Manufacture:	1980	
Date & Time (UTC):	5 April 2008 at 1220 hrs	
Location:	Leicester Airport, Runway 28	
Type of Flight:	Private	
Persons on Board:	Crew - 1	Passengers - None
Injuries:	Crew - None	Passengers - None
Nature of Damage:	Right propeller blades bent, engine shock-loaded, scraping on right wing tip, passenger step displaced	
Commander's Licence:	Private Pilot's Licence	
Commander's Age:	54 years	
Commander's Flying Experience:	682 hours (of which 64 were on type) Last 90 days - 1 hour Last 28 days - 0 hours	
Information Source:	AAIB Field Investigation

Synopsis

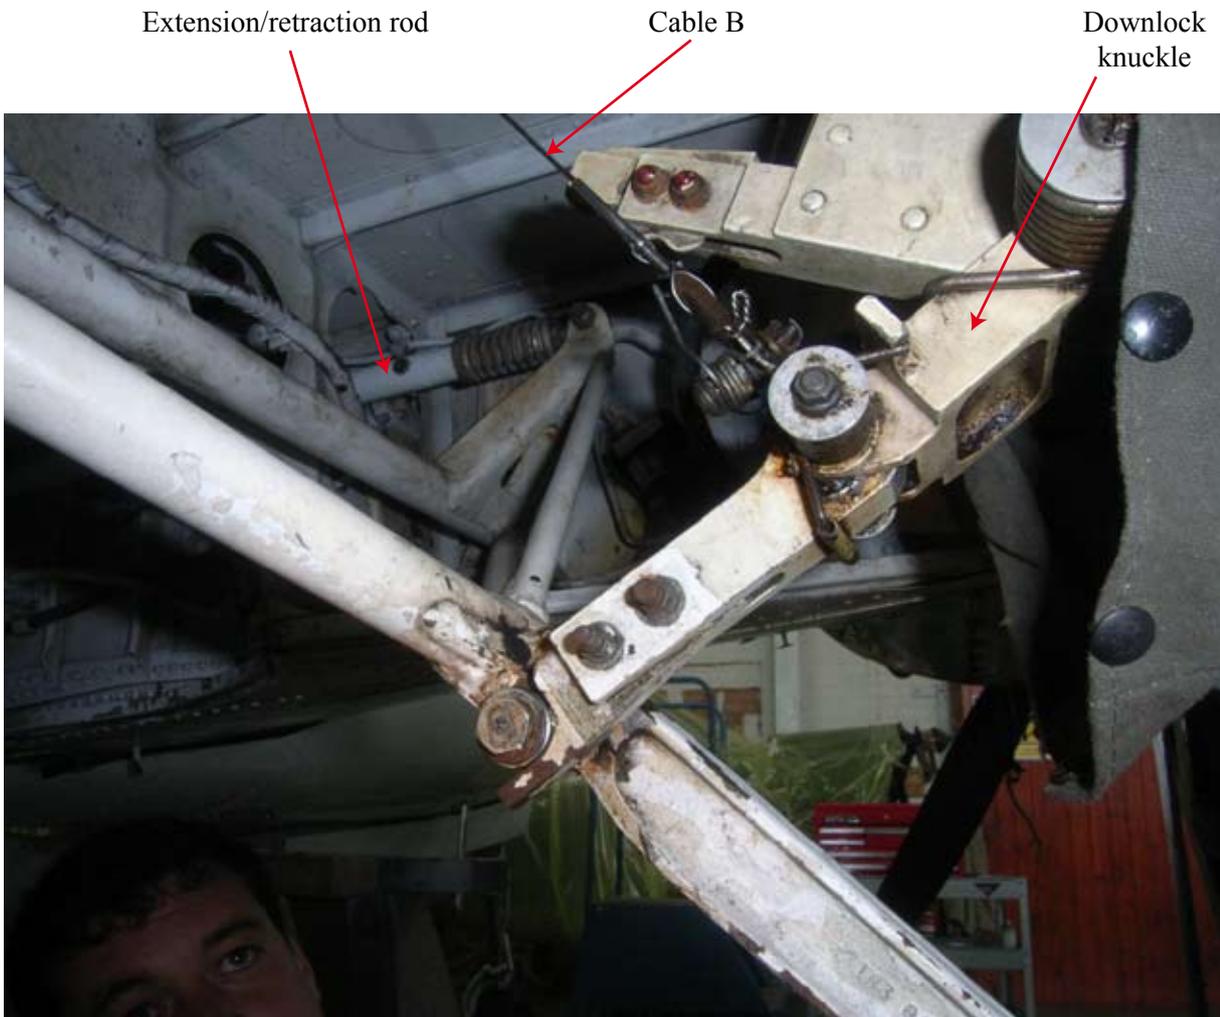
Figure 1
Gear down and locked

condition, the rod overtravels and compresses a spring, which forms part of the rod: the downlock is thus held overcentre by this spring pressure (see Figure 1). As this occurs, cable 'B' tensions and pulls the secondary downlock into place underneath a roller on the sidebrace; this is to prevent the gear from being forced out of lock by cornering forces or yawed landings. The green indication in the cockpit is not an indication that the gear is fully locked DOWN with the secondary lock in place, but, because it is activated by a striker plate on the sidebrace, it is an indication that the leg is in a position where the sidebrace is overcentre.

Maintenance Manual (MM) requires this gap to be only 0.010 – 0.020 inches. In Figure 1 it can be seen that the secondary lock is hard up against the roller, whereas the MM specifies the same clearance. Both left and right gear rollers were found to have seized solid and could not be freed. A third roller of the same type in the nose landing gear mechanism was also seized.

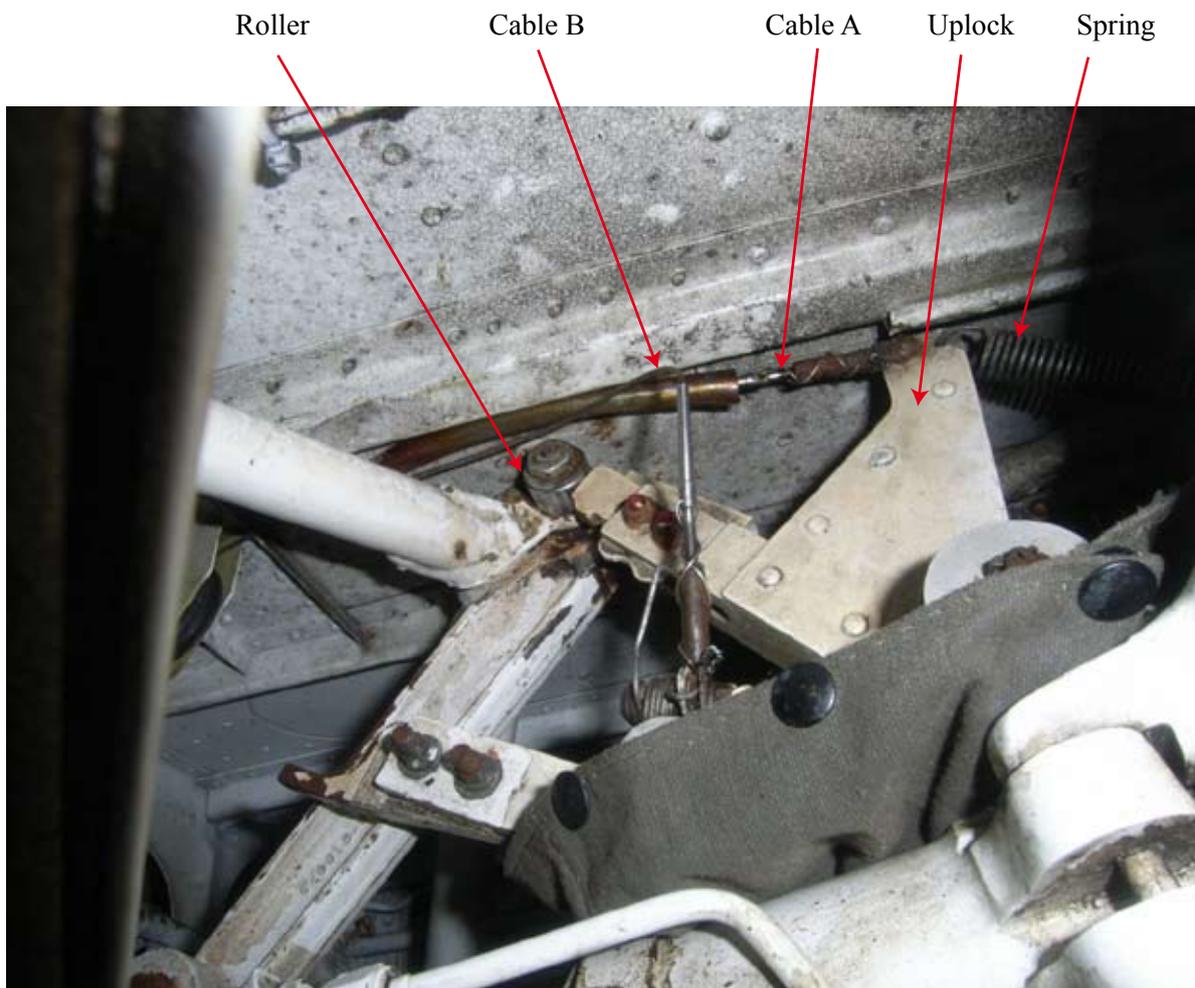
Figure 2
Gear up and locked

Figure 2 shows the right main landing gear of G-OSDI in the up-and-locked condition (doors removed for access): cable 'A' is tensioned and pulling the uplock against its spring under the roller. Although not apparent in the photograph, there was a clearance of about 0.25 inches between the uplock and the roller. The

A test was devised in which the uplock was temporarily prevented from moving during a hand-cranked extension cycle. As the gear started to move, the roller contacted the uplock and the whole mechanism jammed; further cranking would have caused the extension/retraction rod to bend. This situation could occur if the extension cycle was initiated during an encounter with turbulence or, possibly, freezing of the uplock. When a ‘free’ roller was used, and the test repeated, the roller was able to nudge the uplock upwards out of the way and gear extension was unimpeded.
