**ACCIDENT**

<b>Aircraft Type and Registration:</b>	Cessna F172M, D-EESE
<b>No &amp; Type of Engines:</b>	1 Thielert TAE 125-01
<b>Year of Manufacture:</b>	1975 (Serial no: F17201297)
<b>Date &amp; Time (UTC):</b>	15 November 2013 at 1630 hrs
<b>Location:</b>	Lower Lough Erne, Co Fermanagh, Northern Ireland
<b>Type of Flight:</b>	Aerial Work
<b>Persons on Board:</b>	Crew - 1                      Passengers - 1
<b>Injuries:</b>	Crew - None                      Passengers - None
<b>Nature of Damage:</b>	Aircraft destroyed
<b>Commander's Licence:</b>	Commercial Pilot's Licence
<b>Commander's Age:</b>	32 years
<b>Commander's Flying Experience:</b>	809 hours (of which 783 were on type) Last 90 days - 205 hours Last 28 days - 43 hours
<b>Information Source:</b>	Aircraft Accident Report Form submitted by the pilot and further enquiries by the AAIB

**Synopsis**

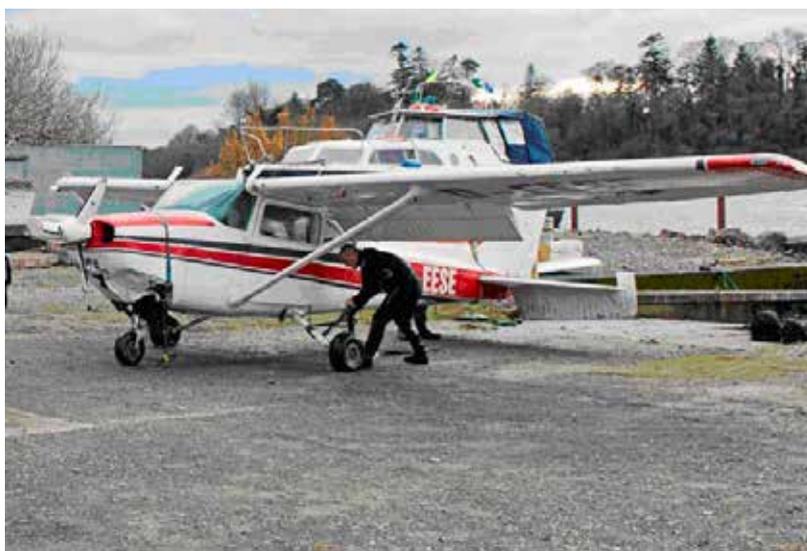
**Figure 1**

Cessna 172, D-EESE after recovery from Lower Lough Erne
