ACCIDENT

Aircraft Type and Registration:	Rotorway Executive 162F, G-JONG	
No & Type of Engines:	1 Rotorway RI 162F piston engine	
Year of Manufacture:	2004	
Date & Time (UTC):	14 June 2009 at 1845 hrs	
Location:	1.5 miles east of Bullington Cross on A303, Hampshire	
Type of Flight:	Private	
Persons on Board:	Crew - 1	Passengers - None
Injuries:	Crew - 1 (Minor)	Passengers - N/A
Nature of Damage:	Tail boom severed, damage to main rotors, landing gear and body panels	
Commander's Licence:	Private Pilot's Licence (Helicopters)	
Commander's Age:	52 years	
Commander's Flying Experience:	1,471 hours (of which 43 were on type) Last 90 days - 19 hours Last 28 days - 5 hours	
Information Source:	Aircraft Accident Report Form submitted by the pilot, an AAIB strip examination of the engine and subsequent metallurgical examination of engine components

Synopsis

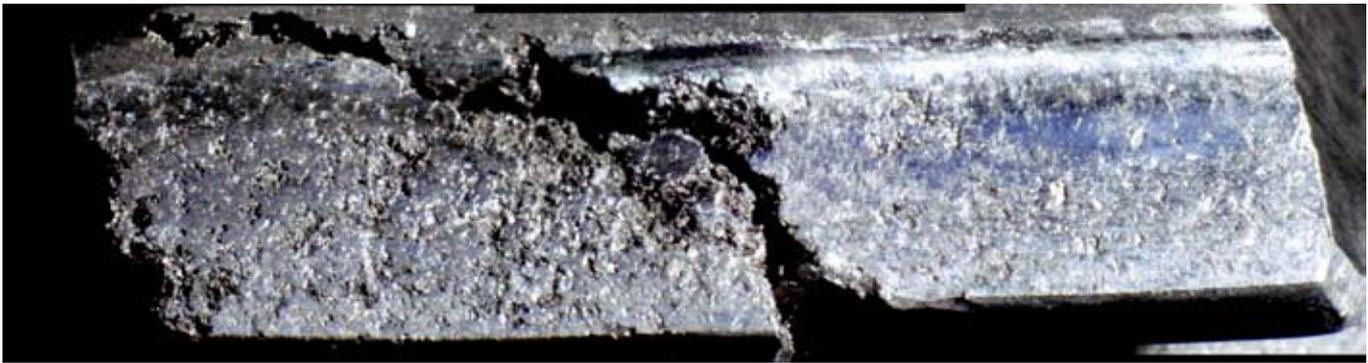
Figure 3

Extensive porosity was also evident in the microstructure of two of the tooth fractures, indicating that these teeth were extremely weak and vulnerable to fracture. Also the drive flanks exhibited gross voiding and flaking, Figures 2 and 3 respectively. Despite these material defects, no evidence was found in the gear generally, of fatigue cracking or any other form

of progressive failure, nor specifically in the tooth fractures that exhibited porosity and surface void defects. In summary, metallurgical examination of the camshaft and gear failed to identify any evidence of pre-existing or progressive fracture, but the poor quality of the casting would have weakened the teeth and pre-disposed them to fracture.

Flank of fractured tooth (separated piece re-positioned, showing porosity at the surface)
