**INCIDENT**

<b>Aircraft Type and Registration:</b>	Airbus A321-231, G-MIDC
<b>No &amp; Type of Engines:</b>	2 IAE V2533-A5 turbofan engines
<b>Year of Manufacture:</b>	1998
<b>Date &amp; Time (UTC):</b>	13 November 2006 at 1647 hrs
<b>Location:</b>	Dublin Airport
<b>Type of Flight:</b>	Commercial Air Transport (Passenger)
<b>Persons on Board:</b>	Crew - 7                      Passengers - 129
<b>Injuries:</b>	Crew - None                      Passengers - None
<b>Nature of Damage:</b>	Loss of thrust reverser blocker door
<b>Commander's Licence:</b>	Airline Transport Pilot's Licence
<b>Commander's Age:</b>	54 years
<b>Commander's Flying Experience:</b>	15,000 hours (of which 1,800 were on type) Last 90 days - 240 hours Last 28 days - 80 hours
<b>Information Source:</b>	Aircraft Accident Report Form submitted by the pilot and follow-up AAIB investigation

**Synopsis**

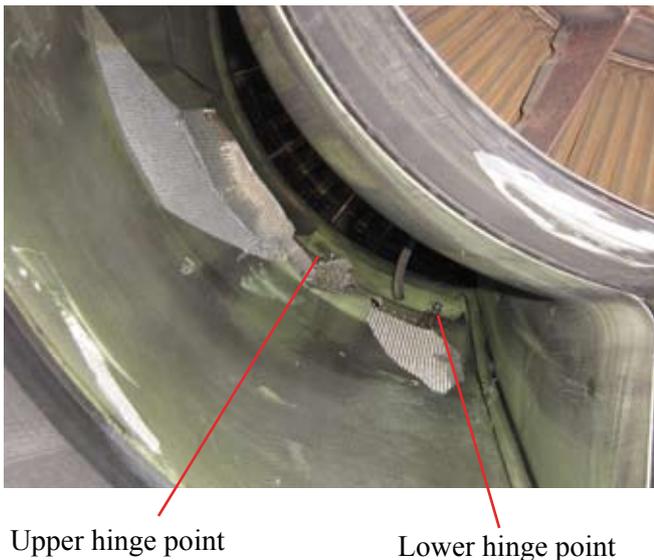
**Figure 1**

The aircraft had completed a flight from Dublin to LHR when, during a post-flight walk-around inspection, the flight crew observed that the acoustic panels lining the interior of the left engine by-pass duct had been damaged and that a thrust reverser blocker door was missing, Figure 1. No defects had been observed during the pre-flight inspection at Dublin, no unusual vibrations or noises were noticed during the flight and the aircraft had not recorded any defects in its fault monitoring systems. The remains of the blocker door were found adjacent taxiway E7 at Dublin Airport.

Damage to by-pass duct (view looking forward)

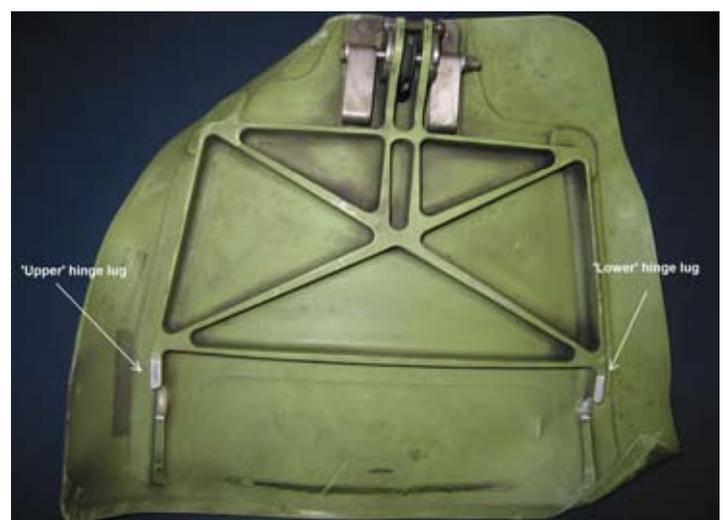
**Figure 2**

Examination of recovered material showed that the door actuation arm had failed due to an overload condition, and that the lugs on the forward edge of the door, into which the bearings had been located, had both failed, Figure 2.

The bearings had remained in their respective mounting brackets on the reverser translating sleeve. Laboratory examination of the fracture surfaces of both lugs showed areas of inter-laminar and inter-granular corrosion cracks, at the lug holes, suggesting stress corrosion. Overload failure areas towards the rear of each lug were also observed. The lower lug had also been distorted due to the application of a torsional load prior to failure.

Examination of the bearings showed that the upper bearing had seized in its race. Some evidence of corrosion staining was present between the bearing roller and race and it was noticed that evidence of primer residue was present between the inner surface of the lug holes and the spherical bearings.

Blocker door, showing failed hinge lugs

Deformation of the lower lug indicated that the upper lug failed first, which resulted in the failure of the lower lug and the actuation arm, which allowed the blocker door to be released.

The use of a stainless steel bearing in the aluminium lug would have provided a source of galvanic corrosion and, therefore, an initiator for the corrosion cracking

observed. In order to minimise this possibility, blocker doors are primed prior to the installation of the bearings; residue found in the lug holes confirmed that primer had been present. However, clear evidence of corrosion cracking in both lugs was present. This was probably as a result of galvanic corrosion between the steel bearing and aluminium alloy blocker door, and it is possible that the primer was of insufficient thickness to prevent this happening, or had become damaged during the installation of the bearings. The seized upper bearing would have introduced additional torsional loads in the door lugs, accelerating the rate of crack propagation.

The manufacturer is currently investigating several similar events and will, based on the results of these investigations, take action to minimise the possibility of additional failures of this nature. In view of this, no Safety Recommendations are considered necessary to be made at this time.
