**ACCIDENT**

<b>Aircraft Type and Registration:</b>	Aerola Alatus-M, G-CFDT	
<b>No &amp; Type of Engines:</b>	1 Corsair M25Y piston engine	
<b>Year of Manufacture:</b>	2008	
<b>Date &amp; Time (UTC):</b>	11 June 2010 at 1400 hrs	
<b>Location:</b>	Davidstow Airfield, Cornwall	
<b>Type of Flight:</b>	Private	
<b>Persons on Board:</b>	Crew - 1	Passengers - None
<b>Injuries:</b>	Crew - None	Passengers - N/A
<b>Nature of Damage:</b>	Propeller separated, damage to right wing and fuselage/engine	
<b>Commander's Licence:</b>	National Private Pilot's Licence	
<b>Commander's Age:</b>	72 years	
<b>Commander's Flying Experience:</b>	n/k hours (of which 2 were on type) Last 90 days - n/k hours Last 28 days - n/k hours	
<b>Information Source:</b>	Aircraft Accident Report Form submitted by the pilot

**Synopsis**

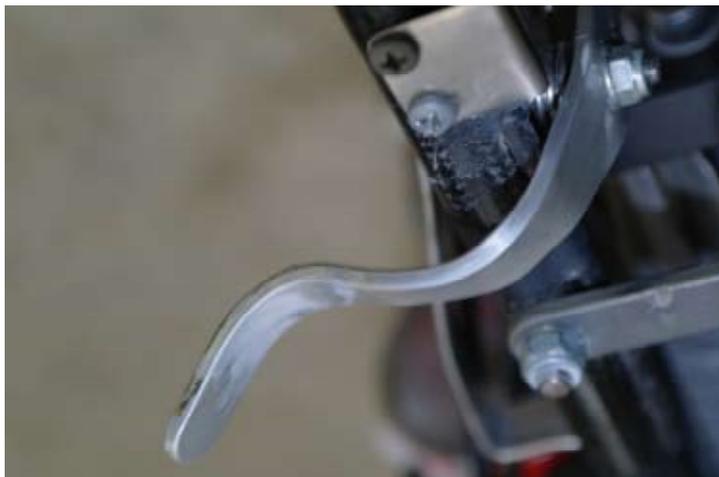
**Figure 1**

bending. The fracture surface had been subject to mechanical wear, which made some of the features indistinct, but no evidence of crack propagation in fatigue was found. Some scoring of the inner diameter of the shaft was also identified. The deformation of the propeller lock was consistent with it having been struck by the rotating propeller, see Figure 1.

Paint had been transferred from the propeller onto the lock. The pattern of paint transfer indicated that the propeller lock had not been in the fully deployed position when it was struck by the propeller and that after the initial impact the lock had been moved into the fully deployed position before being deformed against the pylon structure.

The damage and paint transfer on the propeller lock indicated that it was in a partially extended position when it was struck by the rotating propeller. The position of the throttle and propeller lock control on opposite sides of the cockpit are such that when operating the throttle the pilot would be unable to operate either the decompressor valve or the propeller lock without first releasing the control column. It is therefore possible that the extension of the propeller lock into the arc of the propeller may have been caused by the vibration experienced immediately before the loss of the propeller.

Damaged propeller lock
