AAIB Bulletin No: 8/94

Aircraft Type and Registration: ATR 42-300, G-BUEB

Date & Time (UTC): 11 February 1994 at 1507 hrs

Location: Stand 3, London Gatwick Airport

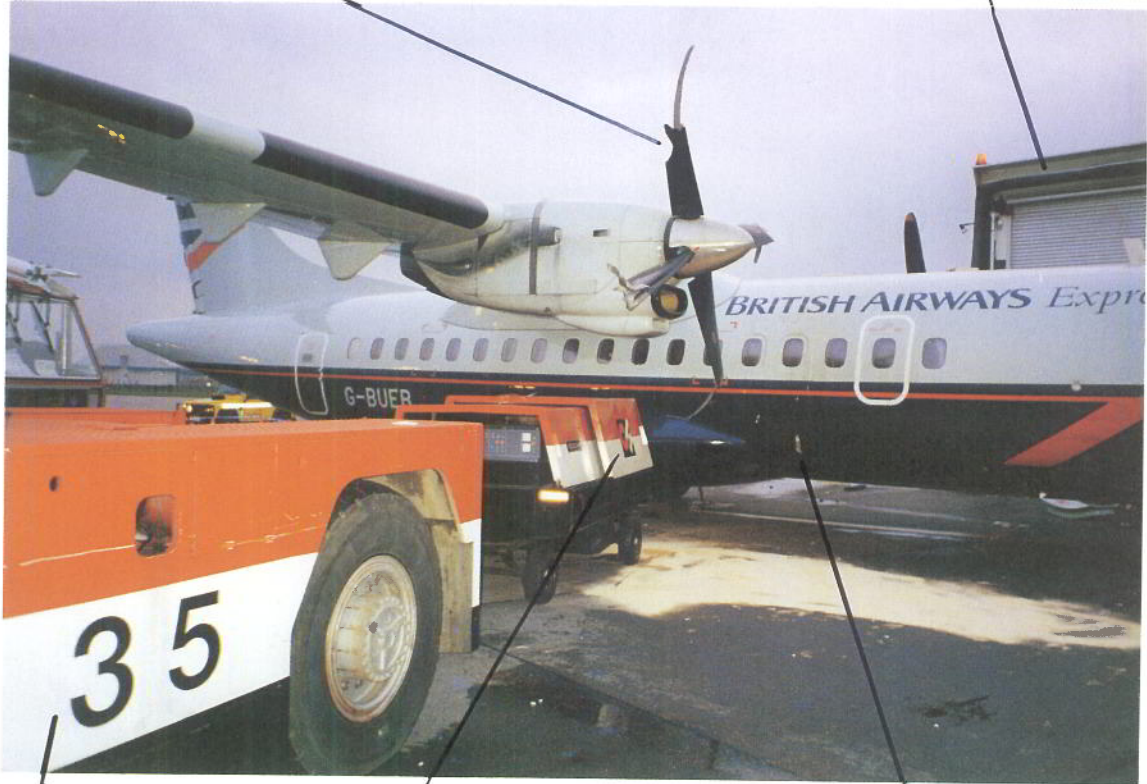
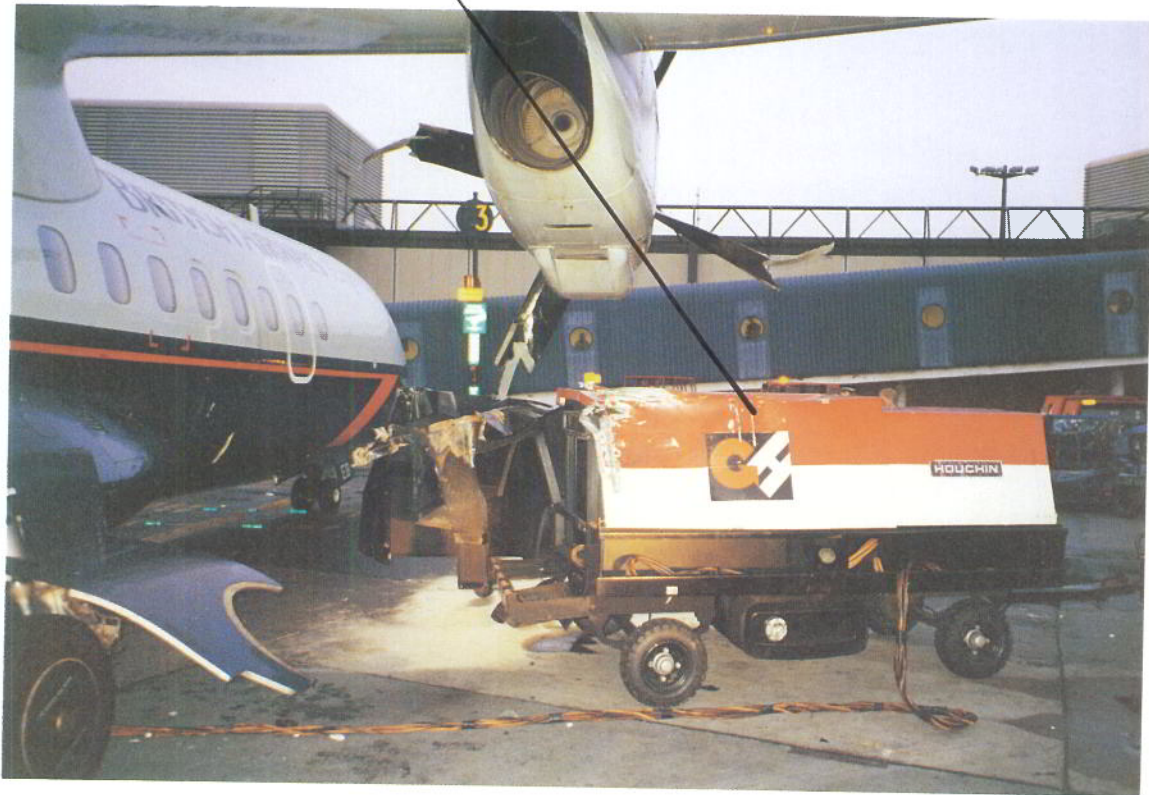
FIG 1

Examination of the accident site showed that the GPU rig was positioned almost laterally across the stand (Fig 2), facing away from the centreline and with the back of the GPU approximately 3.8 metres right of the centreline and just forward of the extended line on which the aircraft nose wheels would normally stop, the crossbar marked '146 100'. The aircraft had come to rest approximately 8 metres beyond its normal stop position on a heading 2° right of the stand centreline and with the nose landing gear 0.74 metre right of the centreline. The evidence indicated that none of the main landing gear wheels had skidded during the stop. With the aircraft in this position, the left propeller was situated within 7 cm (3 inches) of portions of the fixed airbridge. The right propeller was forward of the GPU and the right propeller blades had sustained multiple strikes on the upper rear portion of the GPU. The aft portion of the GPU cover had been severely damaged. It exhibited a number of propeller blade slashes, but these were unevenly spaced, apparently because of propeller distortion on striking the heavyweight GPU structure, and estimation of aircraft ground speed was not possible. Fragments of the blades were scattered over a wide area of the apron, concentrated on the left side of the aircraft, up to 60 metres from the No 2 propeller axis.

Hole created by GPU Cover Stop Bar
(8x0.75x0.5 inch, 0.84 lb steel bar)

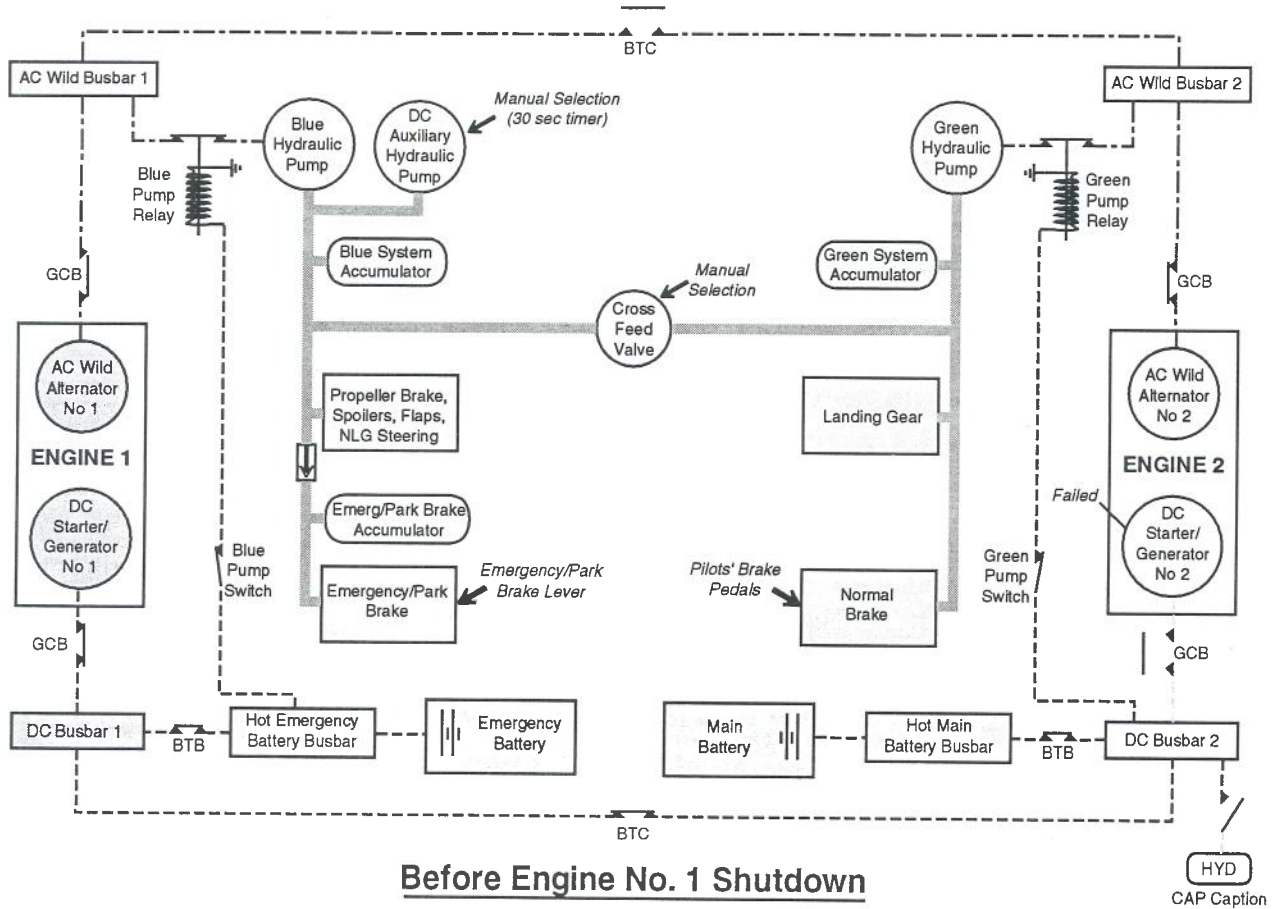
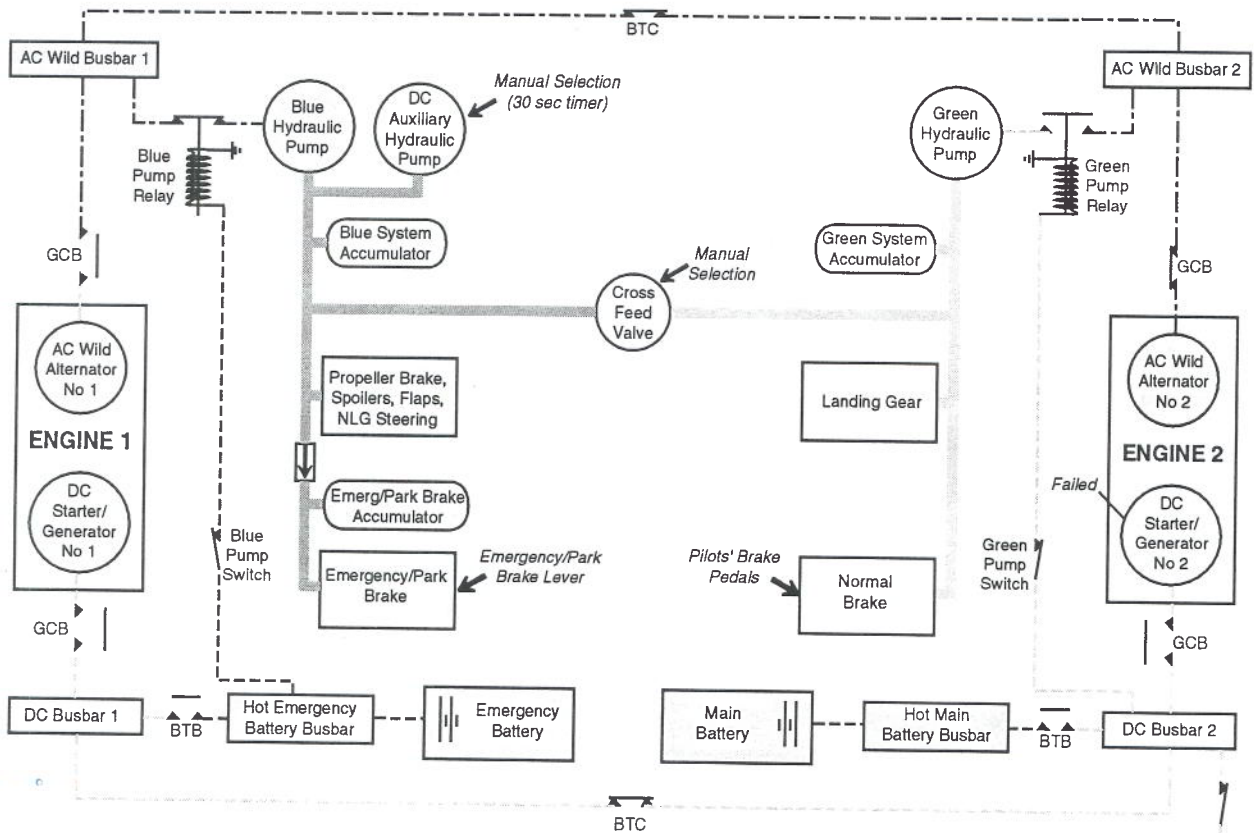
Fig 3

Thus loss of output from one Starter/Generator would not cause de-energisation of any of the busbars associated with the wheelbraking system as the DC Main Busbar associated with the lost generator would be fed from the other generator via the BTB. However, loss of output from both Starter/Generators would de-energise both DC Main Busbars. In this event the Green pump relay

would lose its power supplies and open, removing the AC Wild power supplies from the Green hydraulic pump. Green hydraulic system pressure would then decay, at a rate determined by the usage of services supplied by the system and by the system internal leakage rate, unless the crossfeed valve were opened. Blue system would remain pressurised as its pump relay would remain energised from the emergency battery.

Relevant flight deck indications consist of a triple gauge on the flight deck forward panel showing Green and Blue hydraulic system pressure and the Emergency/Park Brake accumulator pressure, together with caution indications on a CCAS Crew Alerting Panel (CAP) on the forward panel, and on the hydraulic system and DC electrical system panels on the overhead panel. Loss of output from both DC generators is immediately apparent by virtue of a master caution light and audio, a CAP ELEC caution illumination, a series of caution illuminations on the DC electrical system panel and by loss of instrument flood lighting and of three of the four cathode ray tube indicator displays. With the aircraft on the ground the associated loss of Green hydraulic system pressure generation is indicated solely by a Green pump switch LO PRESS caution on the hydraulic system overhead panel and will be apparent on the system pressure gauge when system pressure starts to decay. However, the HYD caution on the CAP signifying hydraulic pressure loss is fed from the DC Main Busbar and does not illuminate in these circumstances. It is recommended that the CAA and ATR consider requiring modification to ATR 42 (and ATR 72) aircraft to provide illumination of the hydraulic system caution caption on the centralised crew alerting panel in all reasonably possible circumstances when pressure in either hydraulic system is lost.

- 94-23** It is recommended that the CAA in conjunction with DGAC and the aircraft manufacturer consider requiring modification to ATR 42 (and ATR 72) aircraft to provide illumination of the hydraulic system caution caption on the centralised crew alerting panel in circumstances when pressure in either hydraulic system is lost while the aircraft is in operation.
