AAIB Bulletin No: 4/93

Ref: EW/G92/10/07

Aircraft Type and Registration: Piper PA-28-161 Cherokee Warrior II, G-BNXT

Location: Manston (Kent International) Airport, Kent

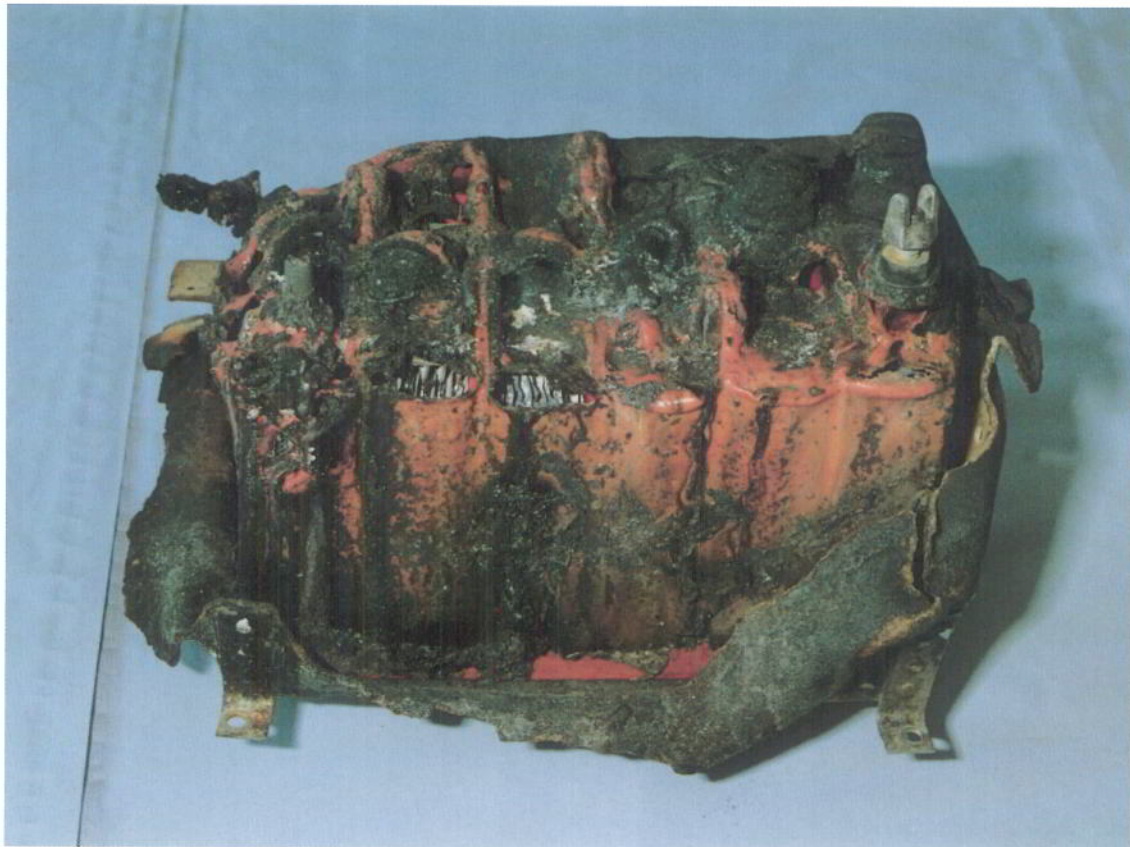
The fire destroyed the battery and damaged seats, interior fittings and parts of the fuselage and wing spar structure (see Figures 1, 3 & 4).

The lid of the battery box and the upper part of the battery had melted and partially burnt away, but there was no evidence to suggest that the fire had been caused by a fault within the battery itself. The heating and fire damage appeared to have been from outside the battery, with damage concentrated around the negative terminal post. The leaded part of the terminal post had melted, allowing the terminal attachment bolt and the battery cable to separate from the battery. It appeared that the upper part of the battery earth cable had been cut by the fire service and neither the separated terminal bolt nor the adjoining section of earth cable were recovered. The remaining section of the earth cable was still securely bolted to the structure. It had been severely overheated and its insulation had burnt away, except at the extreme bottom end of the cable, adjacent to the earthing attachment to the structure.

Figure 1
Battery and battery box remains from G-BNXT

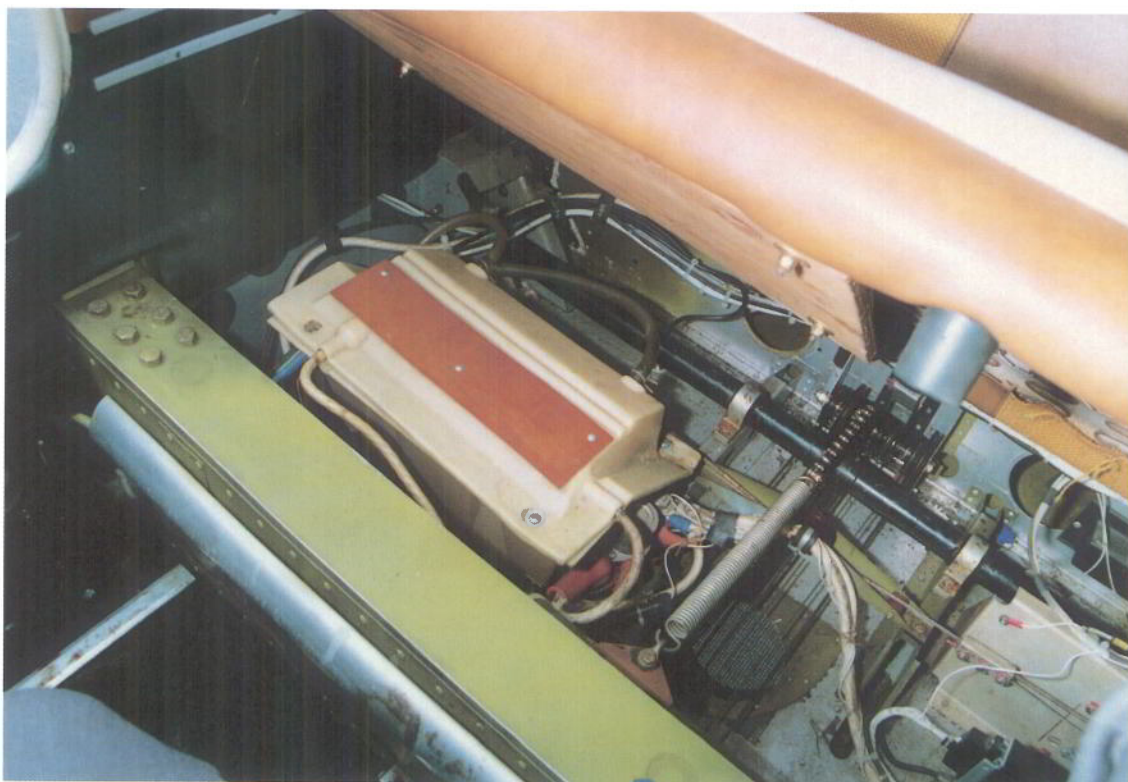
Although the battery cover was destroyed on this aircraft, it was noted that the battery box lid on a sister aircraft was designed to fit very closely over the top of the battery, particularly in the region where the cables entered the battery box and around the terminal areas, see Figure 2. The cover shown in this photograph appears to have been of a different type from that on G-BNXT, but this aspect raises the general question of whether battery box lids made of combustible materials should be designed so as to provide a tight fit around the battery terminal areas, when it is known that this area is a potential source of resistive heating.

Figure 2
Typical PA 28 battery installation under rear seat
(Viewed rearwards and to starboard; note close-fit of cover in vicinity of terminals)

93-20 The CAA should consider a review of the design of general aviation battery boxes in general, with particular reference to the fire potential arising from the close proximity of combustible cover materials to terminal posts and other potential sources of resistive heating. (Issued 23 March 1993)

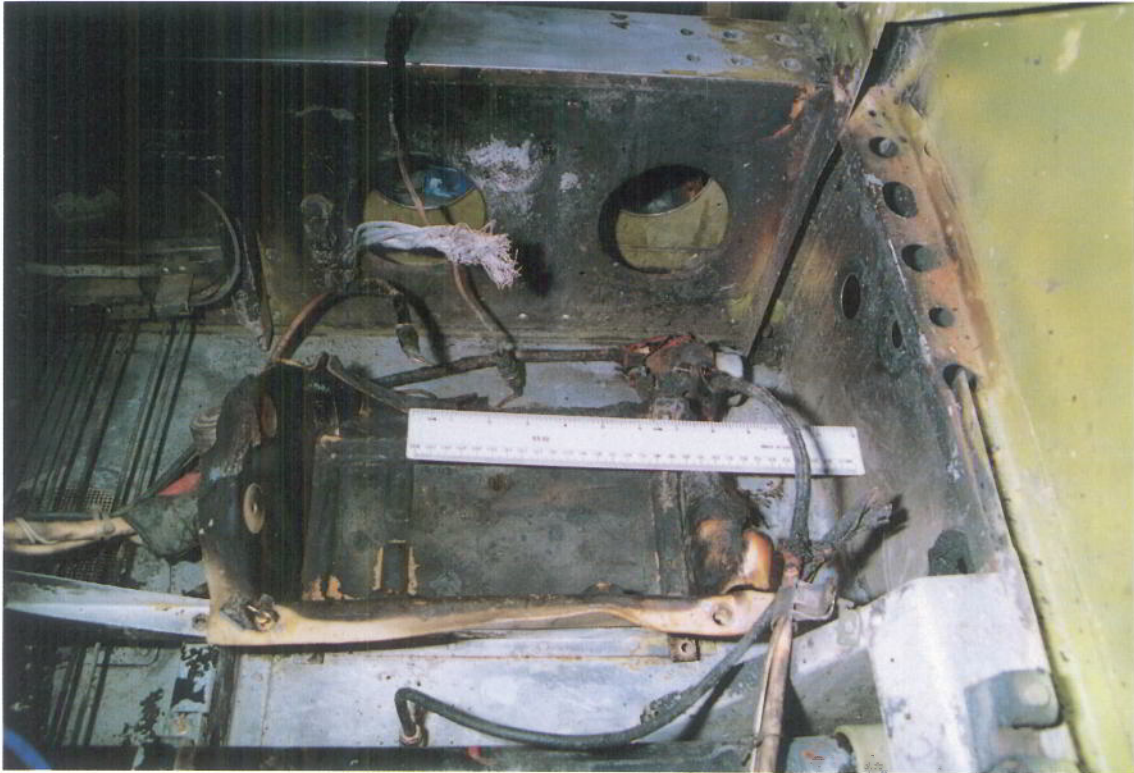
Figure 3
G-BNXT: Battery compartment after fire
(Showing remains of bottom part of battery box and earth cable. Viewed looking forward from baggage door on starboard side of fuselage)

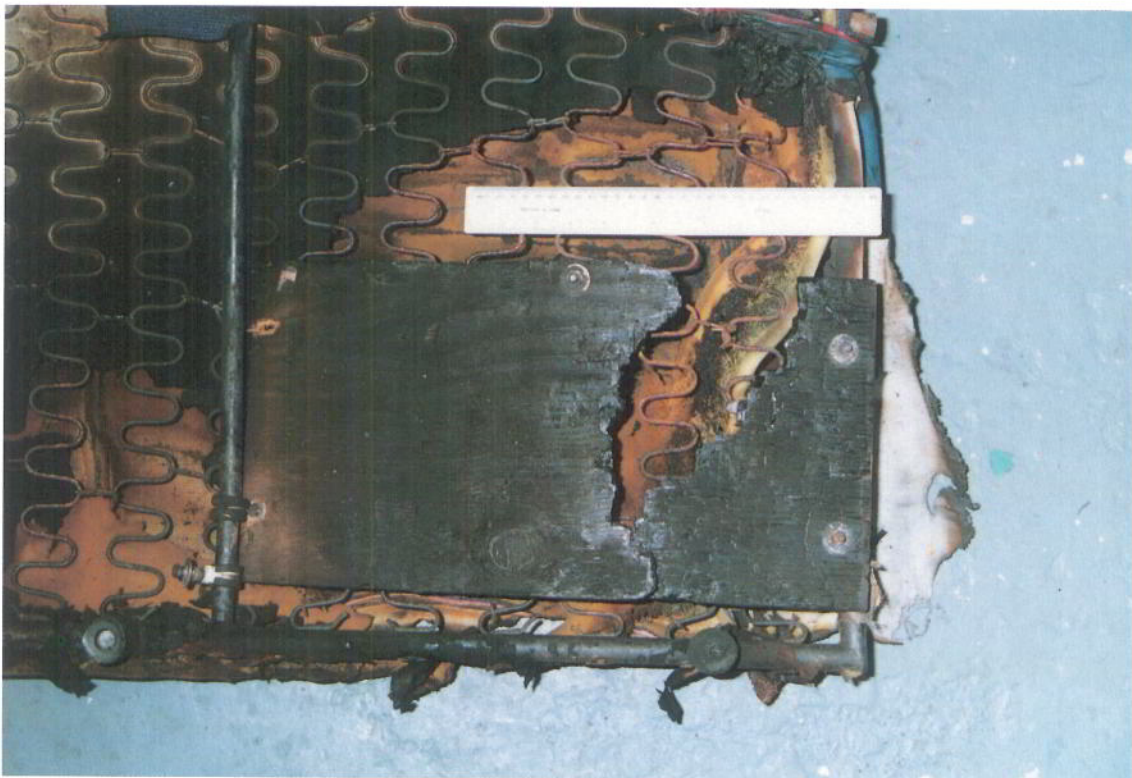
The known tendency for the rear seat springs on this aircraft type to press down onto the battery lid had been addressed on G-BNXT by the introduction of a sheet of plywood attached to the seat springs immediately above the battery. Consequently, even if the seat had been forced down onto the battery, a short circuit between a part of the seat and the battery was most unlikely to have occurred in this case. Furthermore, study of the fire damage to the aircraft and fittings revealed a pattern which was consistent with the damage to the battery itself, and showed beyond reasonable doubt that the primary source of the heat had been centred around the (missing) negative battery terminal. This aircraft type has a negative earth electrical system and consequently an earth short would not have produced any heat build up. Therefore, a resistive connection at the negative battery terminal appeared to be the only viable explanation for the fire. Such a resistive connection would have generated heat under conditions of high current flow, and would also have produced a voltage drop which would have reduced starter performance, even if only slightly.

Figure 4
G-BNXT: Underside of rear starboard passenger seat
Showing extensive fire damage including complete penetration of plywood board attached to underside of seat springs, to prevent springs contacting battery components.
