Cessna 310J, N1158V

AAIB Bulletin No: 9/2003	Ref: EW/C2003/04/01	Category: 1.2
Aircraft Type and Registration:	Cessna 310J, N1158V	
No & Type of Engines:	2 Continental IO-470U piston engines	
Year of Manufacture:	1965	
Date & Time (UTC):	7 April 2003 at 1815 hrs	
Location:	In a field close to Sandtoft Airfield, Humberside	
Type of Flight:	Private	
Persons on Board:	Crew - 1	Passengers - None
Injuries:	Crew - 1 (Fatal)	Passengers - N/A
Nature of Damage:	Aircraft destroyed	
Commander's Licence:	United Kingdom Private Pilot's Licence	
Commander's Age:	59 years	
Commander's Flying Experience:	302 hours (of which 84 hours were on type)	
	Last 90 days - 6.5 hours	
	Last 28 days - 5.5 hours	
Information Source:	AAIB Field Investigation

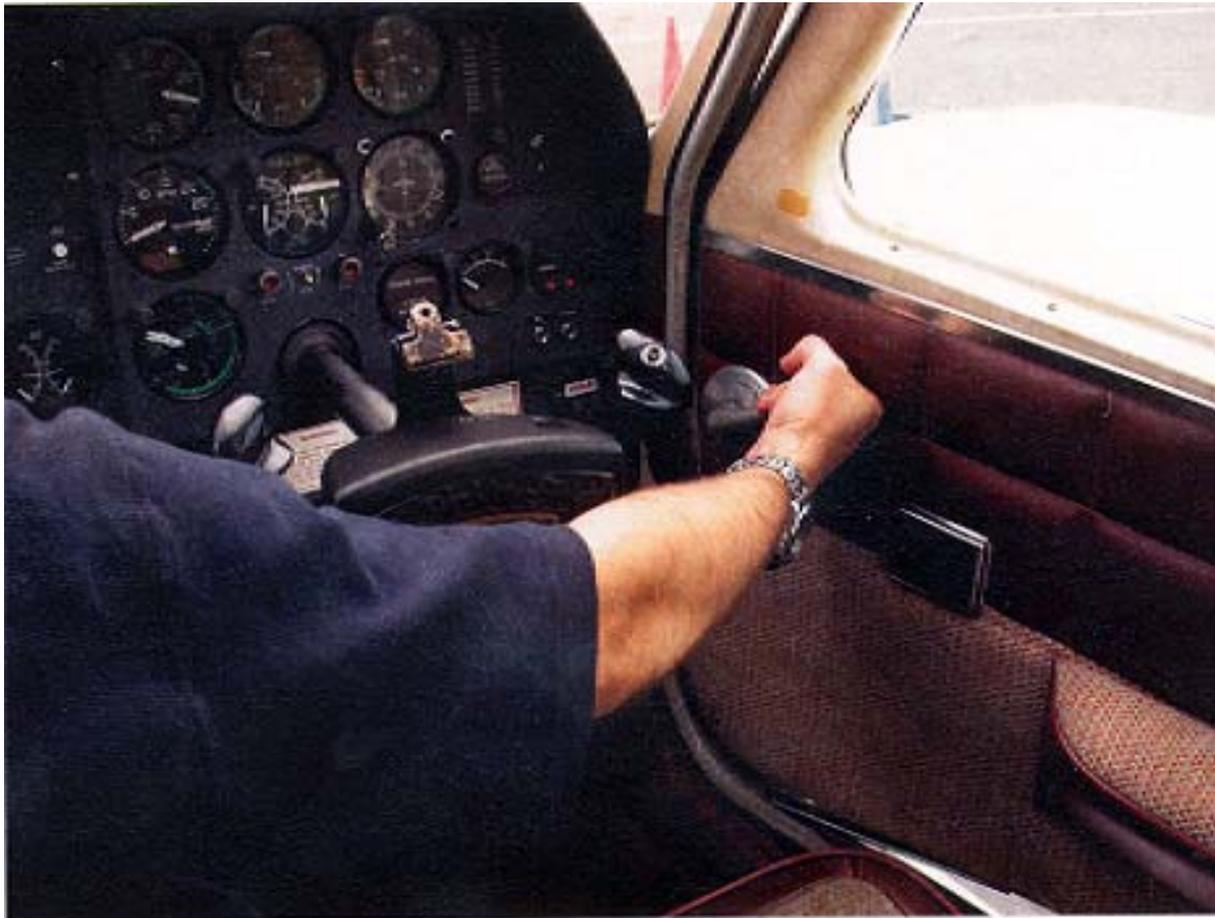
Figure 1 illustrates the location of the handle with respect to the pilot in the left seat.

The right control yoke obstructed access to the door locking mechanism and, to a limited extent, the door pull handle. This obstruction would have been exacerbated if the pilot had been trying to continue the climb, as pulling the yoke back obstructs access even further (see Figure 1). The pilot may have tried to move the yoke forward, aft or turned it to the left, with the intention of gaining easier access to the handle. Any such action would have been extremely unwise, especially so, due to the lack of height in which to recover the aircraft if control was lost. The upper torso leaning towards the door causes the control yoke to turn through the path of least resistance as the left arm follows the torso. Essentially, if the pilot has begun turning the yoke either left or right, and then reaches over to the door, then he is likely to inadvertently continue pulling on the yoke further in that direction.

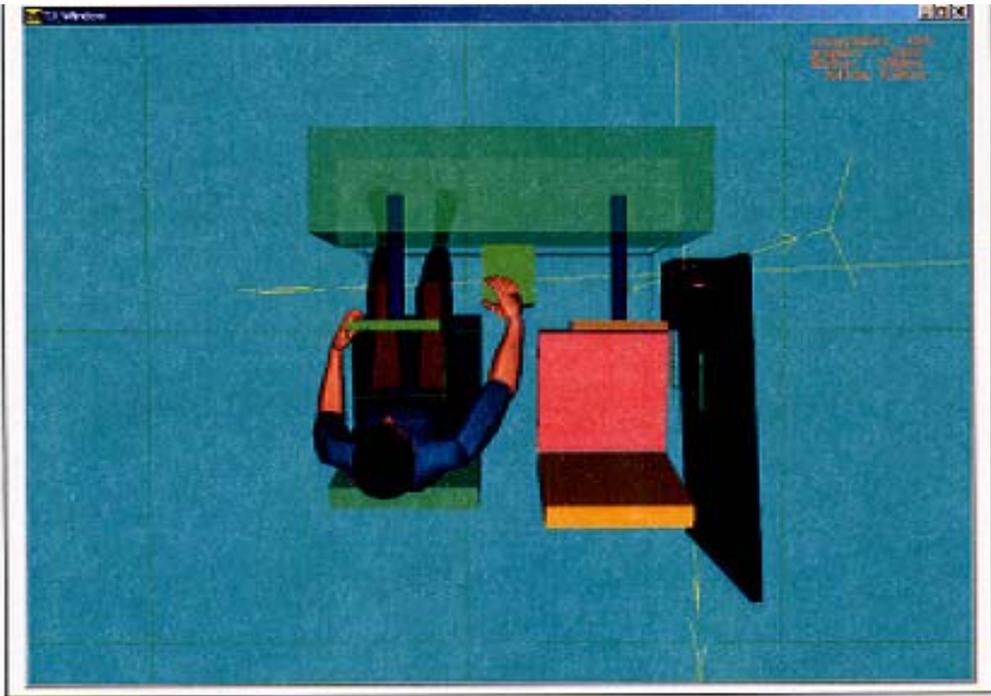
Figure 2: The pilot in the normal seating position left hand on the control yoke, right hand on the throttles and both feet on the rudder pedals.

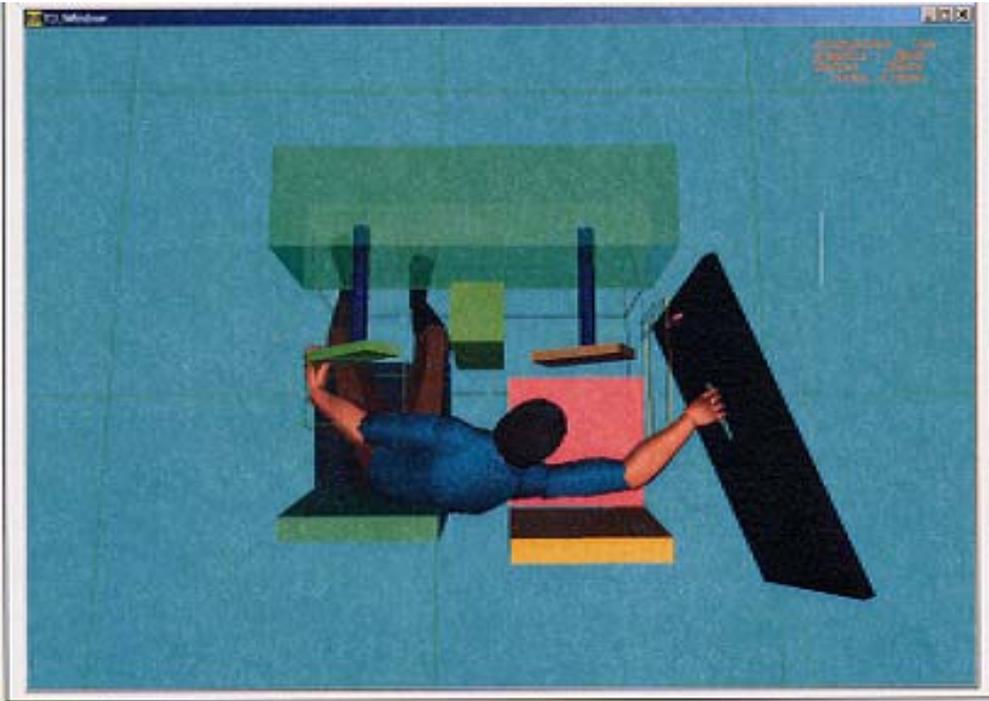
Figure 3: When the pilot reaches across the cockpit and pushes the door into the airflow, his left leg moves to the left with the result the left pedal goes forward. The left hand moves the control yoke down on the left side. This combination of control inputs probably caused the rapid roll to the left.

aircraft. If a conscious effort was being made to keep his feet on the rudder pedals, then this could have been translated into forward movement of the left rudder pedal, causing the rapid roll to the left. This effect would increase if the door was pushed into the airflow in order to allow it to be slammed. The scenario is illustrated at Figure 3, and this position is similar to that of the pilot as found in the wreckage.

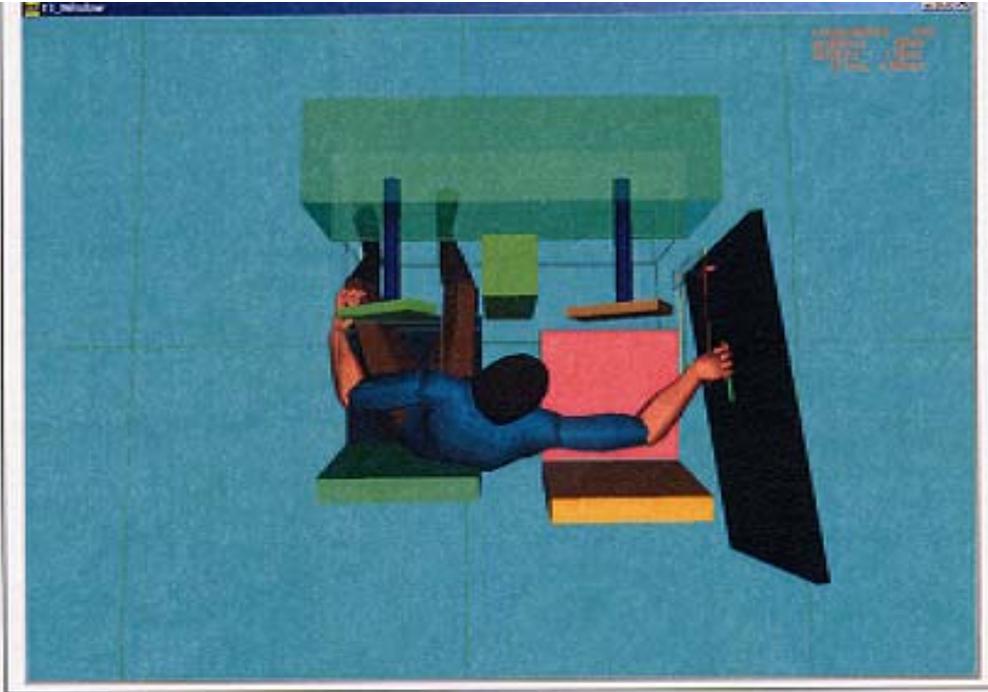
Figure 4: The pilot when pulling the door closed transfers his weight to the right foot, which causes the right rudder pedal to move forward.

The study also showed that when the door was pulled shut the tendency was for the left leg to relax its pressure, which was then transferred to the right foot. This had the potential of applying a force to the right rudder pedal, with the attendant possibility of causing the aircraft to roll to the right. The apparently normal rate of roll seen to return the aircraft to wings level, before the right wing dropped, was considered to be either such an application of right rudder when pulling the door closed, as shown in Figure 4, or AP driven, if engaged. At this stage the pilot would have had no external visual references. With reduced power on the engines, to limit the airspeed, and the aircraft manoeuvring in the manner indicated in the nose high attitude described by a witness, it is quite likely that the aircraft could stall and drop the right wing, as seen by the witnesses.
