INCIDENT

Aircraft Type and Registration:	Agusta A109S Grand, G-CGRI	
No & Type of Engines:	2 Pratt & Whitney Canada PW207C turboshaft engines	
Year of Manufacture:	2005	
Date & Time (UTC):	7 April 2006 at 0919 hrs	
Location:	Liskeard, Cornwall	
Type of Flight:	Private	
Persons on Board:	Crew - 1	Passengers - None
Injuries:	Crew - None	Passengers - N/A
Nature of Damage:	Tail rotor trunnion assembly, tail rotor blade and vertical fin damaged	
Commander's Licence:	Airline Transport Pilot's Licence	
Commander's Age:	61 years	
Commander's Flying Experience:	10,880 hours (of which 1,100 were on type) Last 90 days - 37 hours Last 28 days - 20 hours	
Information Source:	Aircraft Accident Report Form submitted by the pilot and subsequent telephone enquires

Synopsis

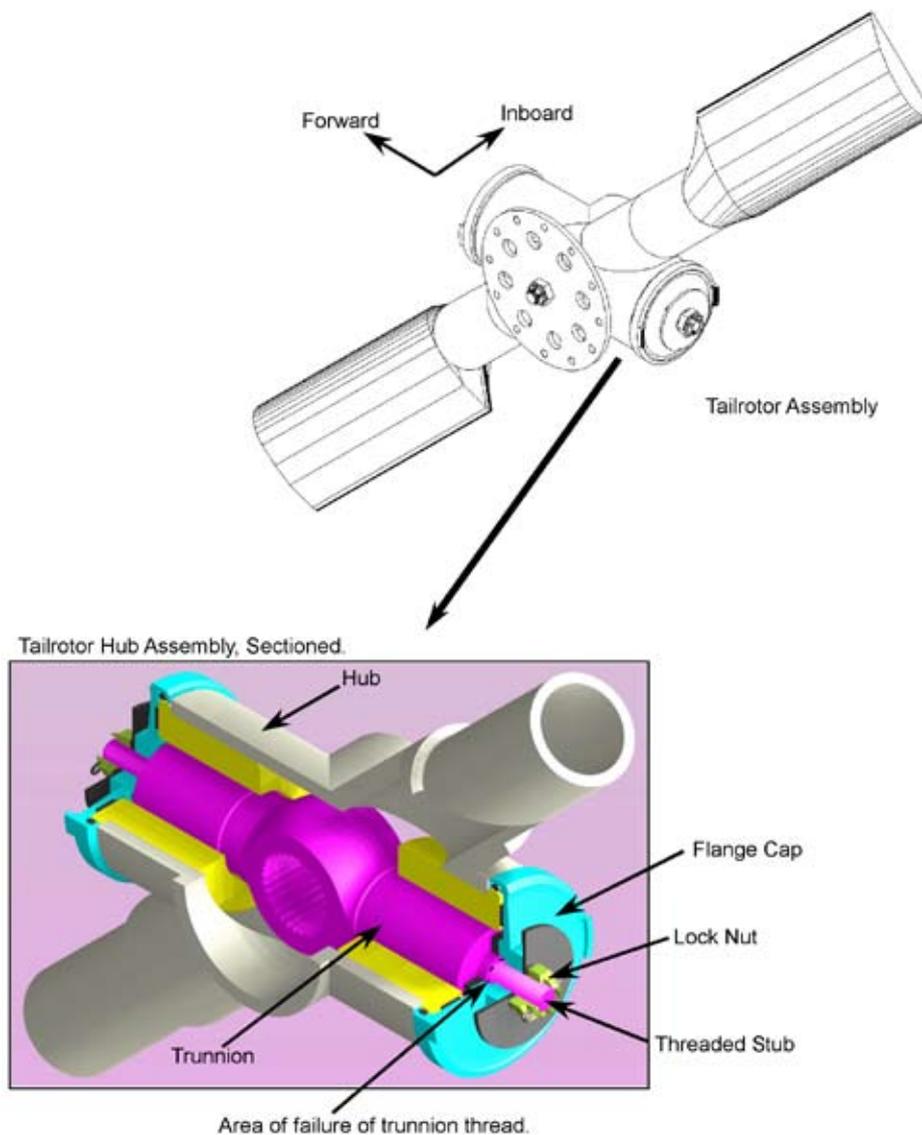
Figure 1

The A109S 'Grand' (Figure 1) has flange caps, with an internal thread, which locate onto the stubs at each end of the trunnion. Lock nuts then secure the assembly in place within the hub.

Trunnion assembly and drive
