ACCIDENT

Aircraft Type and Registration:	Piper PA-31P Pressurised Navajo, N95RS	
No & Type of Engines:	2 Lycoming TIGO-541 piston engines	
Year of Manufacture:	1974	
Date & Time (UTC):	15 January 2010 at 1407 hrs	
Location:	Bladon, Oxfordshire	
Type of Flight:	Private	
Persons on Board:	Crew - 1	Passengers - 1
Injuries:	Crew - 1 (Fatal)	Passengers - 1 (Fatal)
Nature of Damage:	Aircraft destroyed by post-impact fire	
Commander's Licence:	Airline Transport Pilot's Licence	
Commander's Age:	54 years	
Commander's Flying Experience:	12,500 hours (hours on type not known) Last 90 days - n/k hours Last 28 days - 10+ hours	
Information Source:	AAIB Field Investigation

Synopsis

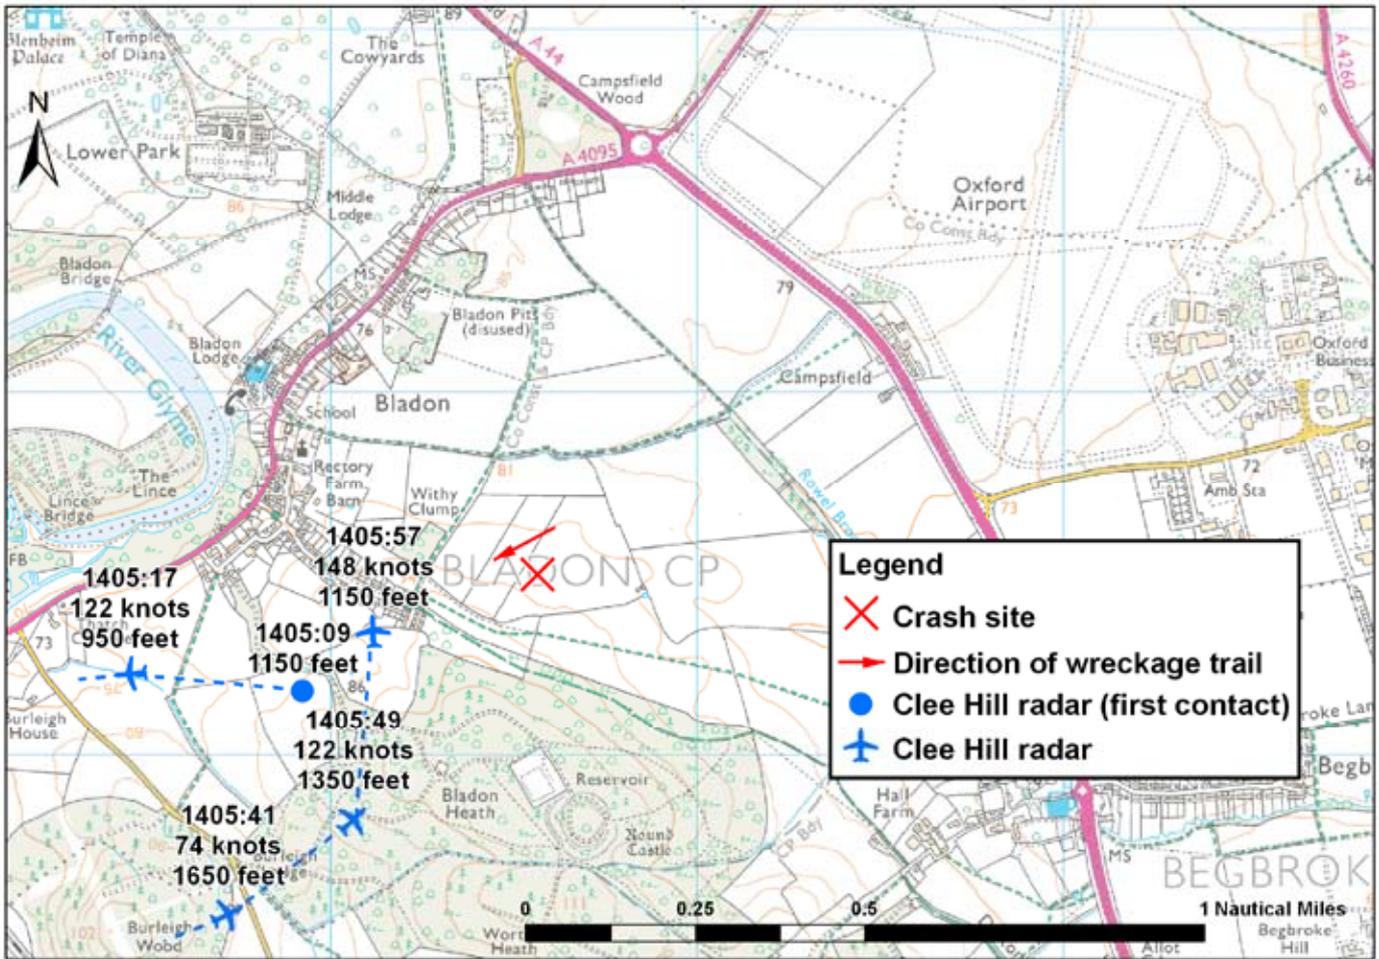
A limited amount of radar data for the accident flight, covering a period of 48 seconds, was recorded by Clee Hill radar, 58 nm to the northwest. The first contact was at 1405:09 and the last at 1405:57; however, contact with the aircraft was lost during this period for two consecutive sweeps of the radar. The aircraft was fitted with a Mode S transponder that transmitted true track angle, groundspeed and altitude (with 100 foot resolution) information. This information was recorded for all the returns except the first, which contained altitude information only¹. The radar track is presented in Figure 1 together with the time, groundspeed, altitude (adjusted to 1015 mb QNH) and track information.

During the 24-second period that radar contact was lost, the aircraft turned to the left through 200° (see Figure 1) and gained 700 (±100) feet, as well as losing 48 kt groundspeed in the turn and climb. Radar contact was probably lost because the radar coverage was initially obscured by rising terrain between the radar head at Clee Hill and the aircraft, and in the latter part of the turn the aircraft’s antenna was out of sight of the radar as the aircraft was in a bank to the left.

Radar track and accident site location

Radar coverage between the recorded track and the airfield to the northeast was at least to the level of the first and last contacts, which were both 1,148 feet amsl. Therefore, it is likely that the aircraft was between the ground and this altitude from takeoff to the first contact, and from the last contact to the site of the accident.

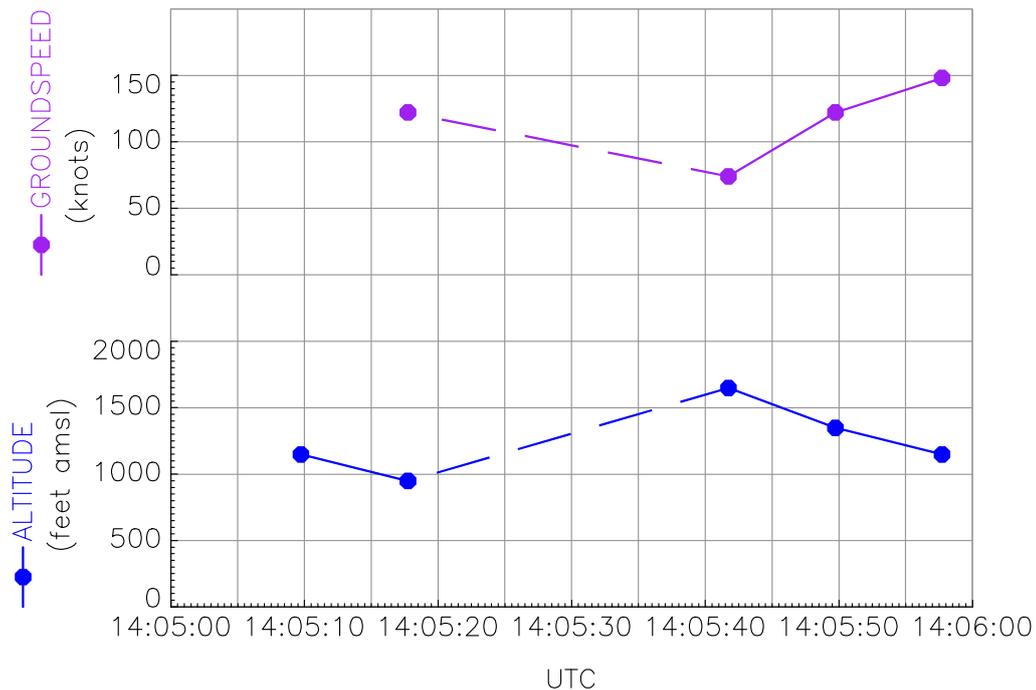
Figure 2

The groundspeed and adjusted altitude data are also presented in Figure 2.

Aircraft groundspeed and altitude
