ACCIDENT

Aircraft Type and Registration:	Pegasus Quantum 15-912, G-BZMI
No & Type of Engines:	1 Rotax 912 piston engine
Year of Manufacture:	2000
Date & Time (UTC):	21 March 2010 at 1630 hrs
Location:	Longacre Farm, Bedfordshire
Type of Flight:	Air Experience flight (Exercise 3)
Persons on Board:	Crew - 1 Passengers - 1
Injuries:	Crew - 1 (Serious) Passengers - 1 (Serious)
Nature of Damage:	Damaged beyond economic repair
Commander's Licence:	National Private Pilot's Licence
Commander's Age:	47 years
Commander's Flying Experience:	1,051 hours (of which 963 were on type) Last 90 days - N/K hours Last 28 days - N/K hours
Information Source:	AAIB Field Investigation

Synopsis

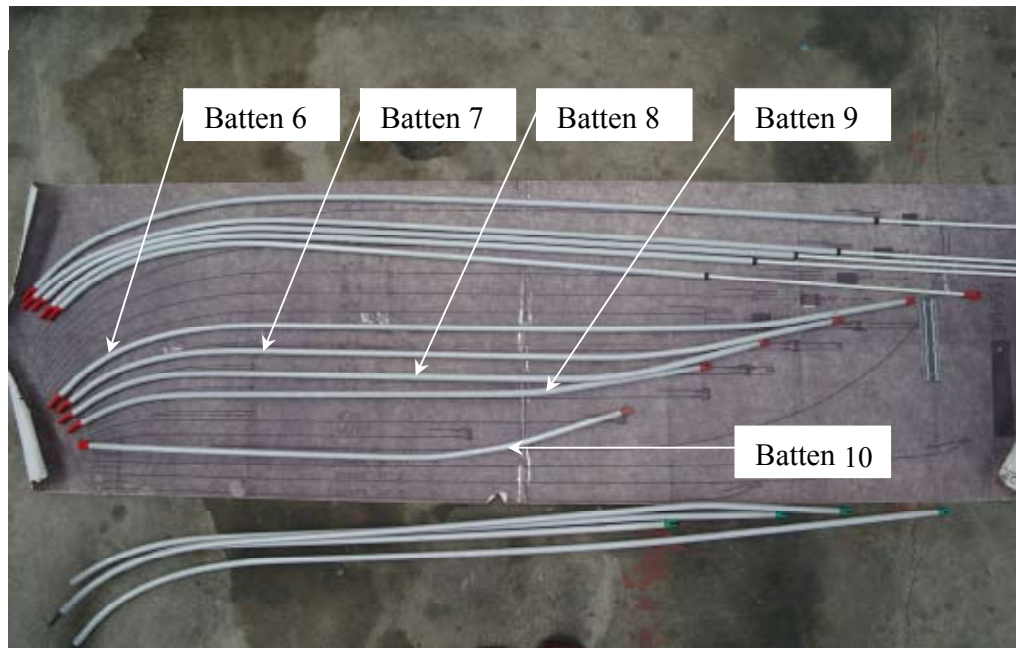
Figure 4

Battens 1 to 5 matched the manufacturer's profile template. Battens 6, 7, 8 and 9 had a trailing edge upward reflex of 50 mm at the end of the batten (Figure 4; note the rule in this picture indicates where the adjustment measurement was taken). Batten 10 had a bend which was consistent with the upward reflex being applied with the batten still in the sail; the bend was orientated differently from the other battens which were all consistent with bends having been applied with the battens removed. The position and amount of bending of the battens was not consistent with impact damage. The tip trim adjustor at the end of the leading edge pole had been adjusted one division down.

Batten profile for left wing showing trailing edge reflex on outboard battens

having been removed from G-BZMI subsequent to the accident. The downward reflex identified in battens 7 and 8 on the right wing would result in a worsening right turn in-flight. Adjusting the battens in this manner is not permitted by the manufacturer. The excessive upward reflex applied to the left wing battens would lead to an extreme right roll in-flight. The 50 mm deviation from the manufacturer defined profile was double the limit of 25 mm of adjustment permitted in the aircraft Operator's Manual and was significantly greater than anything tested by the manufacturer during aircraft development. The position of the wingtip trim adjusters in isolation would have resulted in a constant left turn at all speeds.

The adjustment to the battens, as found, exceeded the manufacturer's limits by such a significant amount that, combined with the downward reflex on two of

the right wing battens, severe control problems would be anticipated even before any apparent adjustment reported by the pilot. Nevertheless, manipulation of the trailing edge by applying an upward reflex to the left wing instead of the right wing would have exacerbated, rather than reduced a right turn. Whilst increasing airspeed can increase the severity of the turn induced by an out-of-trim wing, as the problem occurred almost immediately after rotation on both flights, it was not possible to determine why the aircraft was reported as uncontrollable on the accident flight, but not on the initial aborted flight, or why the aircraft handling deteriorated after the flights successfully undertaken by the pilot in G-BZMI earlier in the day. However, in the absence of any evidence of other pre-impact defects, it is likely that the uncommanded right roll experienced by the pilot was the result of the wing being excessively out of trim.
