Aircraft Type and Registration:	Piper PA-30 Twin Comanche, G-AVPS	
No & Type of Engines:	2 Lycoming IO-320-B1A piston engines	
Year of Manufacture:	1967	
Date & Time (UTC):	30 November 2004 at 1345 hrs	
Location:	Farley Farm Airstrip, Romsey, Hampshire	
Type of Flight:	Private	
Persons on Board:	Crew - 1	Passengers - None
Injuries:	Crew - None	Passengers - N/A
Nature of Damage:	Both propellers bent, both engines shock loaded, lower fuselage skin and landing gear mechanism damaged	
Commander's Licence:	Private Pilot's Licence	
Commander's Age:	76 years	
Commander's Flying Experience:	3,000 hours (of which 1,300 were on type) Last 90 days - 20 hours Last 28 days - 15 hours	
Information Source:	Aircraft Accident Report Form submitted by the pilot and further enquiries

Synopsis

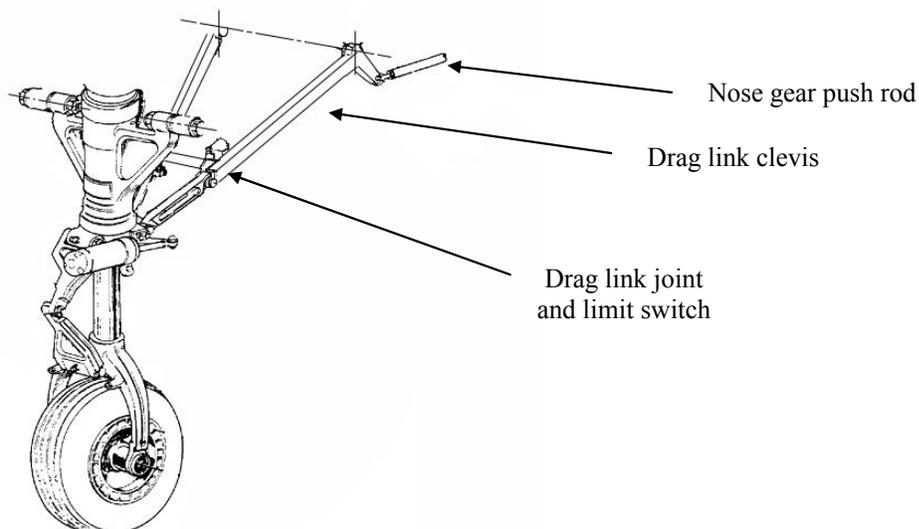
When the landing gear selector is placed in the down position, the screw jack pushes the main gear cables and pulls back the nose gear push rod. The push rod is connected to a drag link clevis, which forms the upper half of the two-piece nose gear drag link. As the push rod retracts, the drag link unfolds as shown below.

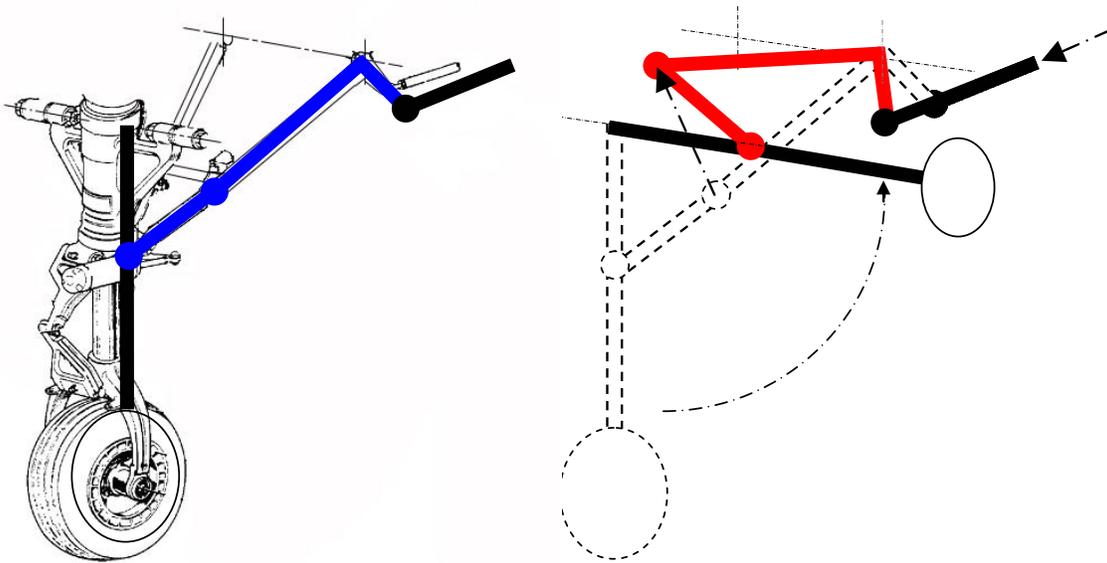
In normal operation, the drag link joint is driven slightly over centre (shown below in blue), and rearward forces on the nose gear leg are resisted by a mechanical stop in the drag link structure. If the drag link does not travel over centre, any rearward force will cause it to fold upwards (shown in red), resulting in a pull force on the screw jack. Because the screw jack is rigid when the electric motor is not running, the pull force will be transmitted directly to the motor itself, which is attached to the front of the wing spar where it passes beneath the cabin floor. The motor attachments, however, are not designed to resist landing forces directly.

If all of the limit switches close before all of the gear legs are fully down and locked, the motor will stop prematurely, even though the green "down locked" light is illuminated. Dirt collects readily on the nose gear drag link, and rigging tolerances are such that a small accumulation is sufficient to cause the nose gear limit switch to close before the nose gear drag link has locked over centre.

The nose gear limit switch is mounted above the drag link joint and is designed to close when the drag link locks over centre. If the rearward force on the nose gear leg was sufficient to force the drag link further over centre, (for example during a heavy landing), the limit switch components would be bent or broken away from the direction of over travel and the mechanical stop would be damaged. No such damage was present on G-AVPS. Consequently, the possibility that the drag link was forced to fold downwards, through the mechanical over centre stop, can be discounted.
