Reims Cessna FA152 Aerobat, G-BIHE

AAIB Bulletin No: 12/2000 Ref: EW/C99/03/04 Category: 1.3

Aircraft Type and Registration: Reims Cessna FA152 Aerobat, G-BIHE

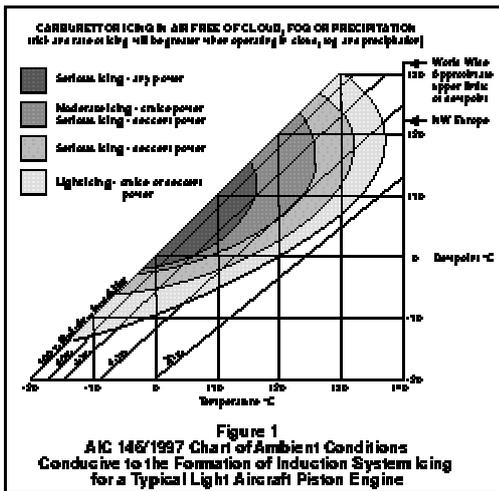
The accretion of ice in a piston engine induction system, causing constriction of the airflow to the engine, disturbance of the fuel/air ratio and power loss or engine stoppage, is described in CAA Aeronautical Information Circular (AIC) 145/1997 (Pink 161) of 30 December 1997. The AIC describes three types of induction system icing, the most common being Carburettor Icing where the temperature drop due to pressure reduction and fuel vaporisation at the carburettor venturi (up to 30°C) can cause moisture to condense and freeze and build up around the venturi and the throttle butterfly. The other types are Fuel Icing, where water suspended in the fuel can precipitate and freeze on the flow passage surfaces, and Impact Icing where ice can build up on air intakes and filters at sub-zero temperatures in precipitation or cloud. The AIC includes a chart showing the 'range of ambient conditions conducive to the formation of induction system icing for a typical light aircraft piston engine operating in clear air' at various power settings (Figure 1). CAA Safety Sense Leaflet 14A (Piston Engine Icing, published 1997) provides similar information.
