DH88 Comet, G-ACSS

AAIB Bulletin No: 5/2004	Ref: EW/C2002/10/03	Category: 1.2
Aircraft Type and Registration:	DH88 Comet, G-ACSS	
No & Type of Engines:	2 De Havilland Gipsy Queen Series II piston engines	
Year of Manufacture:	1934	
Date & Time (UTC):	28 October 2002 at 1320 hrs	
Location:	Old Warden Aerodrome, Bedfordshire	
Type of Flight:	Private	
Persons on Board:	Crew - 1	Passengers - None
Injuries:	Crew - None	Passengers - N/A
Nature of Damage:	Right landing gear severely damaged, minor damage to right engine, nacelle and wing-tip	
Commander's Licence:	Airline Transport Pilot's Licence	
Commander's Age:	55 years	
Commander's Flying Experience:	10,130 hours (of which 26 were on type)	
	Last 90 days - 162 hours	
	Last 28 days - 65 hours	
Information Source:	Aircraft Accident Report Form submitted by the pilot and Field investigations by the AAIB

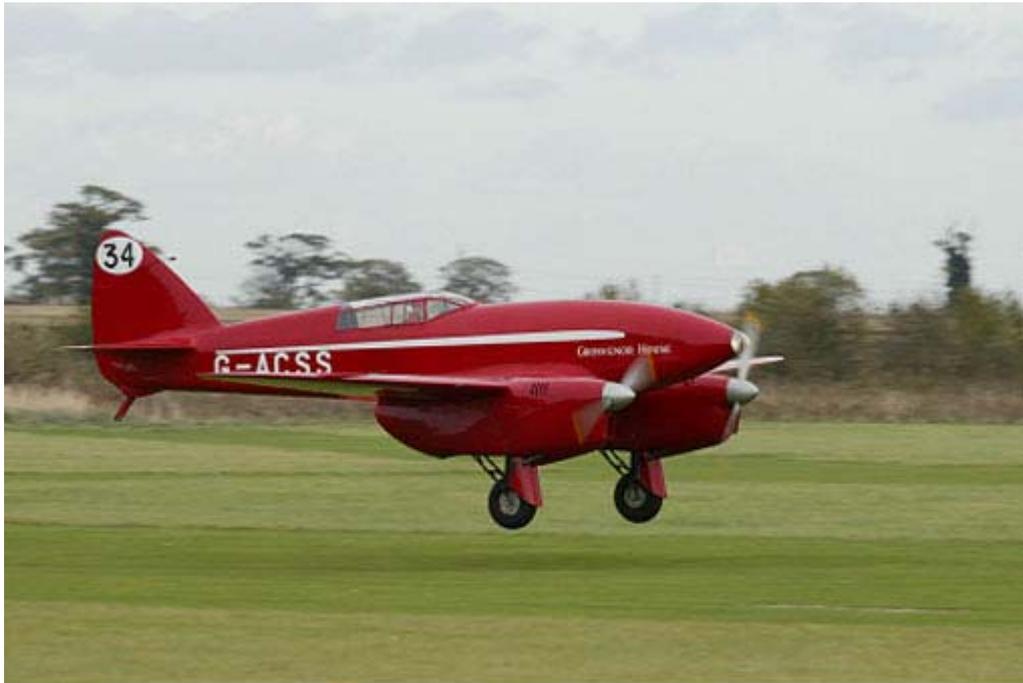
DH88 Comet, G-ACSS, about to touch down

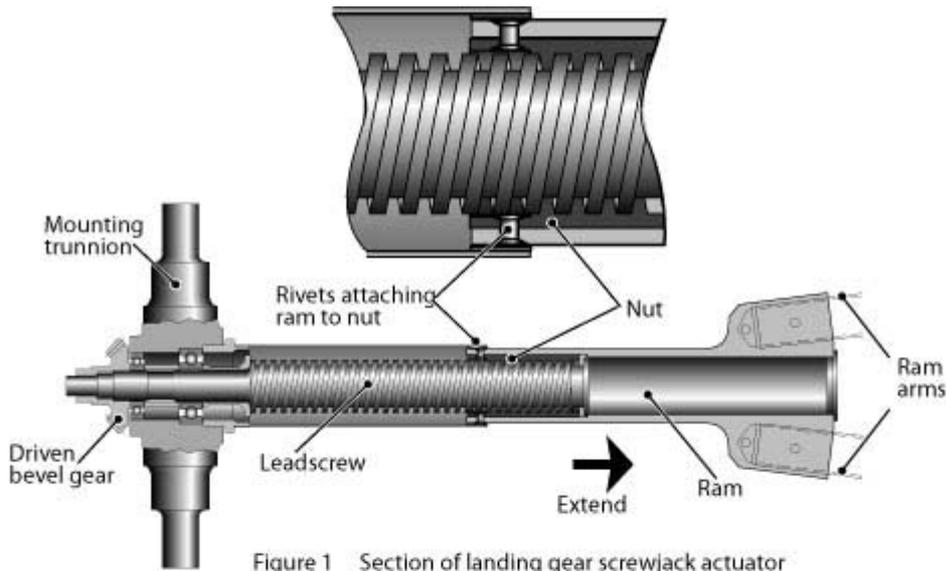
Figure 1 Section of landing gear screwjack actuator

Within the screwjack, the driven nut is attached to the ram assembly by six $\frac{5}{32}$ " mild steel rivets. These transmit the total force applied to the ram, through the screw into the mounting frame. According to the current rigging instructions, the down limit microswitch should be set so that, with the landing gear fully extended, the articulating joint of the drag brace assembly ('C') is just below the direct line between the points 'A' and 'B'. As a result, wheel drag loads will generate compressive loads in the drag brace struts which will, in turn, generate tensile loads in the screwjack assembly.

As a result of the drag brace geometry in the 'down' position, the high compressive loads developed in the upper drag brace struts would have generated considerable tensile forces in the screwjack. These appear to have been sufficient to shear the ram-to-nut attachment rivets. These compressive loads were also probably responsible for causing the aft ends of the lower drag brace to bend downwards whilst its cross-tie was jammed on the wheel.

It would be inappropriate to make a Safety Recommendation affecting this aircraft type but it is considered that the owners should consult the design authority on the advisability of adjusting the position at which the 'down' microswitch on the landing gear operates.

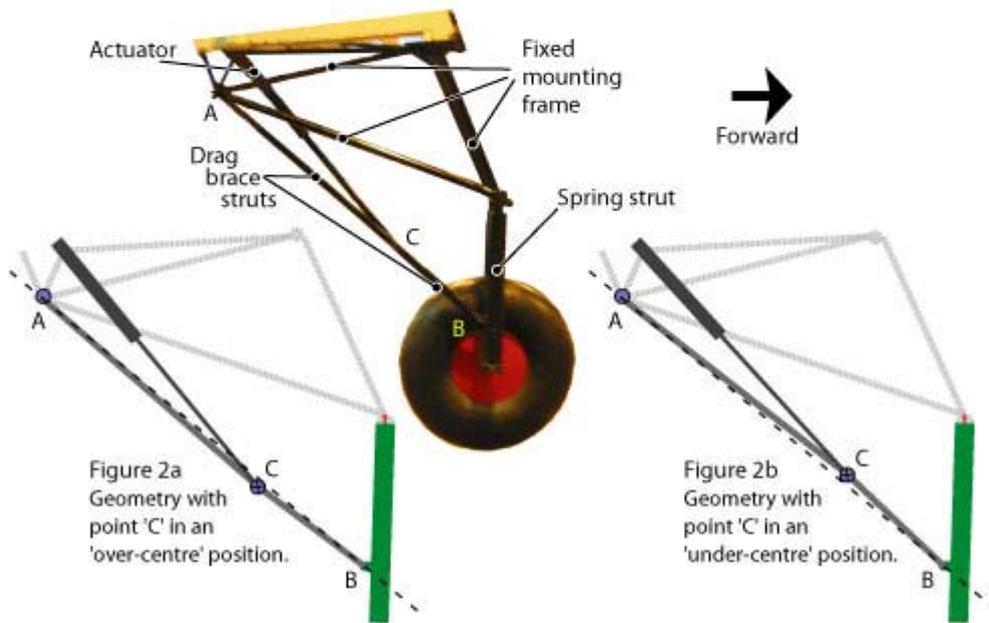
Figure 2 Landing gear in the extended position

Each main wheel axle is mounted on a pair of spring struts which are pivoted on the mounting frame. The lower drag brace consists of two parallel struts connected by a cross-tie, which is just clear of the tyre, pivoted near the bottom of the spring strut outer tubes. The two upper drag brace struts and the screwjack ram arms both link to the aft end of the lower drag brace and pivot about separate points on the rear of the mounting frame; the screwjack pivot axis being above that of the drag brace.

Examination of the failed right main landing gear elements revealed that the lower drag brace had bent downwards and backwards at the point coincident with the cross brace on that assembly. The upper drag brace struts had buckled nearer to their lower ends and the rivets attaching the screwjack nut to the ram had failed in shear in a direction consistent with a tensile force having been applied. There was evidence, within the landing gear bay, that, after the screwjack had parted as a result of the failure of the nut rivets, the freed end of the ram had pushed the jack body up into the underside of the wing and had subsequently punctured the engine oil tank in the rear of the right nacelle.

Most probably this full compression of the spring strut, on the fifth touchdown, resulted in high wheel drag loads being generated. This, in turn, would have resulted in high compressive loads developing in the drag brace elements and it is probable that the longer upper drag brace struts became unstable and bowed. This would be consistent with the photographic record which showed the drag brace articulating downwards at its centre joint; continued articulation in that sense would have brought the lower drag brace cross-tie into contact with the wheel.

With there being no physical down-locks or mechanical 'over centre' blocks, the travel of the drag brace articulating joint, 'C', being positioned 'over centre' results in the generation of forces in the landing gear mechanism tending to drive the point 'C' further 'over centre'. If the landing gear were to be positioned with the point 'C' just 'under-centre', the resultant geometry would be stable and cause both the upper drag brace struts and the screwjack assembly to be in compression. The share of this compression between the elements would be related to the degree of 'under centre' set.
