**ACCIDENT**

<b>Aircraft Type and Registration:</b>	Piper PA-28-161 Cherokee Warrior II, G-BSPM	
<b>No &amp; Type of Engines:</b>	1 Thielert TAE 125-02-99 piston engine	
<b>Year of Manufacture:</b>	1981	
<b>Date &amp; Time (UTC):</b>	5 November 2010 at 1545 hrs	
<b>Location:</b>	Ranmoor Common Road, Dorking, Surrey	
<b>Type of Flight:</b>	Training	
<b>Persons on Board:</b>	Crew - 2	Passengers - None
<b>Injuries:</b>	Crew - 2 (Minor)	Passengers - N/A
<b>Nature of Damage:</b>	Damaged beyond economic repair	
<b>Commander's Licence:</b>	Commercial Pilot's Licence	
<b>Commander's Age:</b>	41 years	
<b>Commander's Flying Experience:</b>	800 hours (of which 387 were on type) Last 90 days - 70 hours Last 28 days - 16 hours	
<b>Information Source:</b>	AAIB Field Investigation

**Synopsis**

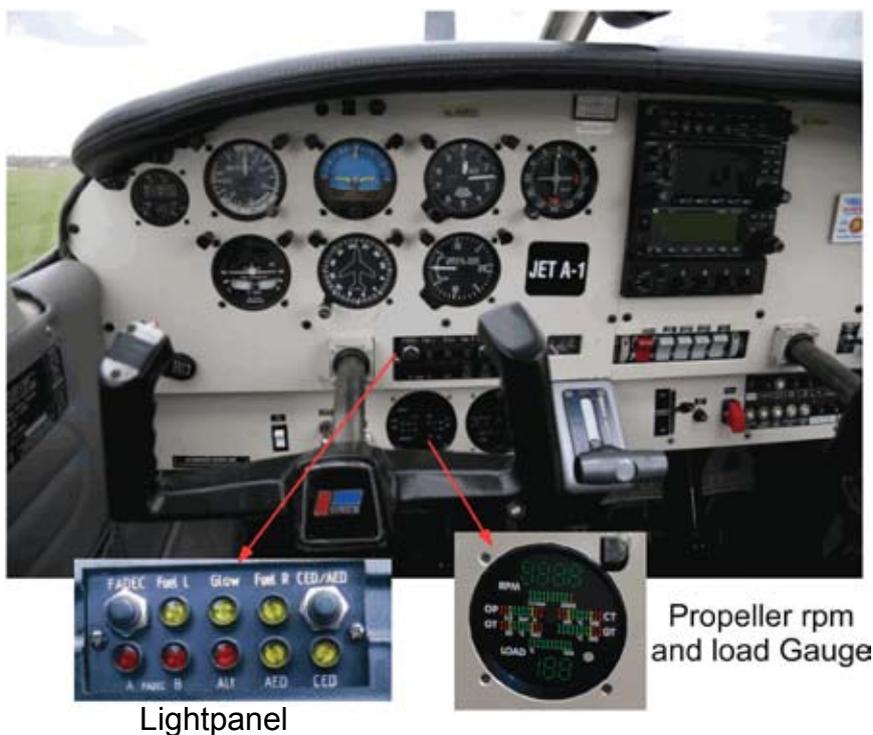
The aircraft was fitted with a multi-function instrument which displayed the propeller rpm, engine load, reduction-gearbox oil temperature and pressure, and engine cylinder temperatures, Figure 1. Both propeller rpm and ‘load’ were displayed digitally and in the form of a strip of green LEDs. The propeller rpm LED strip

**Figure 1**  
Typical Thielert TAE 125 engine layout instrumentation

The only other indication of the overspeed condition would have been the illumination of the small red LED at the end of the rpm indication strip and the reading on the digital rpm gauge which, due to the nature of such gauges, would have been continually changing. In addition, the propeller rpm and load gauge was located low on the instrument panel, Figure 1. A review of the POH supplement confirmed that pilots are only directed to check the propeller rpm during the *'FADEC AND PROPELLER ADJUSTMENT FUNCTION CHECK'*; during all other phases of flight the 'load' gauge is the primary means of confirming engine power.
