Enstrom F-28F Falcon, G-BYKF

AAIB Bulletin No: 4/2004	Ref: EW/C2004/01/01	Category: 2.3
INCIDENT		
Aircraft Type and Registration:	Enstrom F-28F Falcon, G-BYKF	
No & Type of Engines:	1 Lycoming HIO-360-F1AD piston engine	
Year of Manufacture:	1983	
Date & Time (UTC):	6 January 2004 at 1315 hrs	
Location:	Crowhurst Park, Crowhurst, East Sussex	
Type of Flight:	Private	
Persons on Board:	Crew - 1	Passengers - 2
Injuries:	Crew - None	Passengers - None
Nature of Damage:	Damage to tail rotor drive shaft bearing and rubber bushes	
Commander's Licence:	Private Pilot's License	
Commander's Age:	44 years	
Commander's Flying Experience:	537 hours (of which 430 were on type)	
	Last 90 days - 15 hours	
	Last 28 days - 5 hours	
Information Source:	AAIB Field Investigation

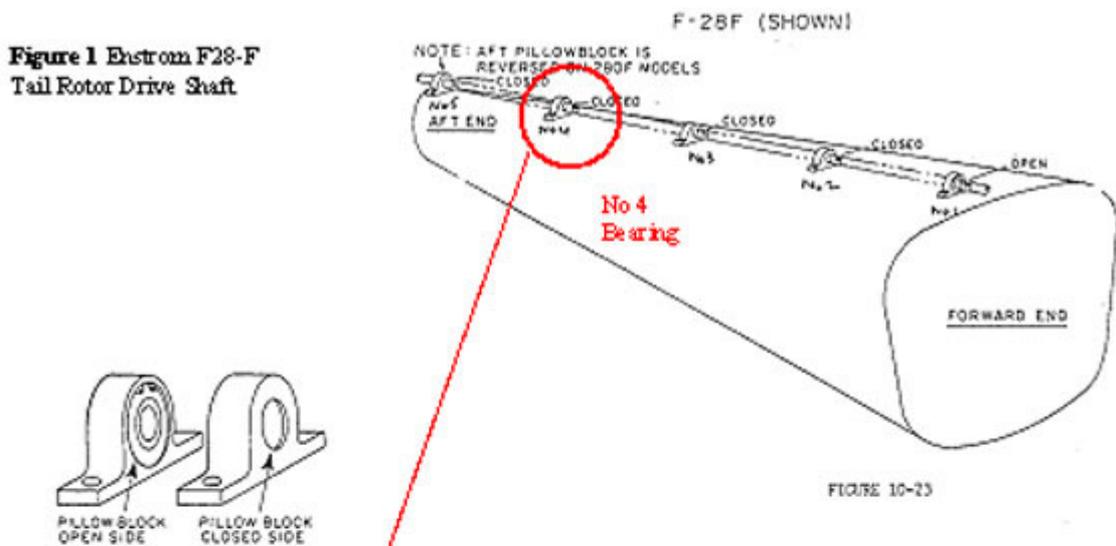
Figure 1 & 2: Tail Rotor Drive Shaft and Photo of final location of Number 4 bearing

In this type of helicopter, drive is transmitted to the tail rotor via a shaft running externally along the top of the tail boom and supported along its length by five roller bearings located within blocks. Between each block and the bearing is a rubber bush. The helicopter was examined by the AAIB in conjunction with the maintenance engineer and the pilot. The rubber bush from the No 4 bearing (numbered from the forward end of the shaft - see Figure 1) was damaged and having been released from its location, had migrated aft, although it had remained attached to the shaft (see Figure 2). Release of the bush had allowed the tail rotor drive shaft some radial movement within the bearing, thus causing the vibration. All the bearings and rubber inserts were removed for analysis.

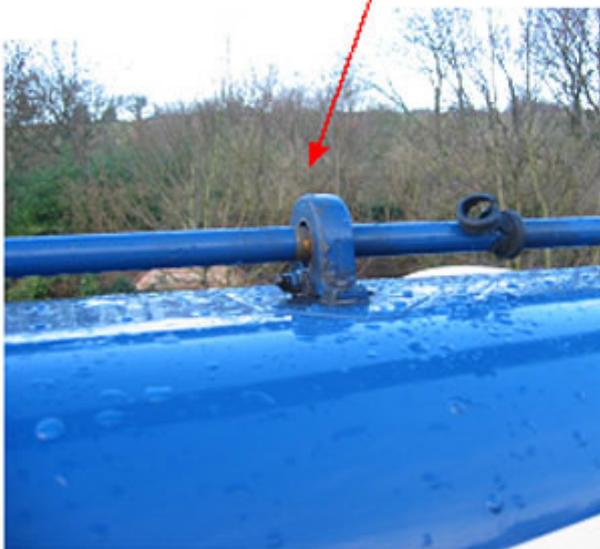
Figure 2 Number 4 bearing and bush as found on G-BYKF with the rubber bush having been released from its location and migrated aft along the exposed tail rotor drive shaft

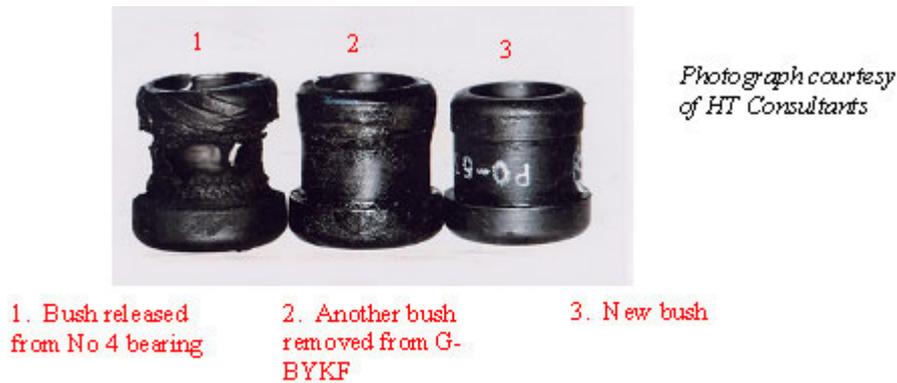
Figure 3: Comparison of rubber bush condition

Examination showed that the No 4 bearing, although filled with grease, was heavily contaminated with elastomer particles from the rubber bush. The bush had become swollen from prolonged contact with grease (see Figure 3); this had resulted in wear of the bush due to contact with the block whilst the bush was rotating, thus contaminating the grease with the associated wear products. The other bushes showed similar signs of swelling. The No 4 bearing showed some evidence of corrosion, although it was probable that this had occurred as a result of moisture ingress whilst idle and it is likely that this had occurred relatively recently after the bush had been released and prior to examination by the AAIB. There is no record of any other in-flight failures of this component.
