INCIDENT

Aircraft Type and Registration:	Boeing 747-200, ZS-SAL	
No & Type of Engines:	4 Pratt and Whitney JT9D-7J turbofan engines	
Year of Manufacture:	Not known	
Date & Time (UTC):	2 April 2000 at 2139 hrs	
Location:	London Heathrow Airport	
Type of Flight:	Public Transport (Passenger)	
Persons on Board:	Crew - N/A	Passengers - N/A
Injuries:	Crew – N/A	Passengers – N/A
Nature of Damage:	Damage to left wing landing gear No 2 wheel, right main gear door and right wing landing gear	
Commander's Licence:	Airline Transport Pilot's Licence	
Commander's Age:	N/A	
Commander's Flying Experience:	N/A	
Information Source:	AAIB Field Investigation

Incident during taxiing for departure

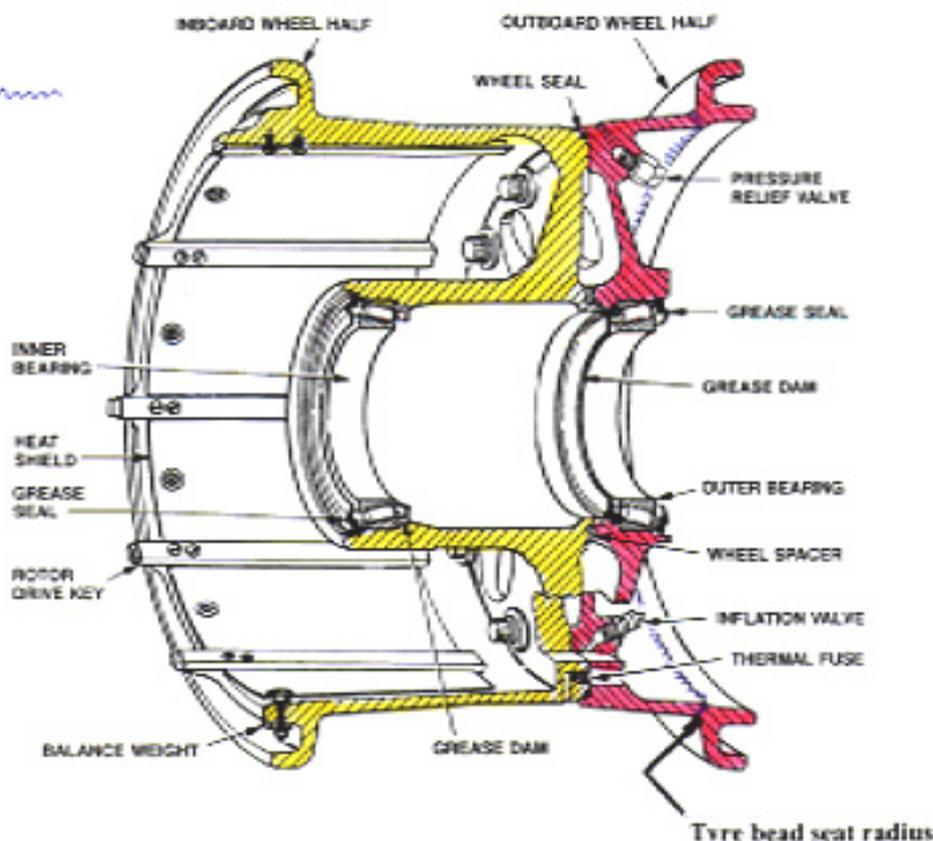
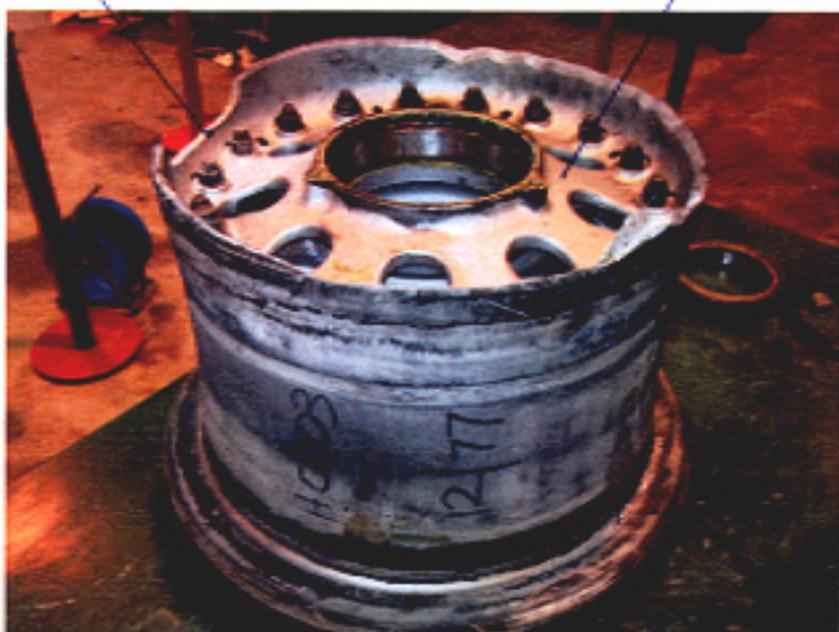
Figure 1

The fracture had occurred in the region where the inboard side rim adjoined the cylindrical section of the wheel hub, as indicated by the 'fracture line' drawn in the diagram at Figure 1, and illustrated in the lower photograph of the wheel. The rim had fractured into three sections, as shown in the photograph at Figure 2; each rim section weighed between 3 and 6 lbs. Metallurgical examination of the fracture surfaces found that all exhibited the characteristics of a single event overload, but initiated by a high cycle tension fatigue crack in the bead radius of the rim, which had extended over a length some 4 inches. The associated fracture characteristics suggested that this fatigue crack had initiated from a single point, possibly a surface defect, rather than from several points as may occur when service loading is higher than predicted.

Fracture line

This area removed for examination

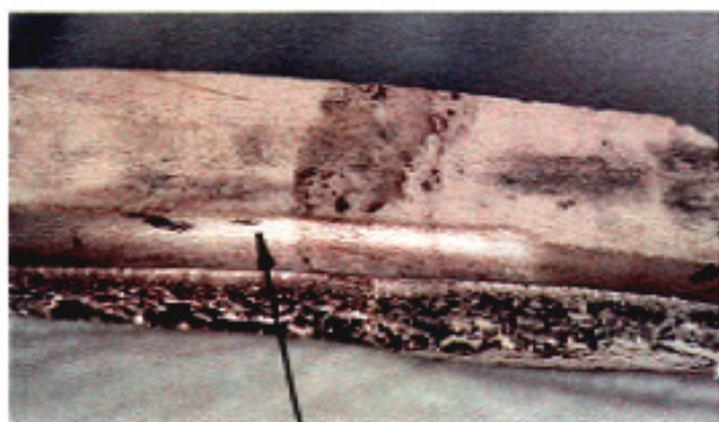
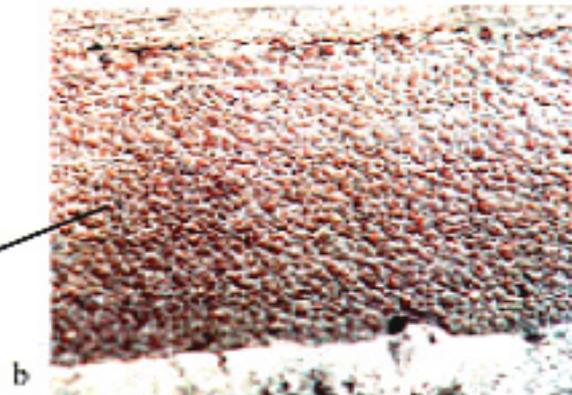
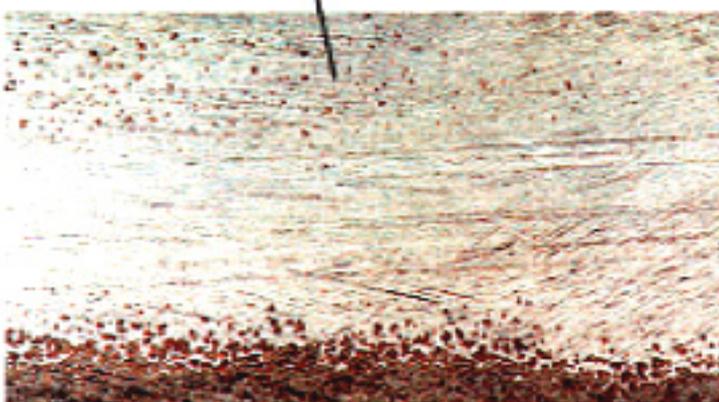
Figure 3

crack origin had been located within this polished band. The effect of this polishing had been to remove most of the compressive layer induced in the radius surface by the peening at manufacture, and the polishing had also left many scores in the new surface. These polishing effects are illustrated in the photographs at Figure 3. The photograph and diagram of the fatigue initiation area at Figure 4 shows that the fatigue origin was no longer present, due to a small layer of material from the surface having been removed by the polishing operation. This indicated that the embryonic fatigue crack had initiated before the polishing operation and had not been completely polished out.

a. Tyre bead seat radius showing region where shot peened surface has been polished away. Crack origin to left of picture.

b. Detail of 'correct' shot peened surface.

c. Detail of surface where shot peened surface is polished away with resulting scratches.

The Component Maintenance Manual (CMM) for this wheel recommended that an eddy current or ultrasonic inspection technique should be used to check for cracks in the area of, and on both sides of, the bead seat radius and stated that ‘no wheel shall be returned to service with cracks’. Some reworking of the bead seat areas was permissible within the limits specified in the CMM, but it was a requirement that the surface treatment should be restored.

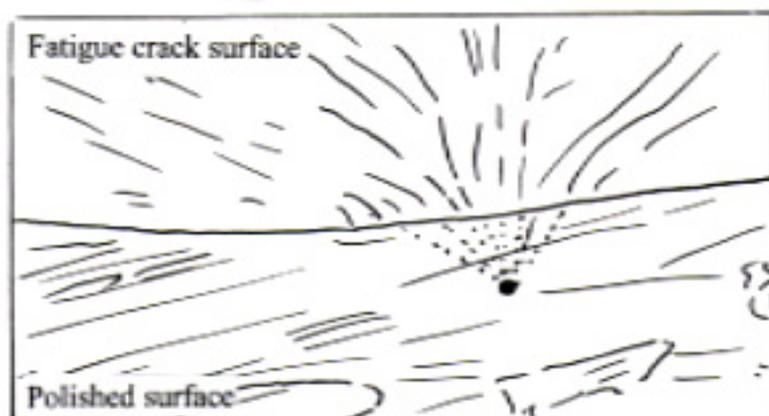
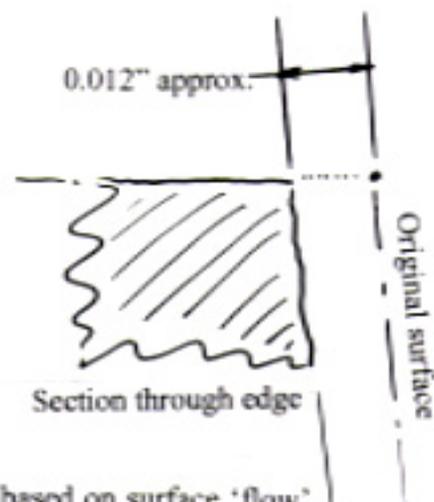
Figure 4

Photograph and diagram illustrating likely position of crack origin based on surface 'flow' lines tending towards a single point.

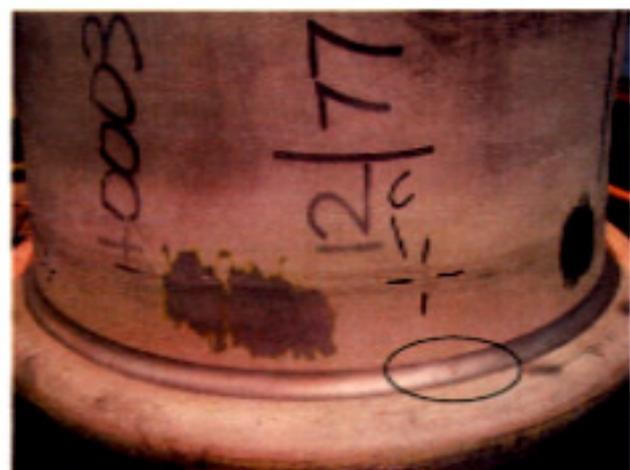
Figure 5

Whilst at the manufacturer’s facility, the opportunity was taken to check for any other cracks or defects in the ‘inboard wheel half’, using their normal (‘Hocking’) eddy current test method where a probe, which lightly rests against the surface, is traversed upwards as the wheel rotates. Several defects were identified, as shown in Figure 5, together with areas of polishing where presumably previously identified defects had been removed. Following this inspection, the relevant parts of this wheel were passed to the manufacturer for further examination.

Defects identified in inboard wheel half
