INCIDENT

Aircraft Type and Registration:	BAE Systems Jetstream 4100, G-MAJI	
No & Type of Engines:	2 Garrett Airesearch turboprop engines	
Year of Manufacture:	1993	
Date & Time (UTC):	12 January 2007 at 0723 hrs	
Location:	After takeoff at Durham Tees Valley Airport, County Durham	
Type of Flight:	Commercial Air Transport	
Persons on Board:	Crew - 3	Passengers - 3
Injuries:	Crew - None	Passengers - None
Nature of Damage:	None	
Commander's Licence:	Air Transport Pilot's Licence	
Commander's Age:	44 years	
Commander's Flying Experience:	4,330 hours (of which 577 were on type) Last 90 days - 206 hours Last 28 days - 49 hours	
Information Source:	Aircraft Accident Report Form submitted by the pilot and subsequent inquiries by the AAIB

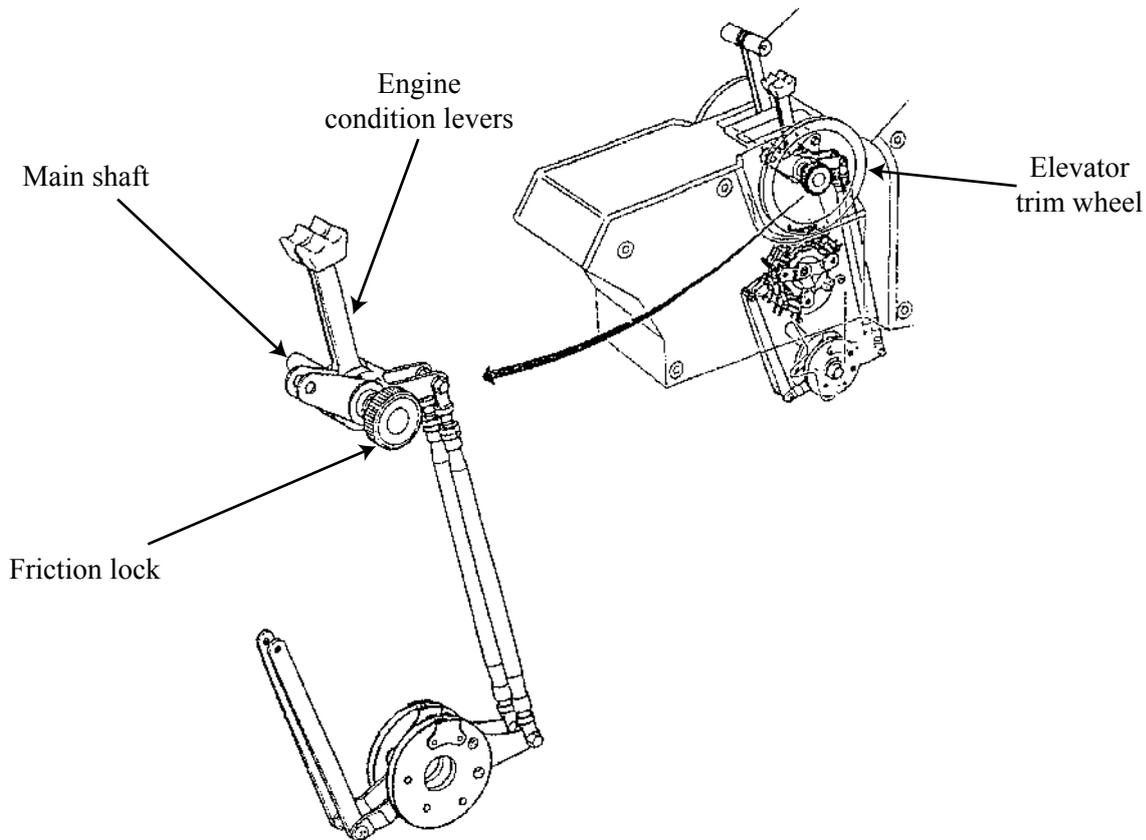
Figure 1

It was soon found that both the elevator manual trim wheel (see Figure 1) and the condition lever friction wheel had jammed and were immovable. The elevator electrical trim also did not work. Vectors were provided for a 10-mile final approach to the airport for an ILS landing on Runway 23 in order for the crew to assess handling. The decision was made to keep the flaps at their takeoff setting of 9° in case further

Investigation by the company’s engineers found that the condition lever friction wheel, which rotates about a common shaft with the elevator manual trim wheel (Figure 1), had made contact with the trim wheel such that application of nose-down elevator trim also caused rotation of the friction wheel in the ‘tighten’ sense until the two had jammed together. When the two wheels were freed, both mechanisms worked correctly. The aircraft manufacturer provided the information below

Jetstream 41 centre console, showing relationship between engine condition lever friction lock and elevator trim wheel

It is of concern that this incident, apparently a rather more extreme variation of incidents that had occurred (and which had appeared to have been resolved) about eight years ago, should not have the same root cause. The AOM described how the friction wheel is fitted with a boss which 'bottoms' on the main shaft before it can interfere with a correctly-fitted trim wheel, and therefore only a displaced trim wheel can cause contact. Despite a thorough check against the maintenance manual, no abnormalities were found in G-MAJI, and the aircraft has operated without further incident since then. The conclusion drawn by the operator is that the condition lever friction wheel had been tightened with greater than normal force to cause this incident.

However, the aircraft manufacturer has advised that, as an added precaution, it is revisiting the design review of the mechanism, carried out in response to the earlier occurrences.
