ACCIDENT

Aircraft Type and Registration:	DG505 Elan Orion, BGA 4432 JDN	
No & Type of Engines:	None	
Year of Manufacture:	1997	
Date & Time (UTC):	22 April 2007 at 1542 hrs	
Location:	North Hill Airfield, Broadhembury, Honiton, Devon	
Type of Flight:	Private	
Persons on Board:	Crew - 1	Passengers - None
Injuries:	Crew - 1 (Serious)	Passengers - N/A
Nature of Damage:	Aircraft destroyed	
Commander's Licence:	Gliding Certificate with Silver Badge	
Commander's Age:	48 years	
Commander's Flying Experience:	144 hrs / 414 launches (of which 5 hrs were on type) Last 90 days - 3 hours Last 28 days - 3 hours	
Information Source:	AAIB Field Investigation

Synopsis

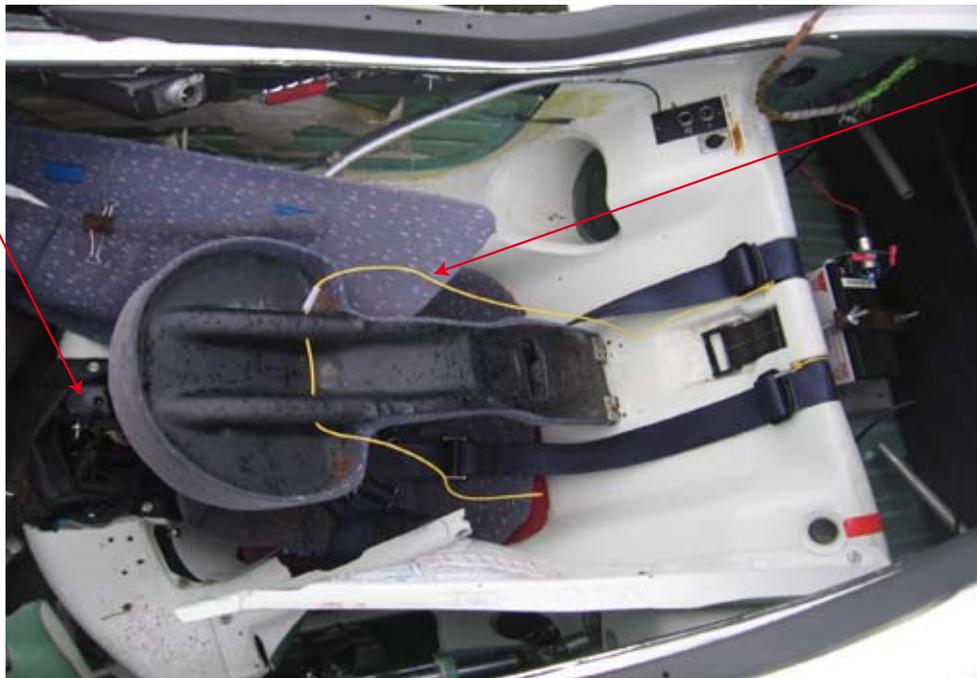
Figure 1

Examination of the glider at the accident site confirmed that there were no disconnections within the control circuits. However, the rear cockpit headrest was found to have pivoted forward and was resting on the top of the control column (Figure 1), the restraining wire having broken at the point where it was secured to the shoulder harness attachment. A smear of a black plastic-like substance was found on the headrest cover where it had been resting on the control column. The gliding club confirmed that JDN had been kept permanently rigged and club records indicated that it had rarely been flown solo. However, the rear headrest would have been moved forward to install the main battery prior to the first flight of the day and to check the security of the wing rigging pins.

The black plastic material on the rear headrest cover originated from the hand grip on the rear control column. Detailed inspection of the hinged seat back in the rear cockpit showed that it had failed approximately half way along its length and the foam at the top of the headrest had been distorted. The failure indicated that a large compressive force had been applied between

Rear seat headrest in ‘as found’ condition

the top of the headrest and the hinge point. The distortion in the foam matched the shape of a collar at the base of the control column. The length of the headrest was such that, if unrestrained, it would sit on top of the control column when the column was in the neutral position. If the column was then moved forward, the headrest would drop behind it, preventing any rearward movement of the column. In order to prevent the headrest dropping onto the control column, it had been restrained by a length of electrical cable which had failed where it had been secured to the rear shoulder harness location points. The wire was 2.4 mm in diameter, with a conductor made up of 14 x 0.3 mm diameter copper strands.

The damage to the top of the rear headrest and the compressive fracture of the headrest structure, indicated that the headrest had dropped behind the rear control column and that the column had been pushed against the headrest with considerable force. The black deposit on the headrest confirmed that it had also come into contact with the top of the rear control column with some force. It is unlikely that sufficient force would have been exerted by the pilot before impact to fracture the headrest itself, so it was probably already in its lowered position when the accident occurred and would have restricted rearward movement of the control column. Examination confirmed that the headrest would readily fall forward when the type is flown solo and if unrestrained could fall behind the control column causing a restriction.

The accident was caused by the failure of a piece of electrical cable used to restrain the hinged rear cockpit headrest. This fell forward at some stage of the flight and, as the pilot manipulated the controls during the approach

It is recommended that the Luftfahrt-Bundesamt and the EASA require DG-Flugzeubau GmbH to review the design of the hinged headrest introduced to the DG500 series glider by Glaser Dirks Flugzeubau GmbH Technical Note 348/5 to remove any possibility of a control restriction in the event that the headrest becomes unrestrained.
