SERIOUS INCIDENT

Aircraft Type and Registration:	Bell 206L-4 Longranger IV, G-PTOO	
No & Type of Engines:	1 Allison 250-C30P turboshaft engine	
Year of Manufacture:	1995	
Date & Time (UTC):	3 March 2011 at 1512 hrs	
Location:	London City Airport	
Type of Flight:	Private	
Persons on Board:	Crew - 1	Passengers - 1
Injuries:	Crew - None	Passengers - None
Nature of Damage:	Tail rotor balance weight detached, damage to tail rotor gearbox mountings and tail boom	
Commander's Licence:	Commercial Pilot's Licence	
Commander's Age:	46 years	
Commander's Flying Experience:	2,200 hours (of which 480 were on type) Last 90 days - 30 hours Last 28 days - 15 hours	
Information Source:	Aircraft Accident Report Form submitted by the pilot

Synopsis

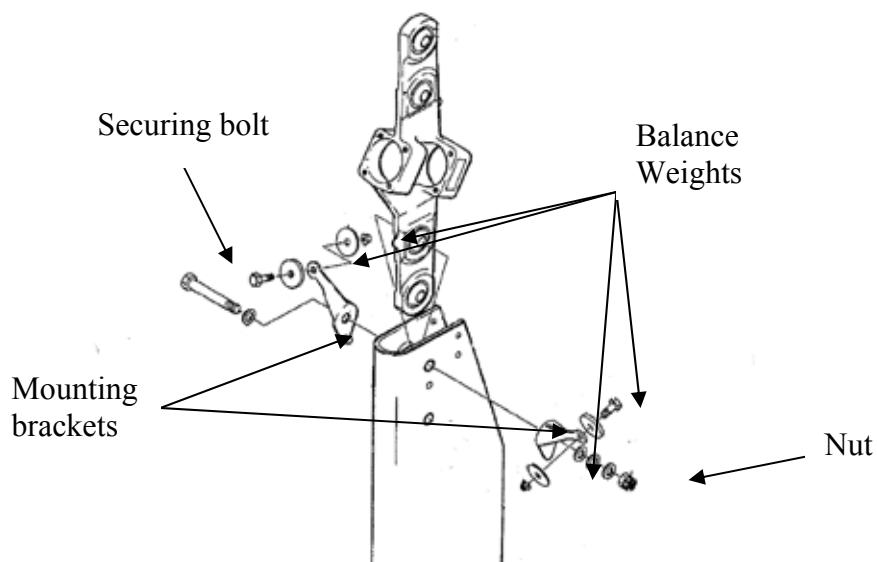
Each tail rotor blade is balanced by the use of individual weights mounted on a bracket to form an assembly. Two such assemblies are installed on each blade, one either side of the blade root, see Figure 1. They are held in place by a bolt which passes through both

Figure 1
Tail rotor balance weights and brackets
(Courtesy of Bell Helicopters)

The bolt had failed approximately 12 mm from the end of its shank and included the securing nut and associated split pin. The remaining portion of the bolt had remained in-situ, retaining the second balance weight assembly to the tail rotor blade. Examination

of the remains of the bolt showed that a crack had formed within the bolt shank. This had propagated due to a fatigue mechanism until the bolt shank fractured in overload. The initiation point of this crack was found to coincide with a section of the bolt shank where the cadmium plating had been worn away by contact with the structure of the tail rotor blade, but no cause for the initiation of the crack could be identified.
