INCIDENT

Aircraft Type and Registration:	Boeing 737-528, G-GFFE	
No & Type of Engines:	2 CFM56-3C1 turbofan engines	
Year of Manufacture:	1995	
Date & Time (UTC):	3 September 2005 at 0920 hrs	
Location:	Stand 110, North Terminal, London Gatwick Airport	
Type of Flight:	Public Transport (Passenger)	
Persons on Board:	Crew - 6	Passengers - None
Injuries:	Crew - None	Passengers - N/A
Nature of Damage:	APU failure with extensive axial ejection of turbine debris	
Commander's Licence:	Airline Transport Pilot's Licence	
Commander's Age:	Not known	
Commander's Flying Experience:	18,500 hours (of which 9,400 were on type)	
Information Source:	AAIB Field Investigation

Synopsis

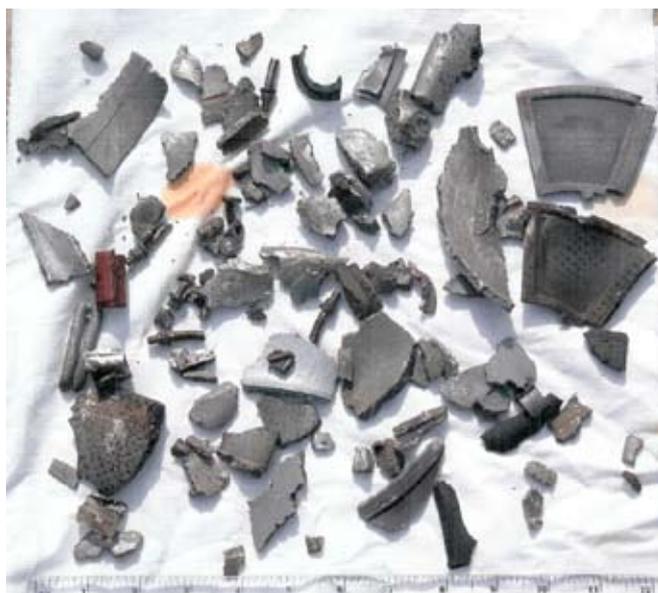
Figure 2

below the rear of the aircraft. A sketch diagram of the distribution of the remaining debris was made on part of a large-scale chart of the apron area before the smaller debris was swept up by the airport authority to bring the taxiway back into use. The diagram and some debris items were subsequently passed to the AAIB. It was noted that the general distribution formed a fan-shaped pattern extending behind the aircraft. A few fragments had travelled as far as the northern part of Stand 135 but none reached Stand 134. A photograph of the fragments collected is shown at Figure 2.

No airframe damage had occurred but on opening the APU access door, it could be seen that an internal failure had bulged and partly split the external casing of the unit. One of the two side-mounts had separated from the unit as a result of the deformation of the casing. Looking down the jet-pipe it could be seen that the turbine was damaged and displaced from its axis, whilst the exhaust duct within the APU had been seriously deformed by contact with high energy rotating turbo-machinery.

APU fragments

Examination of all the failed wheels returned to the manufacturer confirmed that the failures originated at small film inclusions of aluminium-magnesium oxides within the core of the casting. These led to initial fatigue crack growth before rapid failures occurred across the remainder of the cross-sections. Both failures involving separation into two approximately equal halves (bi-wheel) and into three approximately equal sized portions (tri-wheel failures) have occurred. In all instances the containment rings performed as designed.
