**INCIDENT**

<b>Aircraft Type and Registration:</b>	Piper PA-31-350 Navajo Chieftan, G-VIPW	
<b>No &amp; Type of Engines:</b>	1 Lycoming LTIO-540-J2BD piston engine and 1 Lycoming TIO-540-J2BD piston engine	
<b>Year of Manufacture:</b>	1979	
<b>Date &amp; Time (UTC):</b>	13 May 2009 at 1046 hrs	
<b>Location:</b>	10 miles south of Isle of Man Airport, Isle of Man	
<b>Type of Flight:</b>	Private	
<b>Persons on Board:</b>	Crew - 1	Passengers - None
<b>Injuries:</b>	Crew - None	Passengers - N/A
<b>Nature of Damage:</b>	Damage to right engine and right engine cowling	
<b>Commander's Licence:</b>	Commercial Pilot's Licence	
<b>Commander's Age:</b>	29 years	
<b>Commander's Flying Experience:</b>	1,321 hours (of which 483 were on type) Last 90 days - 147 hours Last 28 days - 46 hours	
<b>Information Source:</b>	Aircraft Accident Report Form submitted by the pilot and further enquiries by the AAIB

**Synopsis**

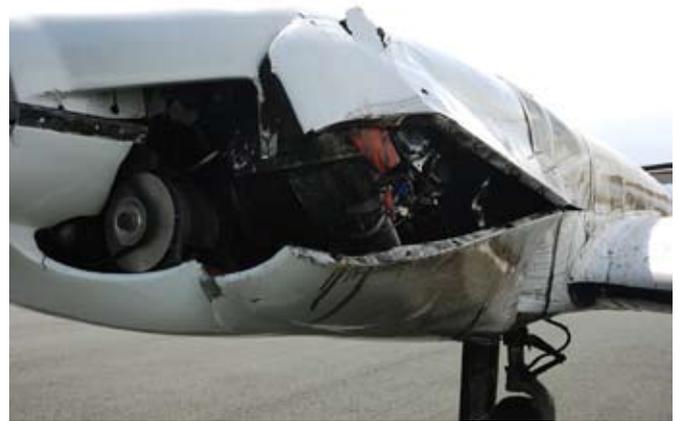
**Figure 1**

The left forward section of the right engine cowling had split apart revealing that the No 2 cylinder had detached from the engine but was still retained within the cowling. The left side of the cowling was coated in oil see Figure 1.

Right engine cowling revealing the separated No 2 engine cylinder

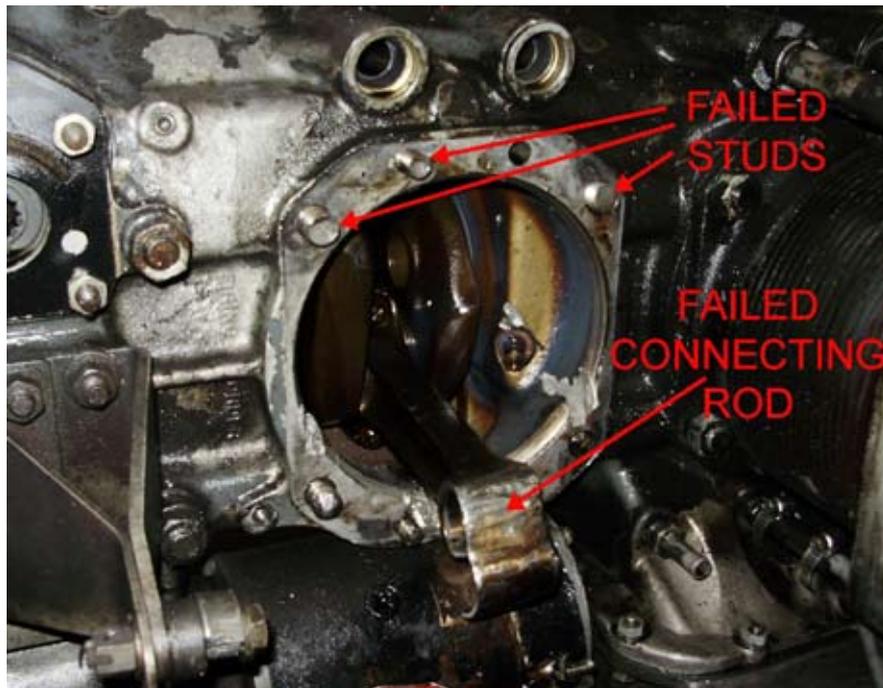
**Figure 2**

Six of the eight studs that had retained the No 2 cylinder had failed in overload and the remaining two studs had been stripped from the casing. The small end of the No 2 connecting rod had failed and its

failed end had been crushed in subsequent impacts with the piston, while the engine continued to turn see Figure 2. The big end of the connecting rod was still securely attached to the crankshaft.

Location of detached No 2 cylinder revealing failed studs and failed connecting rod small end
