INCIDENT

Aircraft Type and Registration:	DHC-8-311 Dash 8, G-JEDE	
No & Type of Engines:	2 Pratt & Whitney Canada PW123 turboprop engines	
Year of Manufacture:	1999	
Date & Time (UTC):	29 November 2004 at 0914 hrs	
Location:	London City Airport, London	
Type of Flight:	Public Transport (Passenger)	
Persons on Board:	Crew - 3	Passengers - 32
Injuries:	Crew - None	Passengers - None
Nature of Damage:	Damage to skin of fuselage in tail section	
Commander's Licence:	Airline Transport Pilot's License	
Commander's Age:	64 years	
Commander's Flying Experience:	17,500 hours (of which 1,400 were on type) Last 90 days - 59 hours Last 28 days - 19 hours	
Information Source:	AAIB Field Investigation

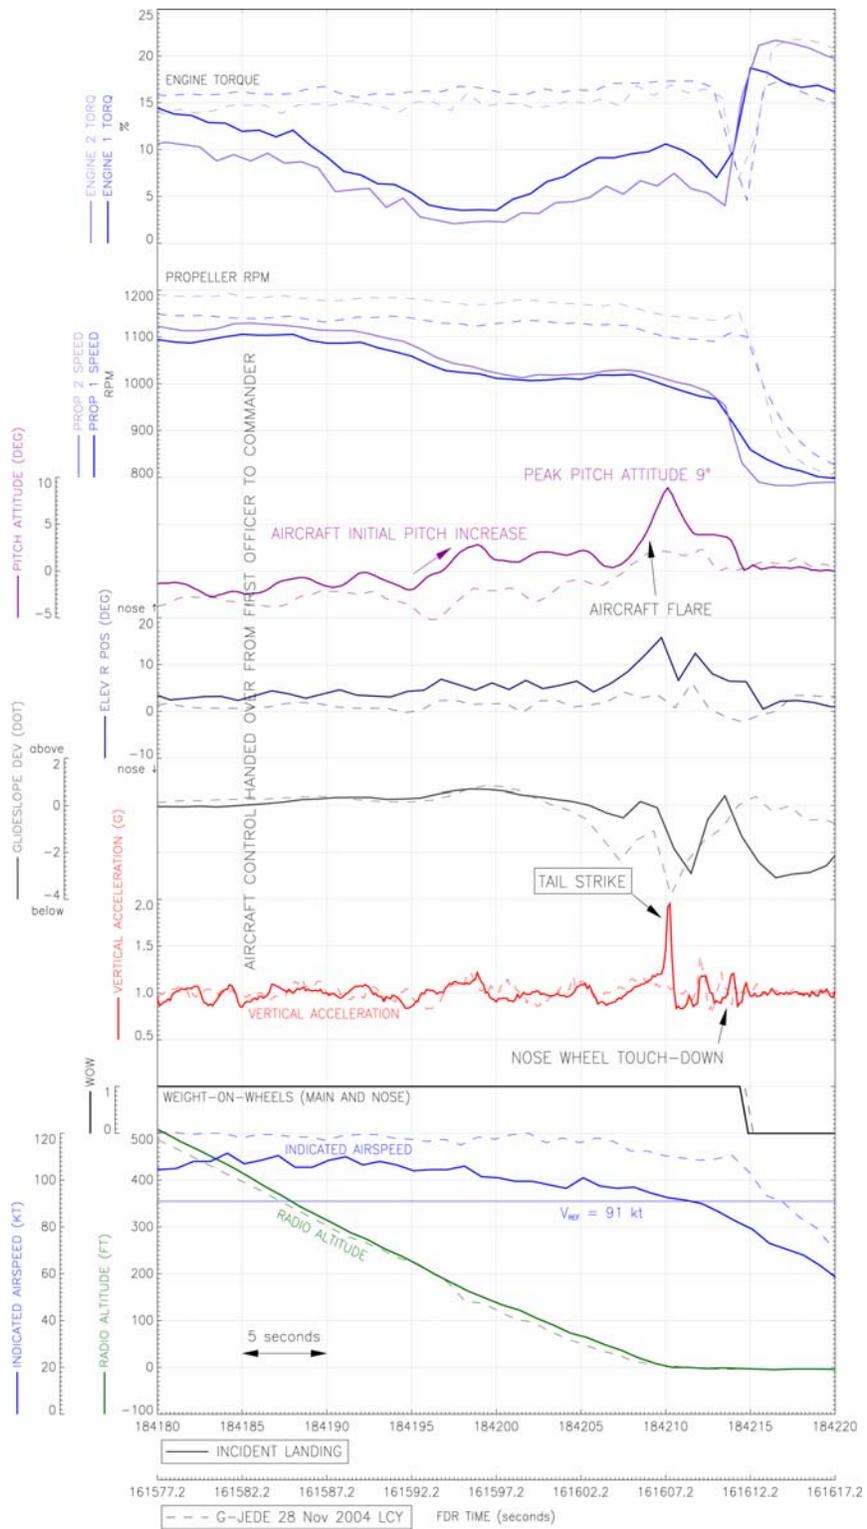
A time-history of the relevant parameters during the incident is shown in Figure 1. For comparison, data, typical of other landings recorded on the FDR, is also presented in Figure 1 (time-aligned for main-wheel touchdown), for a non-event landing, carried out by G-JEDE, two days earlier into LCY. The data presented for the incident starts five seconds before the first officer hands over control to the commander with the aircraft on the glideslope; 450 feet above the ground (radio altitude); $V_{REF} +17$ kt (108 kt) IAS; descent rate of 1,100 ft/min; with just under 15% torque on the No 1 engine and just over 10% torque on the No 2 engine; both reducing.

At the time the commander took control, the torque on both engines had reduced to 12% and 9% respectively; however, they started to reduce even further and more rapidly three seconds later, reaching a minimum of 3.5% and 2% over a ten second period. A change in the elevator angle and corresponding 4° nose up change in aircraft pitch is also evident just before the minimum-recorded torque is reached. Also, the descent rate slowed to 900 ft/min and the airspeed began to reduce.

Ten seconds before the tail struck the ground, the torque on each engine began to increase (reaching 10% and 7% at the time of the tail strike) while the propeller speed remained nominally the same. The descent rate remained at 900 ft/min and the airspeed continued to reduce.

Four seconds before the tail struck the ground there was a large positive elevator deflection (trailing edge up) to 60% full deflection, pitching the aircraft nose-up. The maximum calculated pitch rate was 5°/second and the maximum positive pitch attitude was just under 9°, occurring just after the elevator deflection was reduced, and a fraction of a second before the tail struck the ground. The airspeed at the time of the tail strike was 91 kt (V_{REF}).

FDR Parameters for G-JEDE on 29 November 2004
