**INCIDENT**

| <b>Aircraft Type and Registration:</b> | Airbus A310-222, F-OHPE |
| <b>Date &amp; Time (UTC):</b> | 9 July 1995 at 0118 hrs |
| <b>Location:</b> | On departure from Glasgow Airport |

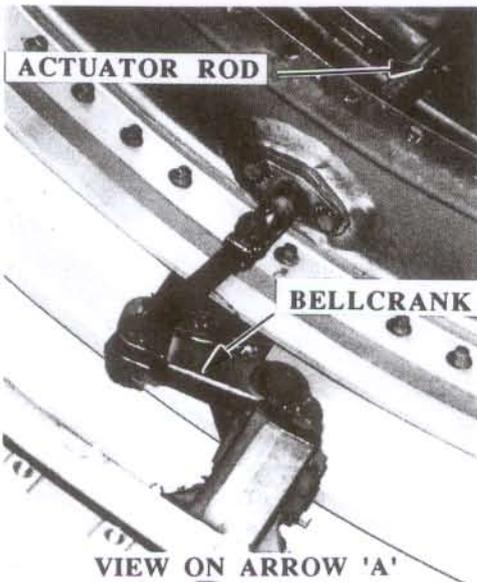
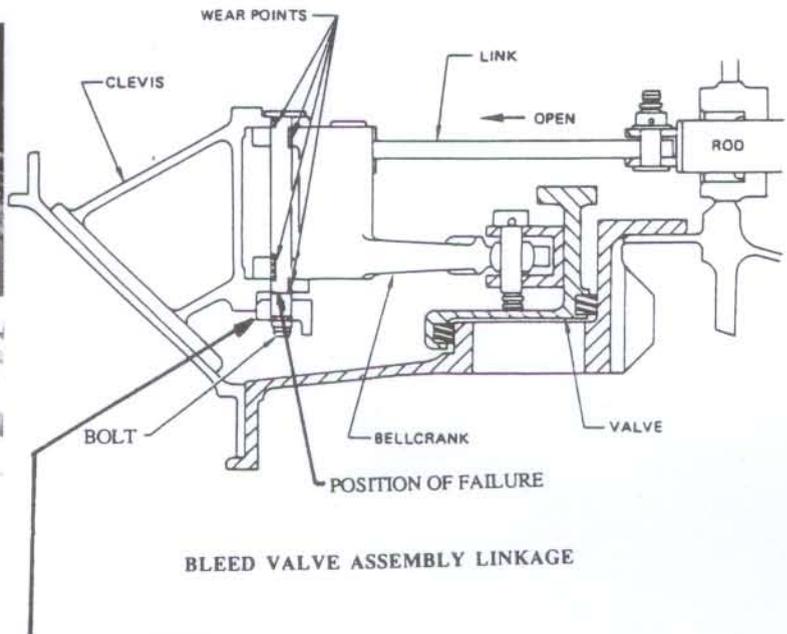
BLEED VALVE ASSEMBLY LINKAGE

The engine was subsequently stripped at an engine overhaul facility in Brussels, and a summary of the findings was later presented to the AAIB. It was established that 3.0 bleed ring had become detached from the actuating linkage due to a failure of a clevis bolt in the bellcrank that attached to the actuator rod. The position of the failure is indicated on the accompanying diagram and photographs. The bolt tail and clevis pad were found in the compressor casing, and it was apparent that the fracture face consisted of approximately 90% fatigue, the remainder being overload. Following the migration of the top portion of the bolt out of its location, the bellcrank would have become disconnected from the clevis. The detached portion of the bolt presumably fell into the bleed annulus and was ingested into the high pressure compressor. Severe damage was caused to the blades and vanes. It was subsequently discovered that the powerplant engineers had not boroscoped this part of the engine at Glasgow. Following the discovery of the broken feedback cable (a failure that they had seen on previous occasions) they had merely wished to check the turbine for evidence of overheat damage. The maintenance organisation's report did not give a reason for the fatigue failure. However, some wear was evident on the shank of the remaining portion of the bolt. The report also noted evidence of wear elsewhere in the actuating linkage.
