## ACCIDENT

<b>Aircraft Type and Registration:</b>	Boeing 747-400SF, B-HKH
<b>No &amp; Type of Engines:</b>	4 Pratt and Whitney 4056 turbofan engines
<b>Year of Manufacture:</b>	1991
<b>Date &amp; Time (UTC):</b>	31 May 2010 at 0700 hrs
<b>Location:</b>	London Heathrow Airport
<b>Type of Flight:</b>	Commercial Air Transport (Cargo)
<b>Persons on Board:</b>	Crew - 3                      Passengers - None
<b>Injuries:</b>	Crew - None                      Passengers - N/A
<b>Nature of Damage:</b>	Failure of end attachment fittings of right wing gear support beam and damage to surrounding panels
<b>Commander's Licence:</b>	Airline Transport Pilot's Licence
<b>Commander's Age:</b>	36 years
<b>Commander's Flying Experience:</b>	7,660 hours (of which 1,694 were on type) Last 90 days - 73 hours Last 28 days - 15 hours
<b>Information Source:</b>	AAIB Field Investigation

## Synopsis

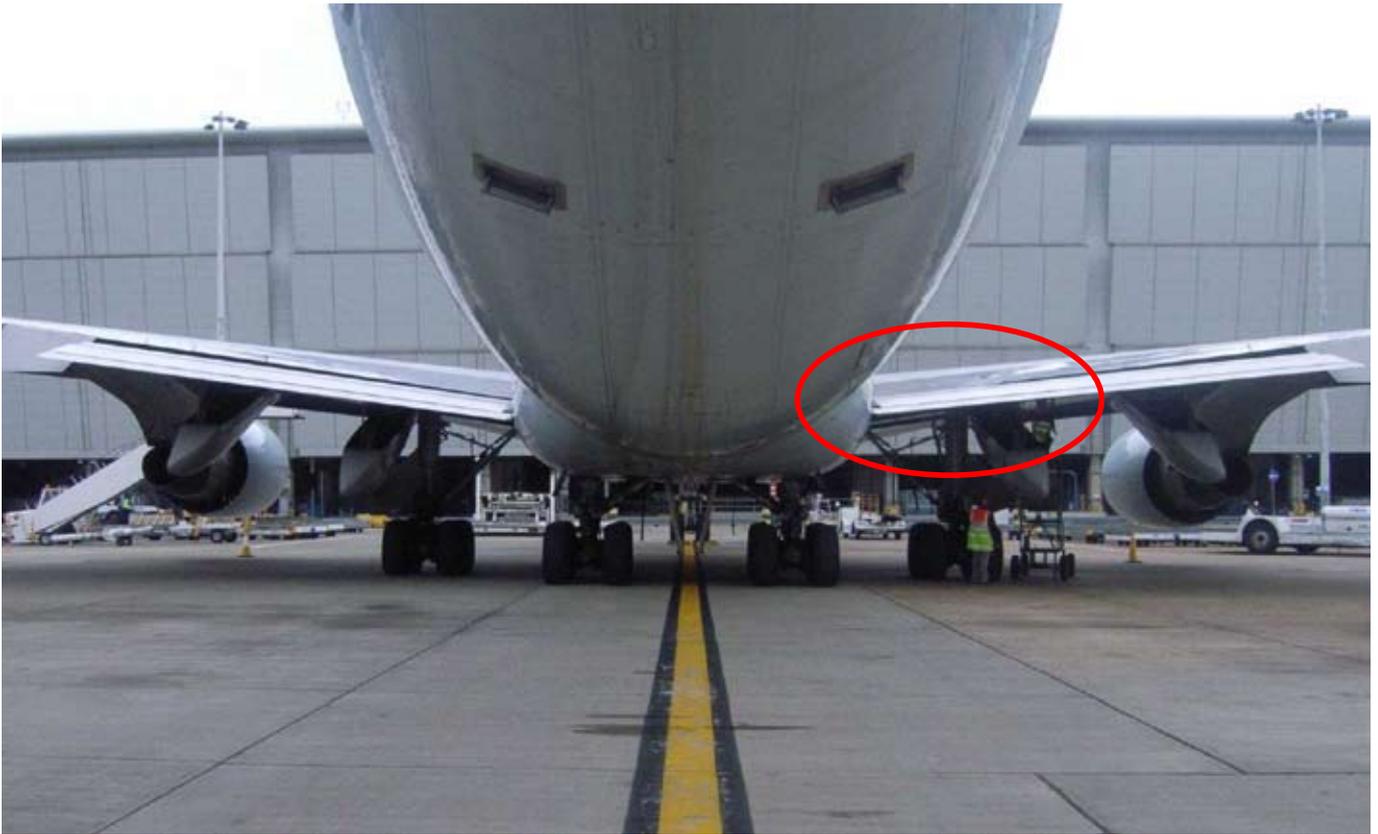
**Figure 1**

During post-flight inspections by an engineer, damage was identified to wing panels above and below the inboard flaps on the right wing and the flaps appeared out of alignment (Figure 1). Further investigation showed that the outboard end fitting of the wing landing gear support beam had failed. The aircraft was withdrawn from service for further inspection and repair.

Rear view of aircraft, showing misalignment of inboard flaps

Following the failure of the outboard fitting, the wing support beam was able to move slightly within the 'gate' fitting, which caused damage to panels above the beam and hydraulic pipes beneath the beam. The inboard flap track is partly mounted on this beam and its movement caused misalignment of the right inboard flaps, leading to damage of the adjacent fairing panels when the flaps contacted them during retraction.

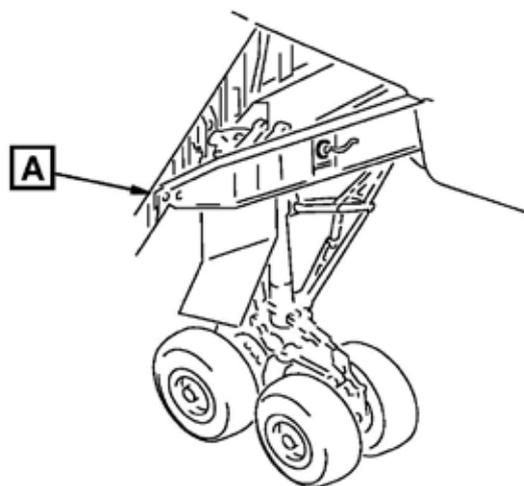
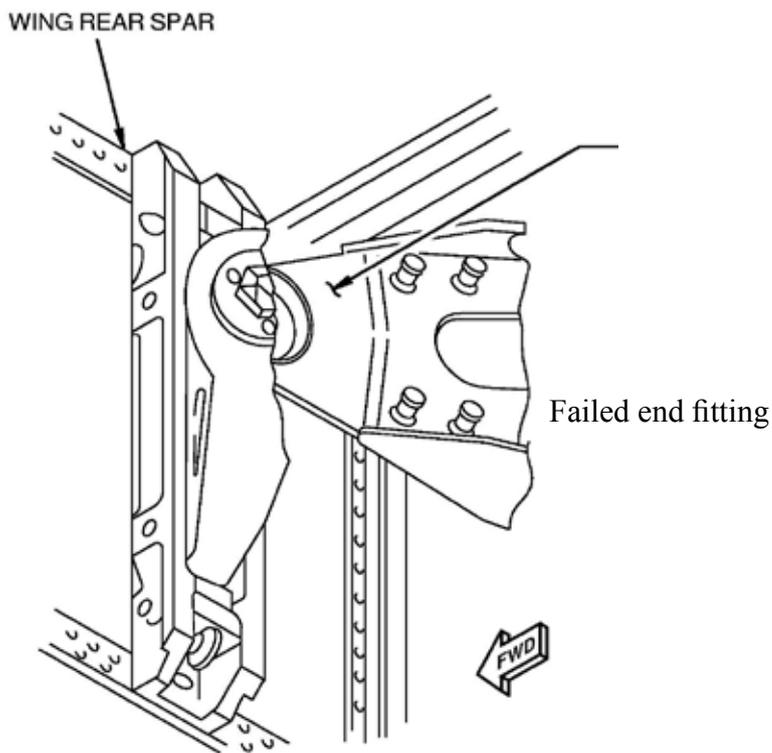
**Figure 2**

The outboard end fitting on this aircraft consisted of two high strength steel plates fastened to the wing landing gear support beam by seven bolts (Figure 2). The end fitting is used to attach the beam to the rear wing spar

Illustration showing location of failed component  
(left wing shown but actual failure on right wing)

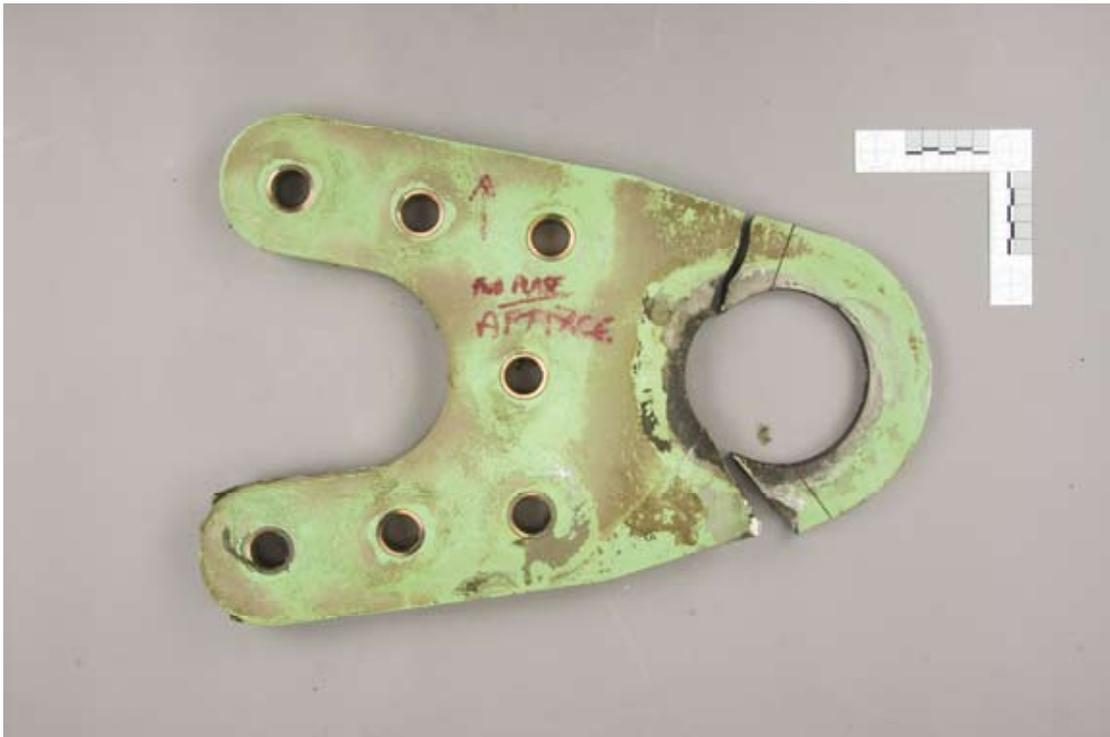
**Figure 3a**

Both fittings on the right wing had failed due to cracks radiating from the main bore of the fittings (Figure 3a and 3b). Significant areas of corrosion were apparent in the bore close to the cracks.

General view of failed forward fitting, right wing

The failed components from the right wing were removed from the aircraft and taken to a specialist forensic metallurgical laboratory for detailed examination. Extensive corrosion was found in the main bore of the fittings. This had allowed the initiation and the development of cracks which had propagated extensively through a 'fatigue' mechanism before separation occurred. It was not possible to determine how long the failure had taken to propagate before final failure occurred. There was no evidence to suggest that

The outboard end fittings of the right wing gear support beam failed due to cracks, propagating from corrosion pits in the main bore of the fitting, reaching a critical length. The manufacturer had been aware of a similar issue on earlier production aircraft of the same type and had instigated design improvements which were incorporated into later aircraft, including B-HKH. These improvements included better corrosion protection in the form of plating to all parts, sealing and an increased interference fit of the bush within its bore to prevent rotation.

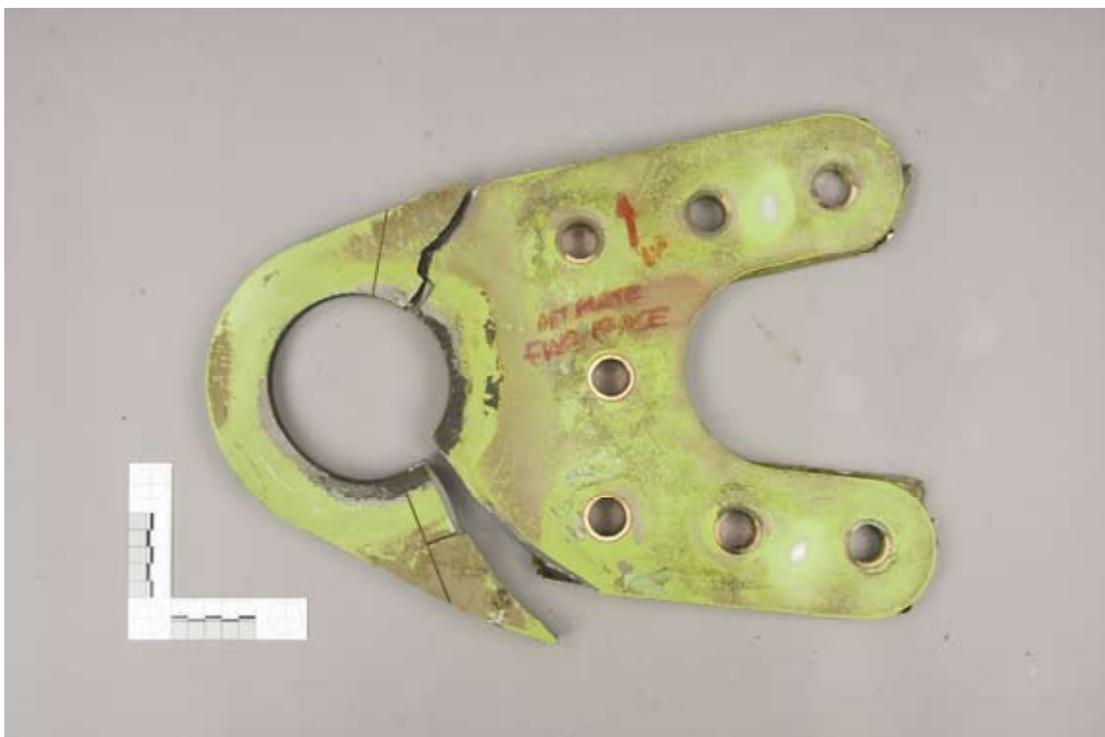
**Figure 3b**

General view of failed aft fitting, right wing

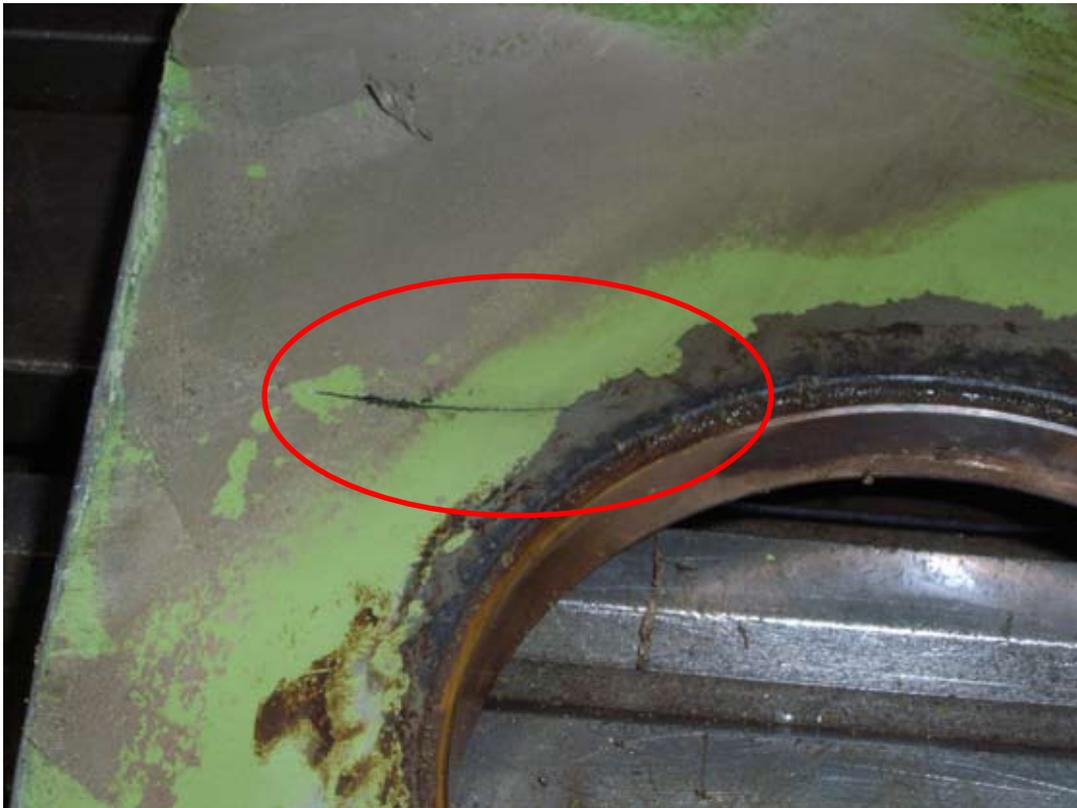
**Figure 4**

The fittings on the left wing were inspected using the inspection technique detailed in the manufacturer's Alert Service Bulletin (747-57A2331) and the forward fitting was found cracked (Figure 4).

The cracked forward fitting from the left wing was returned to the manufacturer for examination. Detailed analysis confirmed that the parts had been manufactured to specification apart from the large bushing, which showed no evidence of the plating which is now required. However, up to September 1989 it was not required that the bushing should be plated and it is possible that this fitting was manufactured before this date. The

Close up of forward fitting, left wing,  
showing bushing, corrosion around main bore and crack

manufacturing records that would have confirmed this had not been retained. Evidence did show that the large bushing had rotated in the fitting and as a result the sealant was dislodged allowing moisture ingress into the joint.

The manufacturer's current Service Bulletin (747-57A2331) details inspection procedures and either rework or replacement schemes to remedy and upgrade any deteriorated fittings that are identified.
