**Fig.1** Wreckage Distribution  
**Accident to Sikorsky S-76A G BGXY**  
**12th March 1981**

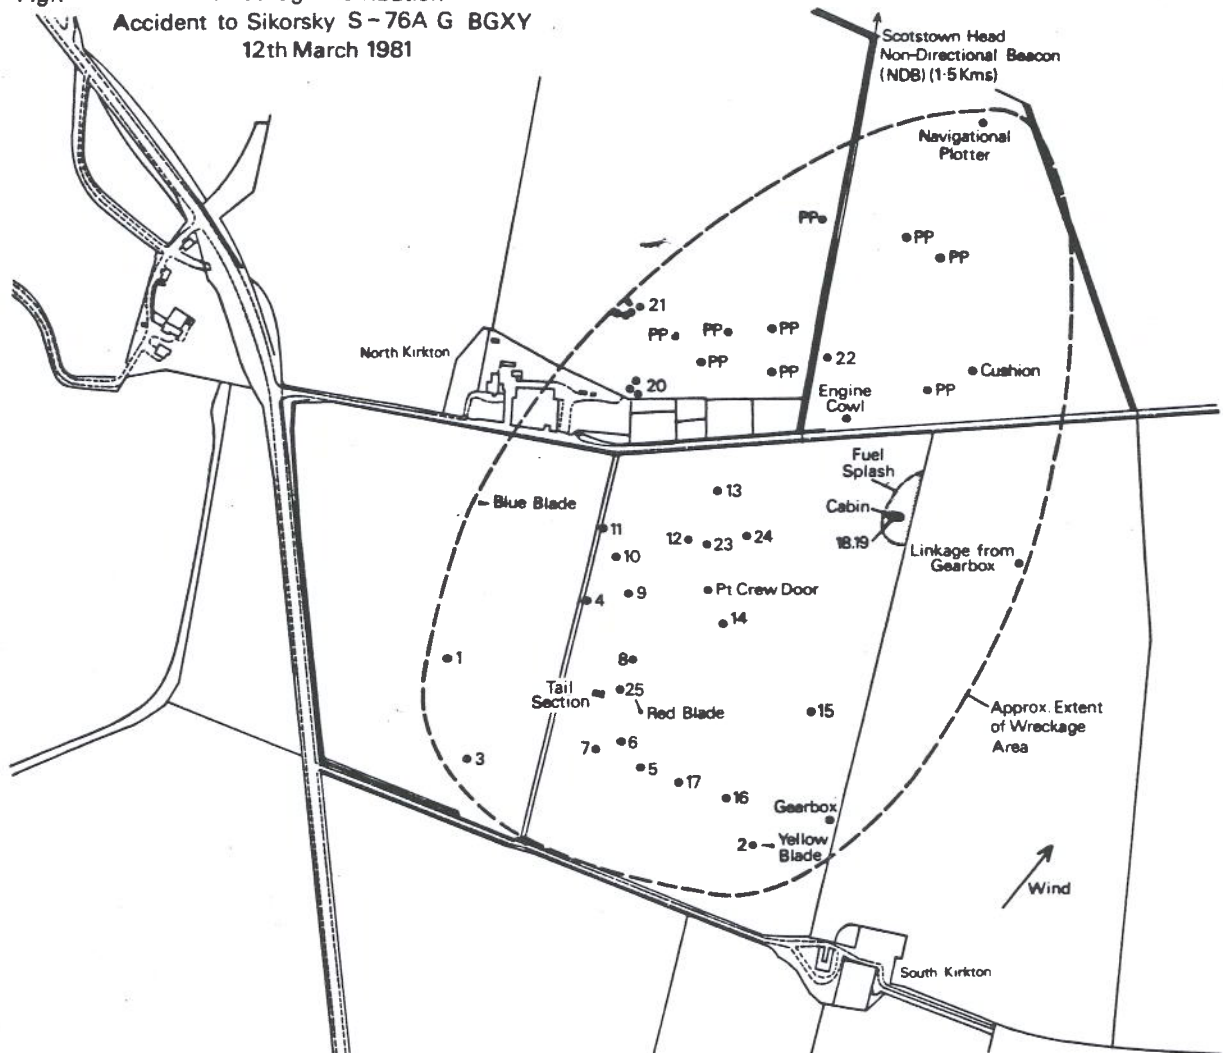
- 1 Black Main Rotor Blade (MRB) Honeycomb Section
  - 2 Yellow MRB Tip Section
  - 3 Main Gear Box (MGB) Fairing
  - 4 Yellow MRB TE (Trailing Edge) Section
  - 5 L H Air Intake Fairing
  - 6 Tail Rotor Blade (TRB) & Oil Cooler Part
  - 7 MGB Oil Cooler Pipe
  - 8 Yellow MRB TE Section
  - 9 MGB Fairing Section
  - 10 Yellow MRB TE Section
  - 11 Yellow MRB TE Section
  - 12 Red MRB TE Section
  - 13 MGB Top Rear Cowl
  - 14 MGB Rear Fairing Section
  - 15 Oil Cooler Assembly
  - 16 TR Drive Shaft No.2 Section
  - 17 TRB
  - 18 R H Crew Entry Door
  - 19 R H Passenger Sliding Door
  - 20 Yellow MRB Skin
  - 21 Yellow MRB Skin
  - 22 Fuselage Top Fairing
  - 23 Fuselage Top Fairing
  - 24 R H Air Intake Fairing
  - 25 Portion Oil Cooler  
MRB Impact
- PP Perspex Fragment

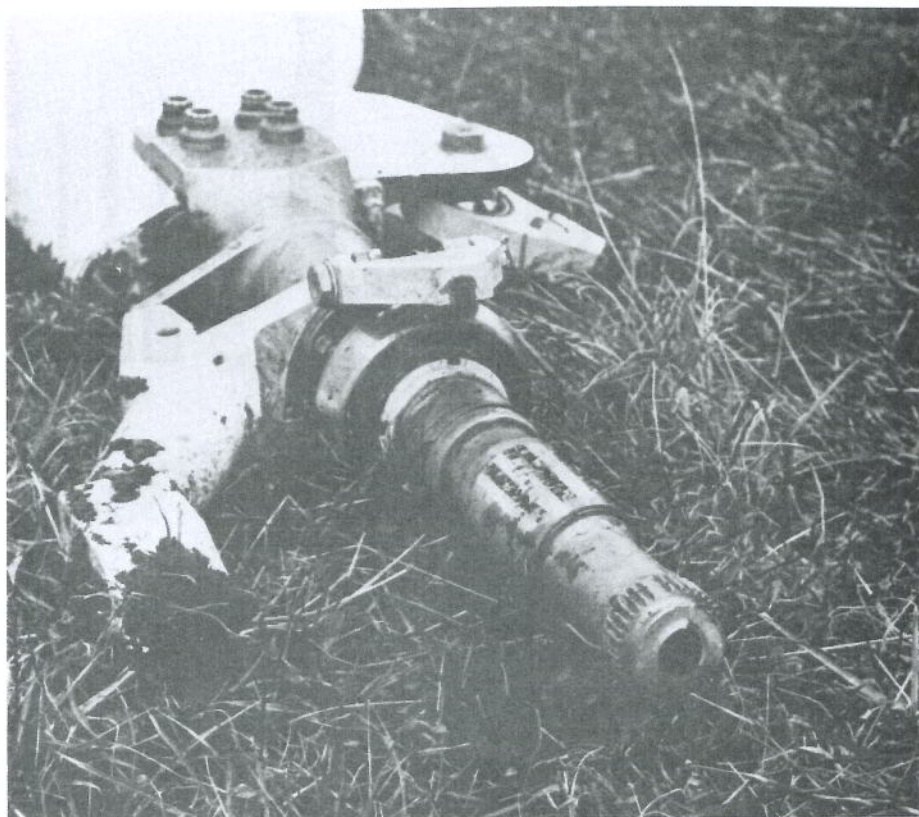
**'Black' Main Rotor Blade Root Fitting (As found)**

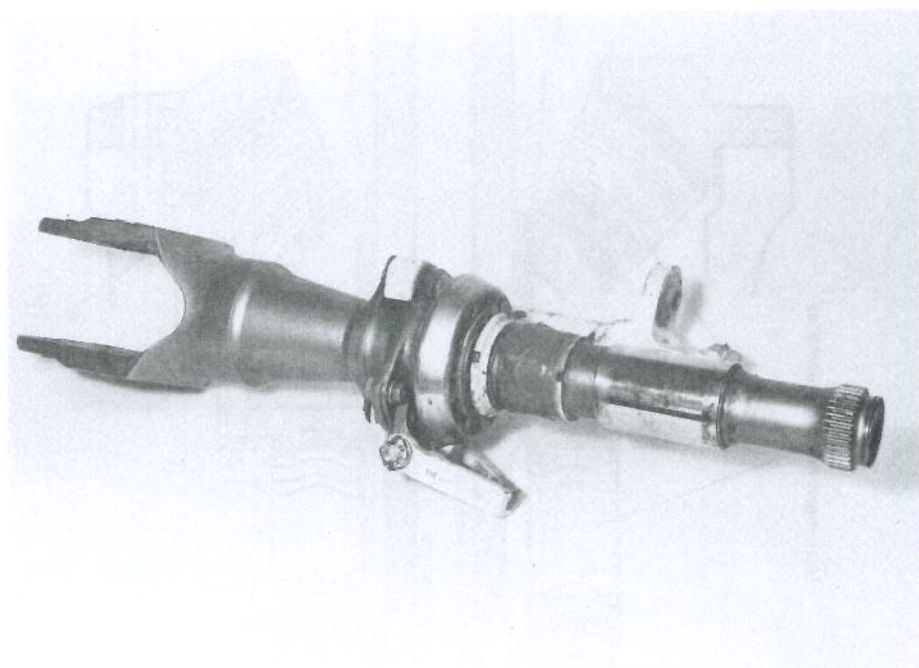
**'Black' Main Rotor Blade Spindle/Cuff**

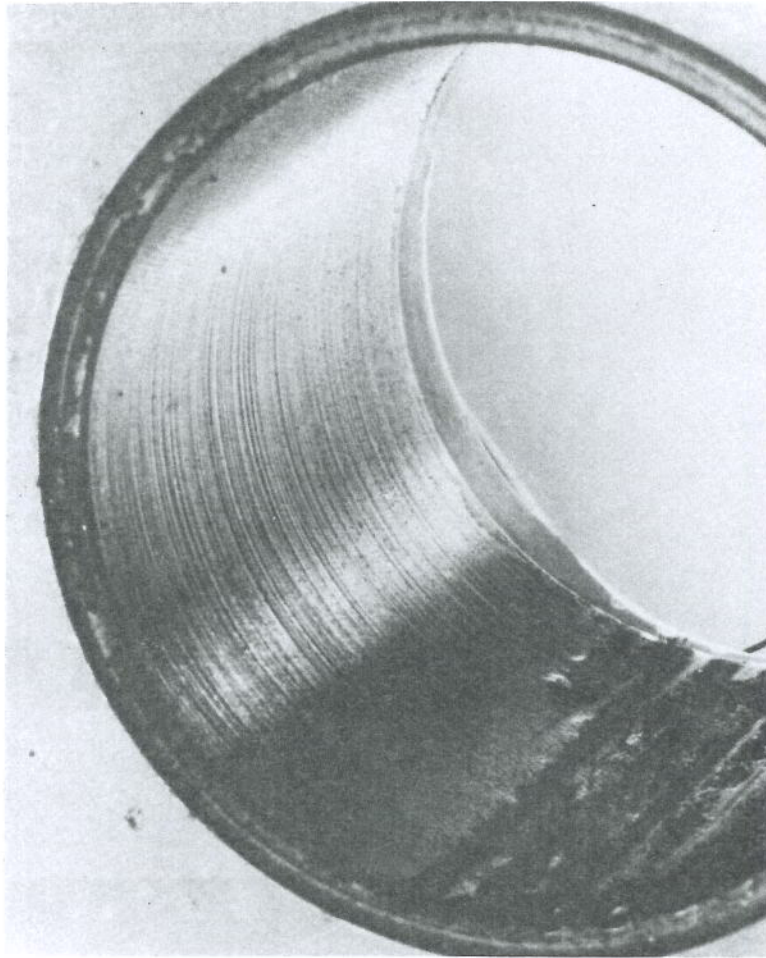
'Black' Shear Bearing —Outer Race

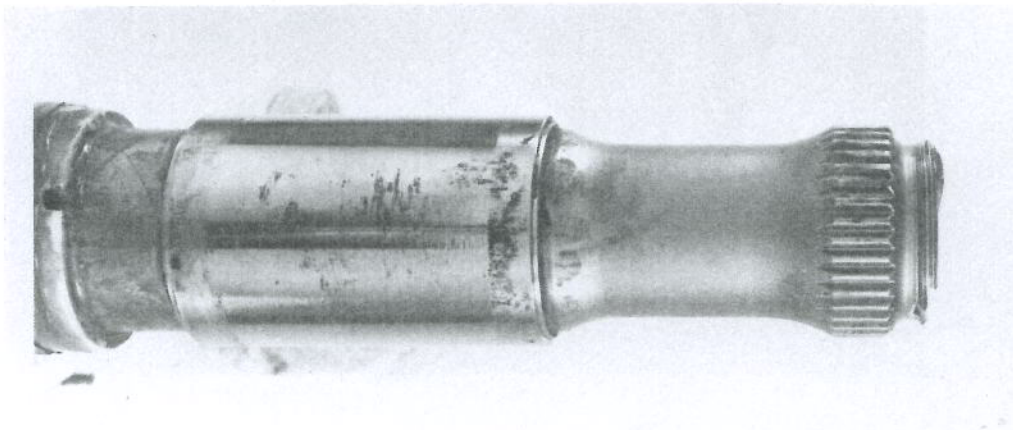
'Black ' Shear Bearing — Inner Race

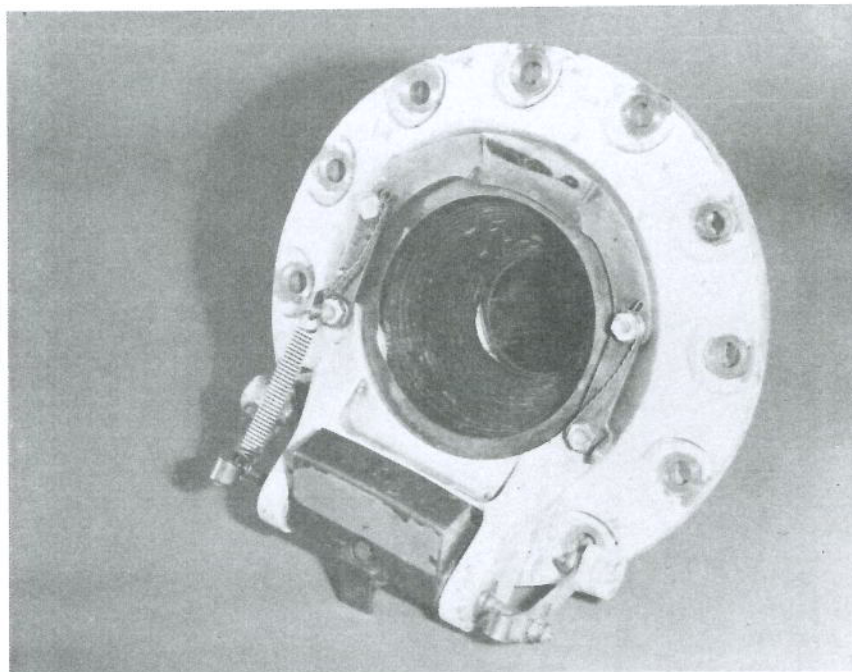
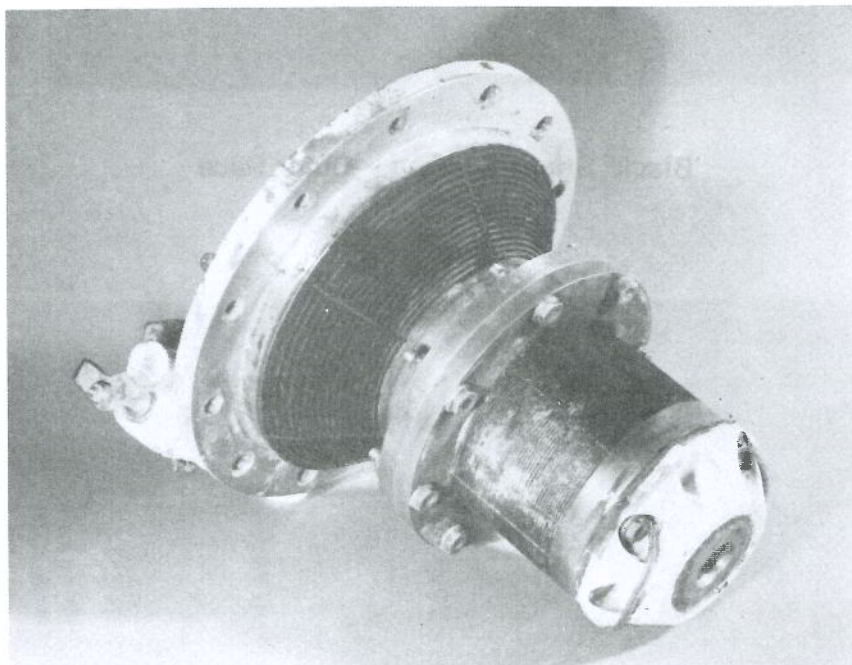
Figure 6

'Black' Elastomeric Bearing Assembly

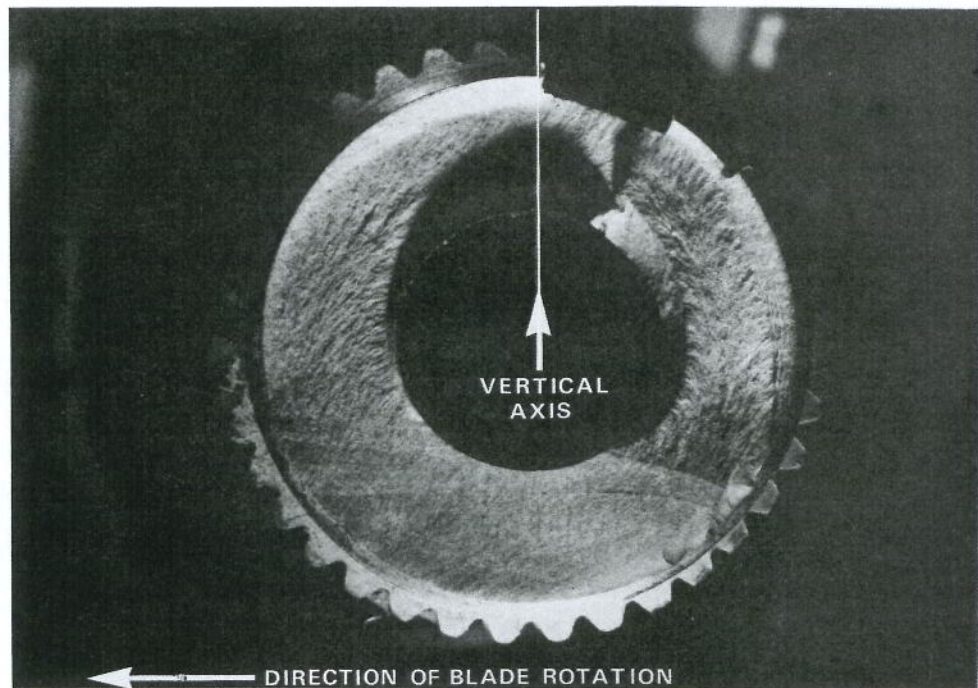
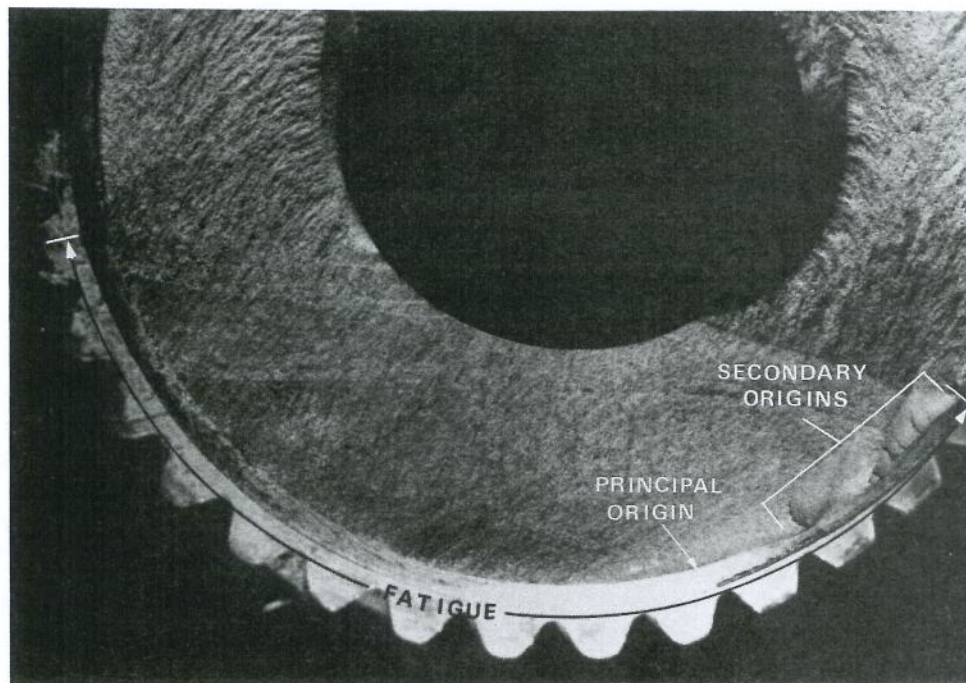
Figure 8

'Black' Spindle-Fracture Face

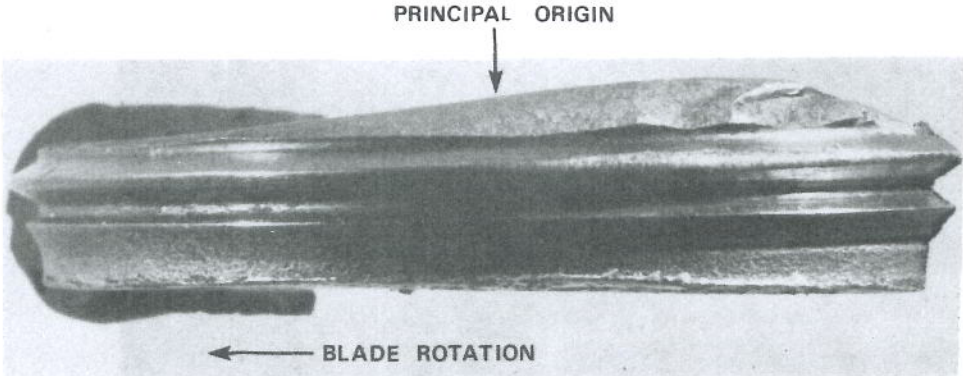
'In-plane' View of Fatigue Fracture

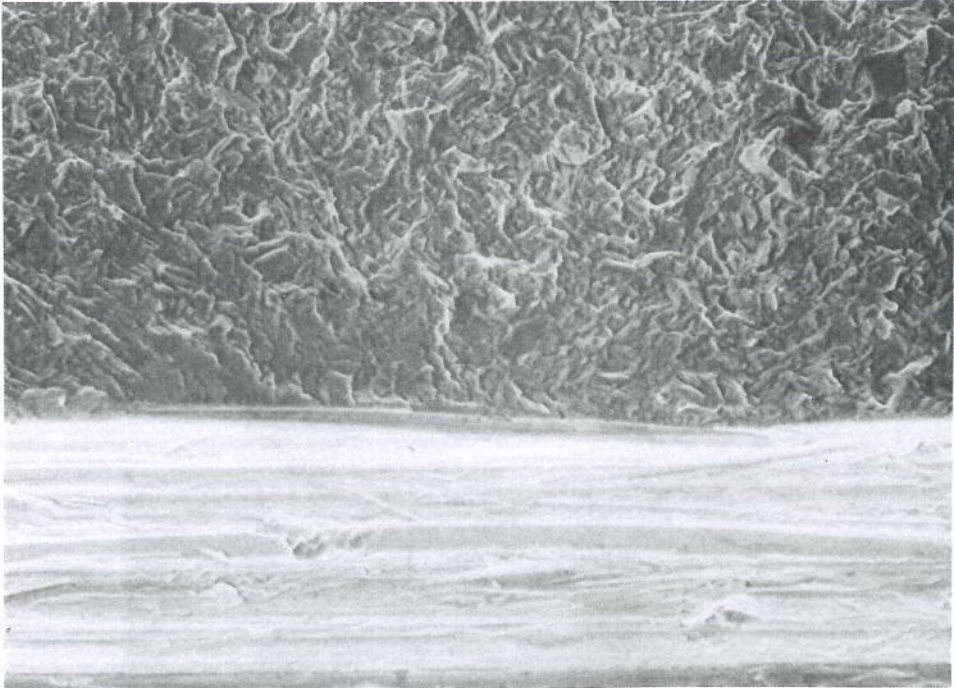
Principal Origin  
× 500  
Magnification

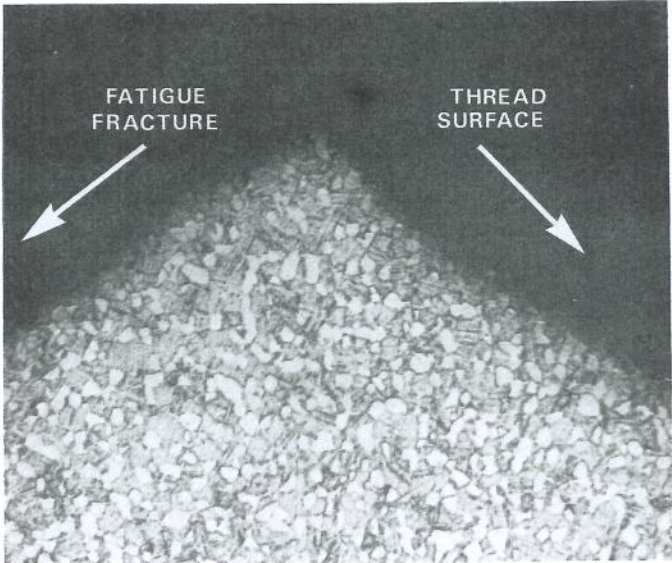
Micro-sections near plane of principal origin  
× 200 Magnification
