RADAR DERIVED TRACK PLOT OF G-OHOT

**ANALYSIS OF METEOROLOGICAL DATA
FOR THE CENTRAL BRITISH ISLES ON 25 FEBRUARY 1994**

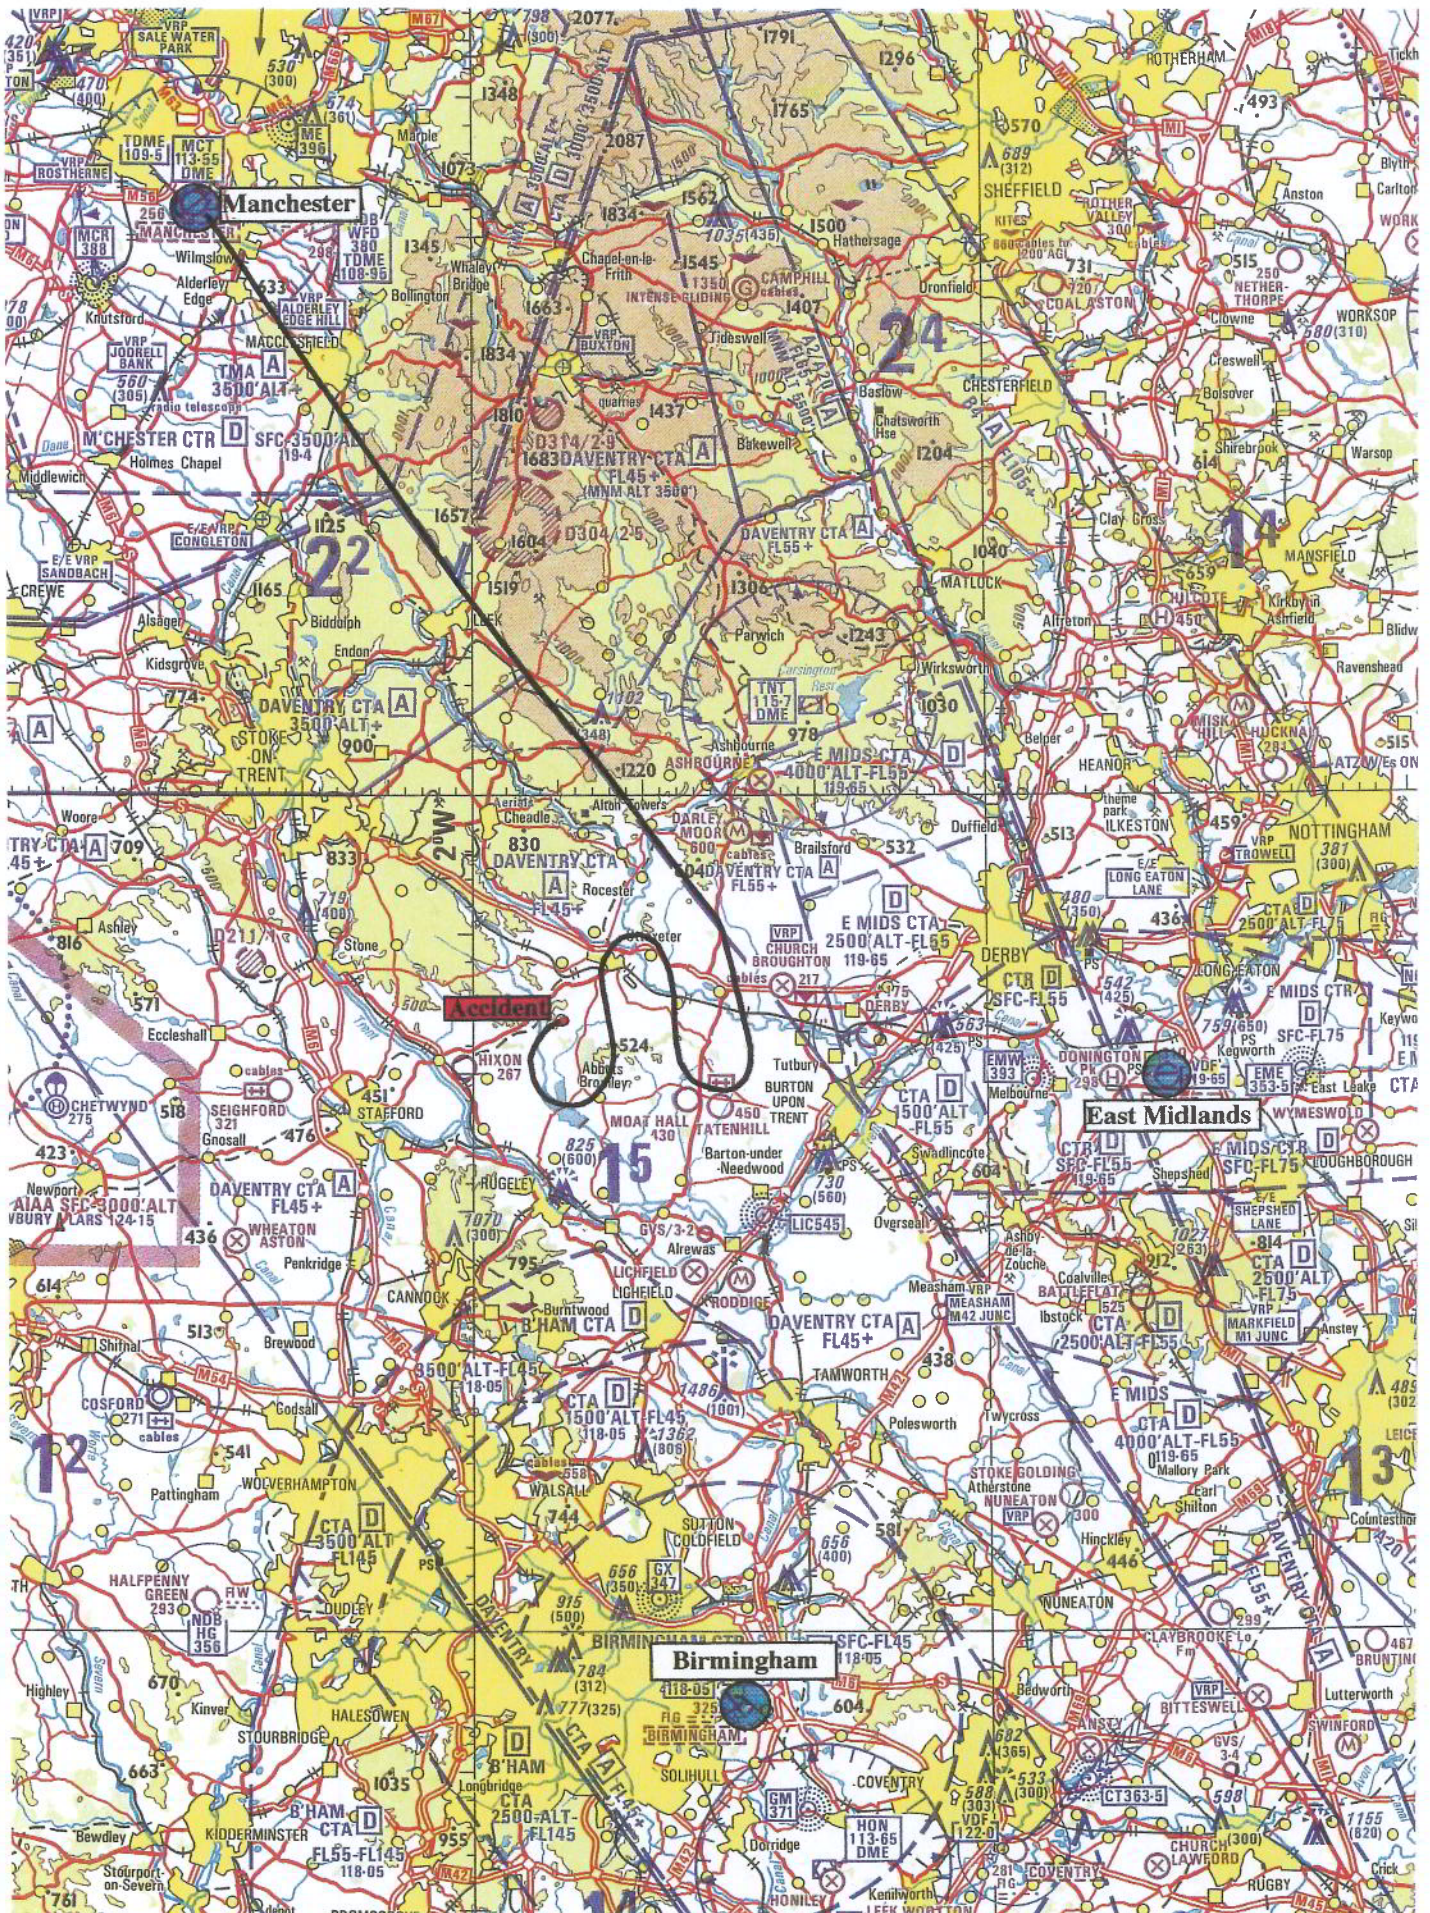
ENGINE FAILURE SEQUENCE
