CIVIL AIRCRAFT ACCIDENT

Report of the Reviewing Body
appointed to consider and report upon
certain matters connected with the
Accident to the Elizabethan Aircraft G-ALZU
at Munich on 6th February 1958

**OF THE REVIEWING BODY APPOINTED TO CONSIDER AND REPORT
UPON CERTAIN MATTERS CONNECTED WITH THE ACCIDENT TO THE
ELIZABETHAN AIRCRAFT G-ALZU AT MUNICH ON 6TH FEBRUARY 1958**

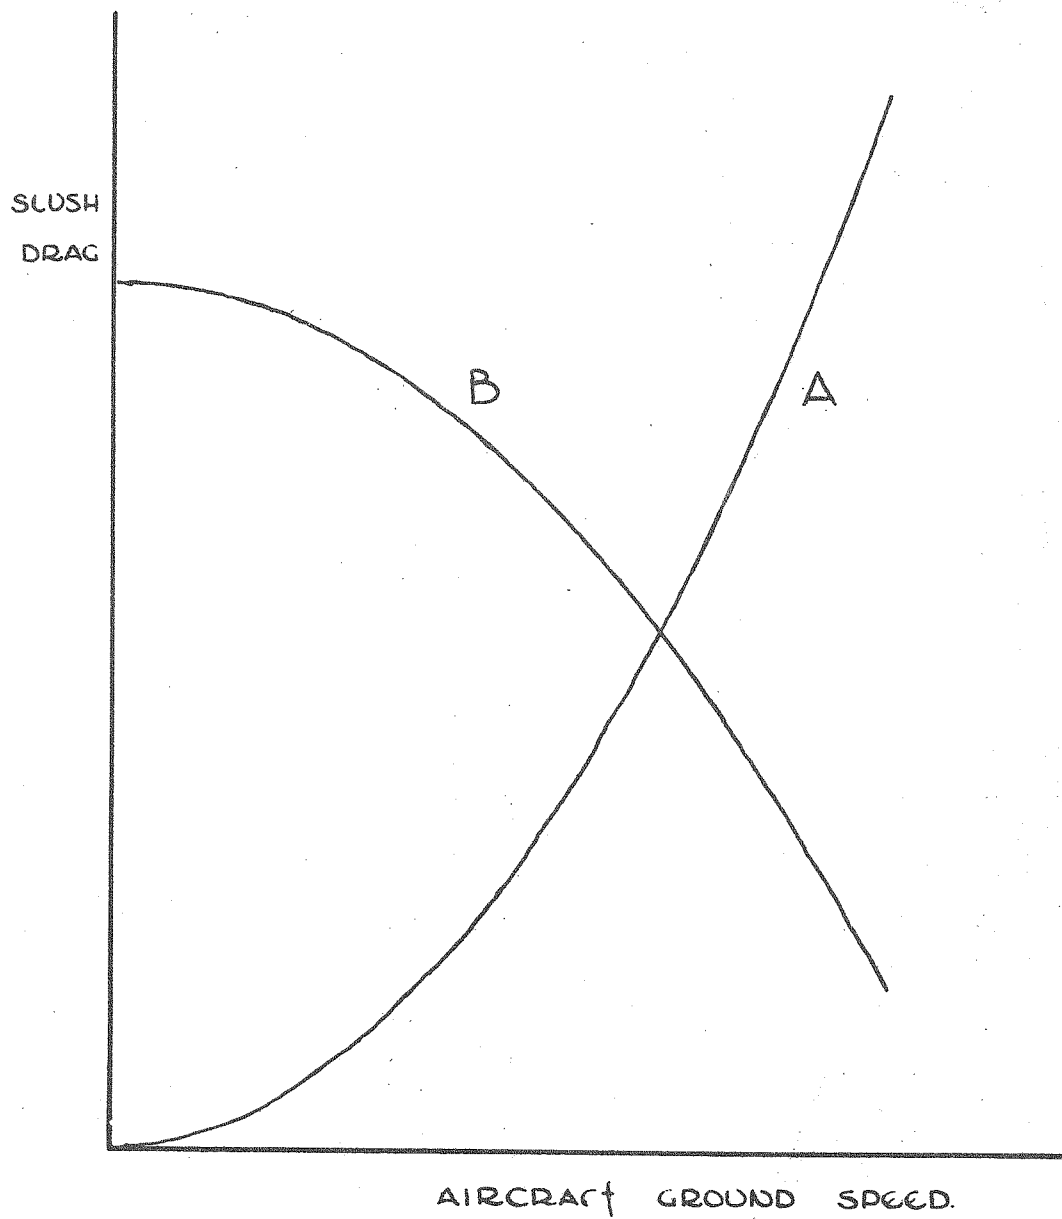
FIG. 1.

(c) No factor other than a sudden increase in slush drag could be found to account for a change from acceleration to deceleration; moreover, it was necessary to assume reimmersion of the nosewheels in the slush, with a 'mudguard' effect to obtain the curves given.

(d) Although it might be possible to reproduce the main curve F...J...N by assuming rather more slush and a clean wing, the aircraft would lift off at the point K; this is why both icing and slush were assumed. However, at this stage so many assumptions as to slush density, pilot's actions (trim, braking, cutting throttle, etc.) are made that the most that can be claimed is that the curve represents a possible state of affairs; no rigorous deduction as to either icing or slush can be made.
