AAIB Bulletin No: 2/95

Ref: EW/G94/08/13

Aircraft Type and Registration: Morane Saulnier MS.893E, G-DOOR

Nature of Damage: Propeller bent, engine shock-loaded and nose landing gear damaged

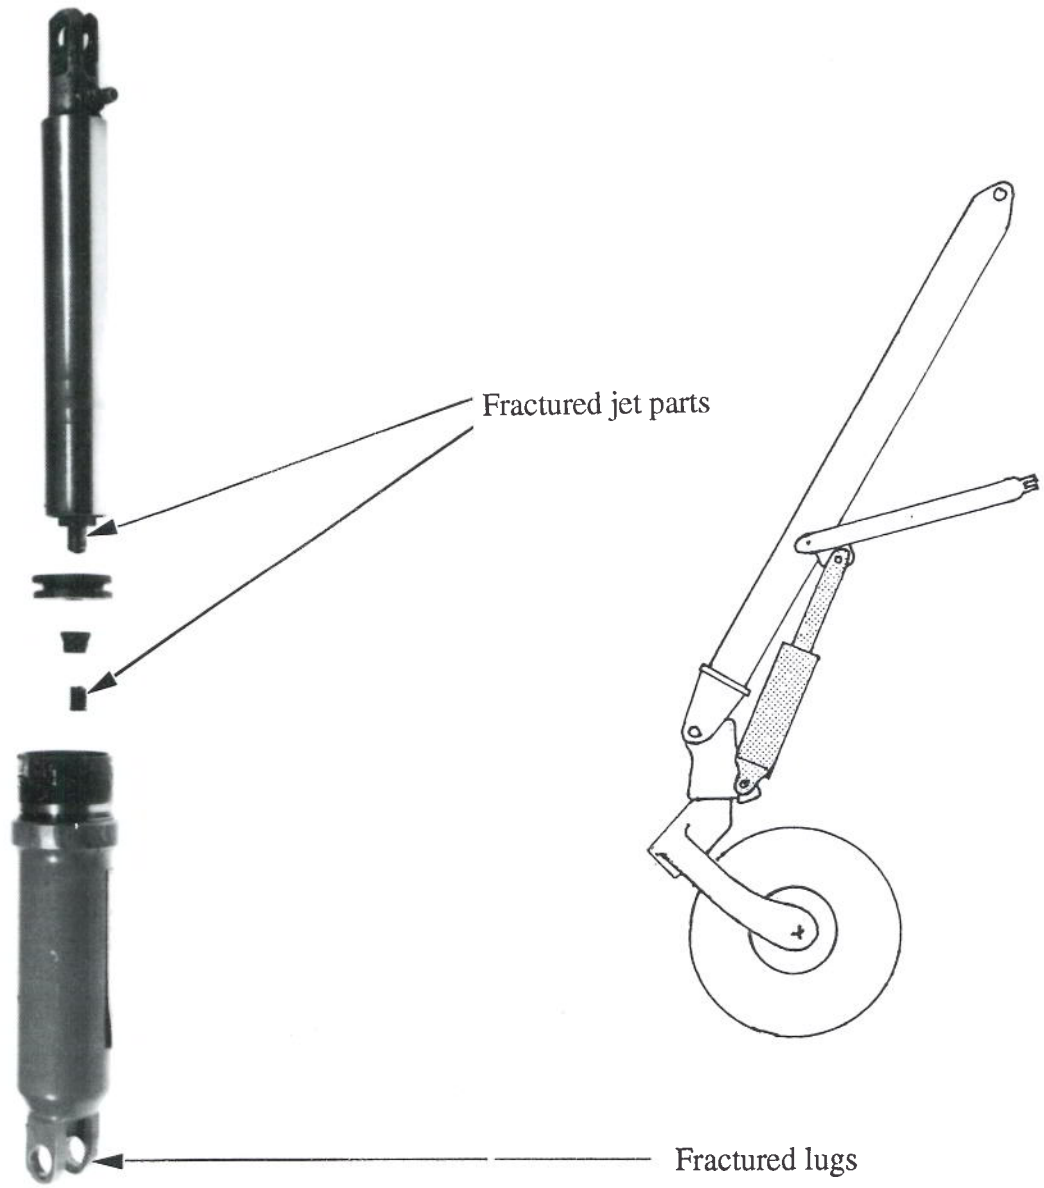
The fixed landing gears on the Rallye series of aircraft are of the trailing-link type, with oleo-pneumatic shock-absorber struts supporting the weight of the aircraft (see diagram). Failure of the shock-absorber or its attachments would allow the nose landing gear to articulate sufficiently for the propeller to strike the ground.

Examination of G-DOOR showed that the shock-absorber cylinder had failed at its attachment forked lugs at the bottom of the assembly (see photograph). The ram had been ejected from the cylinder due to a further failure within the assembly. This latter failure was of a restrictor jet which provides the damping action of the strut but is also threaded to attach the piston and prevents the ram from completely departing the assembly when the strut is fully extended.

Metallurgical examination of the failed shock absorber showed that the cylinder forked fitting had failed in gross overload, whilst the threaded portion of the restrictor jet bore evidence of fatigue damage across about 25% of the fracture surface with the remainder bearing signs of overload. Further fatigue cracks were found in the threads of the latter part.

The SB explained at some length that the effect of such a failure of a jet would be that there was nothing to prevent the ejection of the ram from the cylinder if the shock absorber was not constrained by the geometry of the landing gear itself (see diagram). This highlights the importance of depressurising the strut before removal since if a failure of the jet has occurred, then the ram would be free to eject itself at high speed.

G-DOOR Nose landing gear geometry showing shock-absorber (shaded)

Aerospatiale (SOCATA) Service Bulletin (SB) No 144 dated December 1981 gave details of modified shock absorber jets on both nose and main landing gears to replace the original SOCATA designs across the range of Rallye aircraft. The SB quoted 'some cases' of fatigue failure of the jets as the reason for this change and recommended compliance at the next minor or major inspection. The jet fitted to G-DOOR was of the original type. Its material tensile strength was found to be 564 MPa (36.5 tsi), which appeared to be somewhat lower than the drawing specification. Enquiries with SOCATA revealed that the modification to the jet comprised addition of an undercut in the main body, change of material to a steel of higher strength and substitution of a rolled thread for the previous machined thread.
