Airbus A321-231, G-MIDA, 14 August 1998

AAIB Bulletin No: 4/2000 Ref: EW/C98/8/8 Category: 1.1

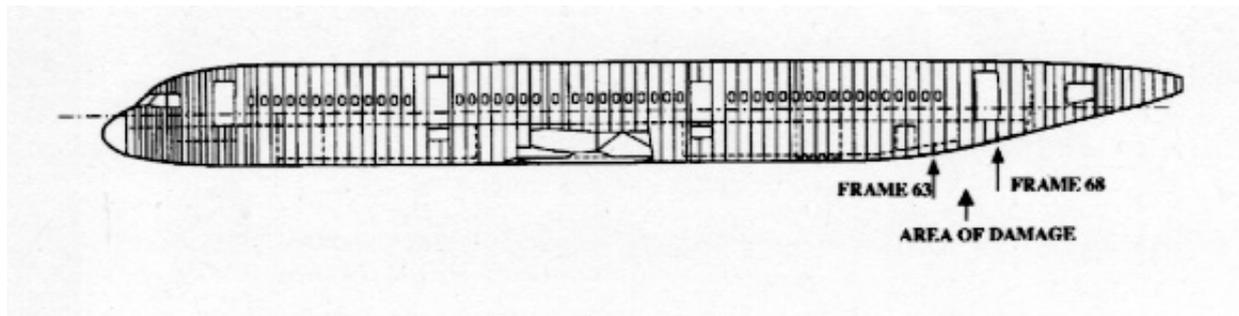
The fuselage underside had suffered abrasion damage consistent with a tailstrike, in the area indicated in the diagram below.

The fuselage centreline on the underside lies midway between stringer 41 left and stringer 41 right. Laterally the damage extended to stringer 40 on the right side and to halfway between stringers 40 and 39 on the left side, suggesting the aircraft had been banked slightly to the left at the time of the occurrence. This was confirmed by the FDR which showed the right landing gear oleo switch decompress again after the initial touchdown, with the oleo switch remaining compressed on the left hand side. The damage was most severe over frame nos. 64, 65 and 66, where the skin had been completely ground away such that the frames and stringers had also been abraded. A section of skin had become detached from the aft edge of frame 65 such that it was free to flap downwards, thus accounting for the pressurisation difficulties on the subsequent flight from Dublin.
