ACCIDENT

Aircraft Type and Registration:	Grob G115, G-BOPT	
No & Type of Engines:	1 Lycoming O-235-H2C piston engine	
Year of Manufacture:	1988	
Date & Time (UTC):	4 August 2008 at 1140 hrs	
Location:	Runway 27L, Manchester (Barton) Airport,	
Type of Flight:	Training	
Persons on Board:	Crew - 2	Passengers - None
Injuries:	Crew - None	Passengers - N/A
Nature of Damage:	Failure of the right main wheel stub axle	
Commander's Licence:	Commercial Pilot's Licence	
Commander's Age:	52 years	
Commander's Flying Experience:	4,637 hours (of which 772 were on type) Last 90 days - 182 hours Last 28 days - 56 hours	
Information Source:	Aircraft Accident Report Form submitted by the pilot, AAIB examination of the failed stub axle.

Summary

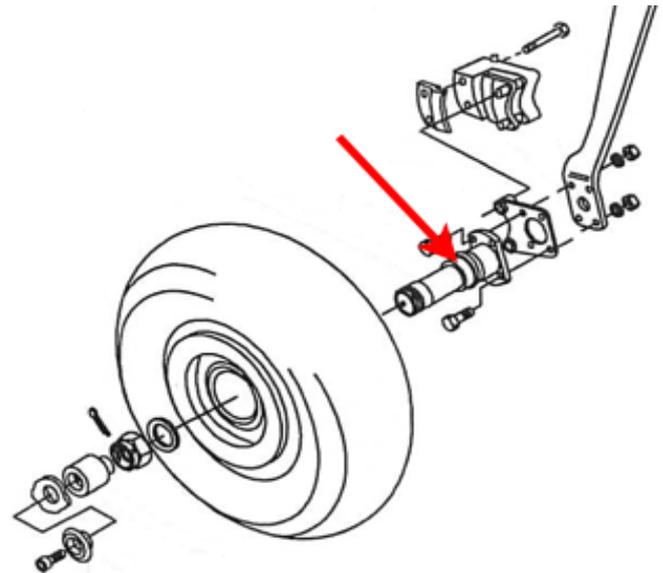
Figure 1

The fractured stub axle was sent to the AAIB for detailed metallurgical examination. The axle had fractured as a result of fatigue cracking at a location a short distance outboard of its attachment to the landing gear strut, Figure 1. This was close to a change of cross-section that formed a shoulder providing an abutment for the inner wheel bearing, Figure 2.

Main landing gear stub axle arrangement, showing location of failure

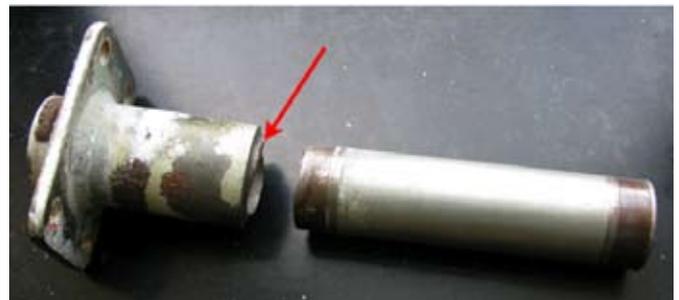
Figure 2

The fracture plane was normal to the axis of the axle, fractionally outboard from the corner formed by the reduced axle diameter at the shoulder. Optical microscopy revealed two separate and distinct regions of fatigue cracking on diametrically opposing sides of the fracture, both originating from multiple origins on the outer surface. The configuration of the axle's flanged attachment to the strut was symmetrical, which allows it to be installed onto the strut either way up. Given the stub axle's loading environment, it was evident that the two opposing zones of fatigue had propagated at separate times, the first crack having initiated and grown to a size insufficient to cause a complete rupture during some earlier period in service. At that time, the axle had been installed at 180° from its position at the time of final failure. The second region of fatigue cracking had so weakened the remaining material that it had ruptured in overload, allowing the wheel to separate.

Stub axle fatigue cracking region
