No: 12/91

Ref: EW/C1190

Aircraft Type and Registration: Aerospatiale AS355-F2 Twin Squirrel, G-WMPA

Nature of Damage: Severe damage to drive train from No. 2 engine to main gearbox

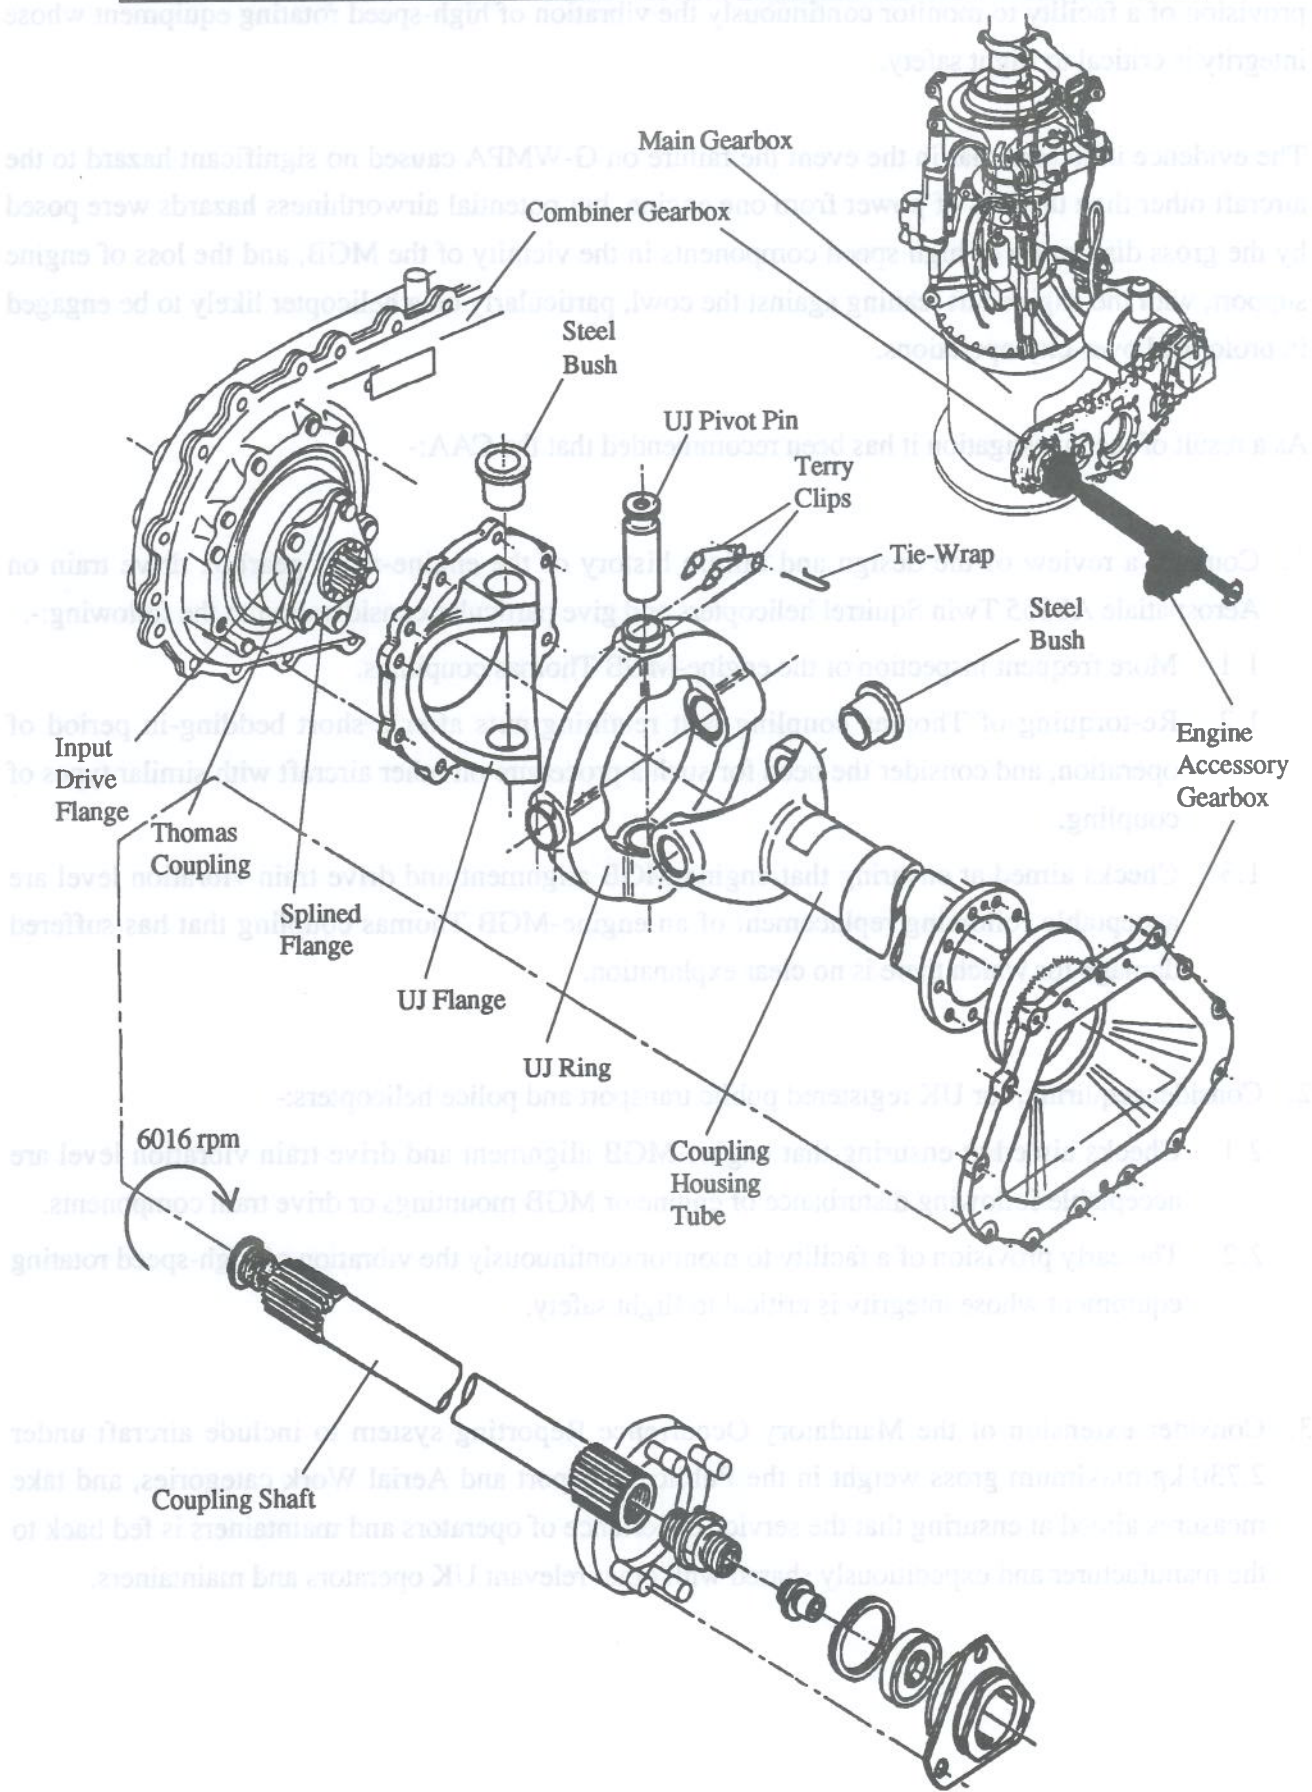
Fig 1

(Fig 1). The Thomas coupling connects a triangular splined flange on the coupling shaft, with an input drive flange of the combiner gearbox. It comprises a 14 element sandwich of 0.2-0.3 mm (8-12 x10⁻³ inch) thick stainless steel leaves able to flex with each revolution in order to cater for minor misalignment (1½° maximum) between the coupling shaft and the combiner gearbox input drive flange. The sandwich is clamped to the splined flange by one set of three bolts and nuts, with washers, and to the input drive flange by a second set, with each nut torqued to 168-203 in-lb and retained by a split pin through its bolt. At 100% rotor speed the engine to MGB drive train rotates at 6,016 rpm.

Examination of G-WMPA showed that on the No 2 side the Thomas coupling had fragmented, into several hundred pieces, thus severing the drive train from the engine to the combiner gearbox; and the forward end of the coupling housing tube forming the horns for the UJ had disintegrated, thus leaving the engine free to pivot on its single aircraft structure mounting until restrained by contact with the engine bay cowl. In addition there was damage to the engine coupling shaft, the splined flange, the UJ ring, the UJ flange and the input pinion bearing housing of the combiner gearbox, although none of these components had failed. Each of the six Thomas coupling clamping bolts had fractured at the position of its split pin holes and the associated nuts were found separated, with signs of considerable external battering but generally with little thread damage. Mangled portions of split pins of a type consistent with having originated from these bolts were recovered in the MGB bay.

It was evident from the damage characteristics that the splined flange and the Thomas coupling and its connecting bolts and nuts had contacted the interior of the coupling housing tube while rotating at high

ENGINE TO MAIN GEARBOX DRIVE TRAIN - EXPLODED VIEW
