## Dornier 328-100, G-BWIR

<b>AAIB Bulletin No: 3/2004</b>	<b>Ref: EW/C2002/03/06</b>	<b>Category: 1.1</b>
<b>Aircraft Type and Registration:</b>	Dornier 328-100, G-BWIR	
<b>No &amp; Type of Engines:</b>	2 Pratt & Whitney PW-119B turboprop engines	
<b>Year of Manufacture:</b>	1995	
<b>Date &amp; Time (UTC):</b>	6 March 2002 at 2046 hrs	
<b>Location:</b>	Runway 24, Edinburgh Airport, Scotland	
<b>Type of Flight:</b>	Public Transport	
<b>Persons on Board:</b>	Crew - 4	Passengers - 16
<b>Injuries:</b>	Crew - None	Passengers - None
<b>Nature of Damage:</b>	Damage to forward door attachment and restraint mechanism. Consequent dent in fuselage skin	
<b>Commander's Licence:</b>	Airline Transport Pilot's Licence	
<b>Commander's Age:</b>	50 years	
<b>Commander's Flying Experience:</b>	3,100 hours (of which 1,000 hours were on type)	
	Last 90 days - 80 hours	
	Last 28 days - 24 hours	
<b>Information Source:</b>	AAIB Field Investigation

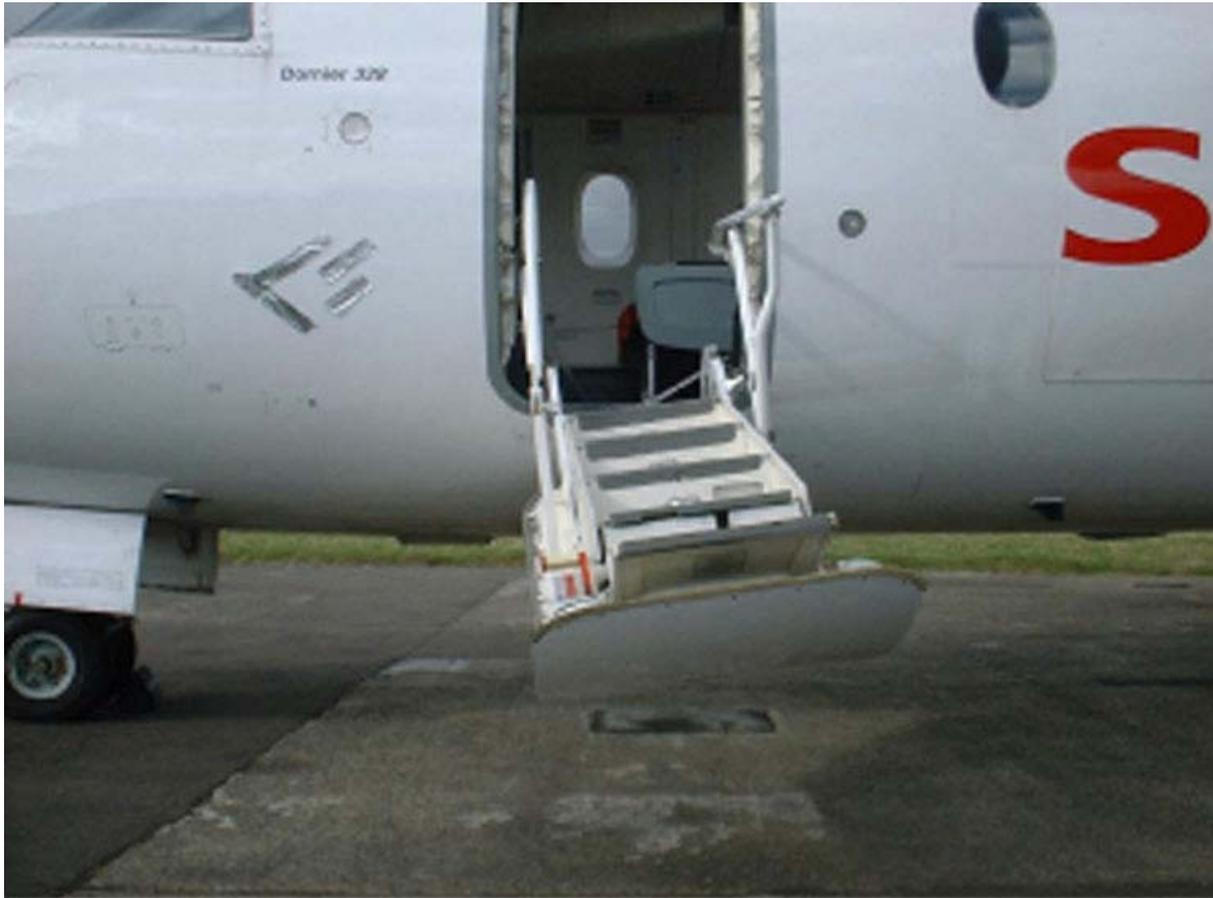
After the accident the aircraft was ferried to its maintenance base at Cambridge where it was examined by the AAIB; photographs taken immediately after the event were also examined. The damaged door is depicted in Figure 1.

**Figure 1**  
**Damaged door on G-BWIR after accident**

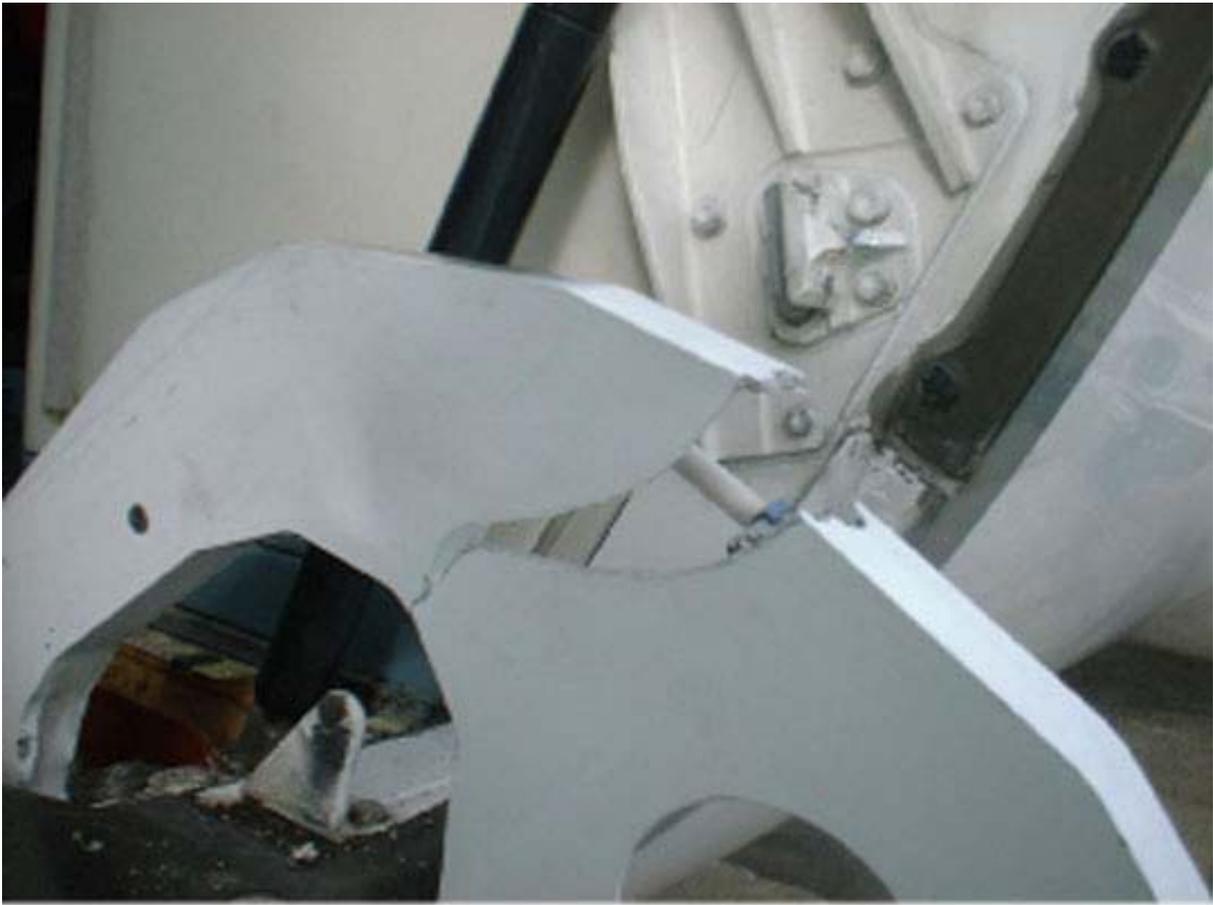
The door and the latching and locking mechanism were undamaged, and were clearly still capable of correct operation. The channel-section hinge arms of the airstairs, however, were both fractured almost fully through their cross sections, leaving only single flanges securing the two parts of each arm together. Figure 2 shows the damage to the aft hinge arm. The banister mechanism was also heavily damaged, Figure 3.

**Figure 2**  
Damaged aft hinge arm

It was concluded that this damage was consistent with the effect of the door becoming unlatched and being forced open by very high forces. It is presumed that these were a combination of aerodynamic and pressurisation loads. Rapid and forceful movement in the opening direction had caused high reaction loads to develop in the damping struts leading to buckling and failure of their attachments. This appears to have destroyed the geometry of the banister mechanism and consequently permitted over-travel of the airstairs. The hinge arms supporting the airstairs thus appear to have acted as limit stops, being then subjected to non-design loads leading to severe damage.

speed close to rotation, with some cabin pressure differential present, would produce high opening loads on the door restraint system. These non design loads are judged to have led to the partial failure of the airstair radius arms.

It is recommended that the European Aviation Safety Agency review the design characteristics of the door operating, attachment and restraint mechanisms of the Dornier 328 aircraft type, in order to minimise the possibility of inadvertent door operation and to ensure that there is sufficient residual strength in the door/airstair attachments to prevent separation of the door in the event of a door coming open during takeoff or initial climb.

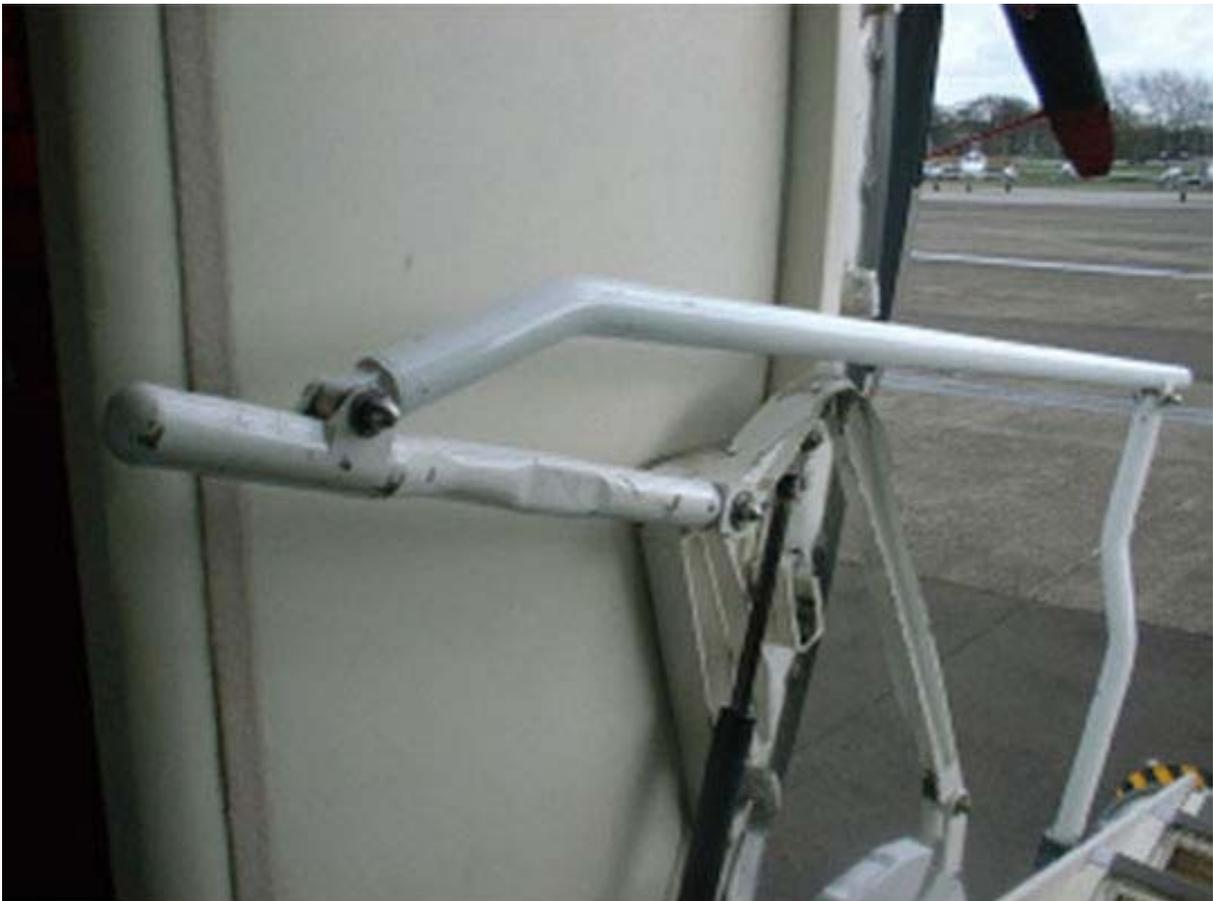
**Figure 3**  
Damaged aft banister restraint system

No evidence of any defect or damage was found other than that observed in the banister mechanism which controls and limits the travel of the door and airstairs in the opening direction, and in the hinge arms supporting and locating the airstairs relative to the fuselage. The second appears to be a consequence of over-travel permitted by the first.

The most probable cause of the accident was that the senior cabin attendant grasped the inner door handle to restrain her upper body during the rapid acceleration of the aircraft. The ergonomics of the cabin crew seat and door handle made such an involuntary action readily conceivable. Such action lead to the door unlatching and opening rapidly. Failure of the damper attachments and disruption of the banister mechanism then allowed forcible over-travel, leading to failure of the airstair attachment arms.

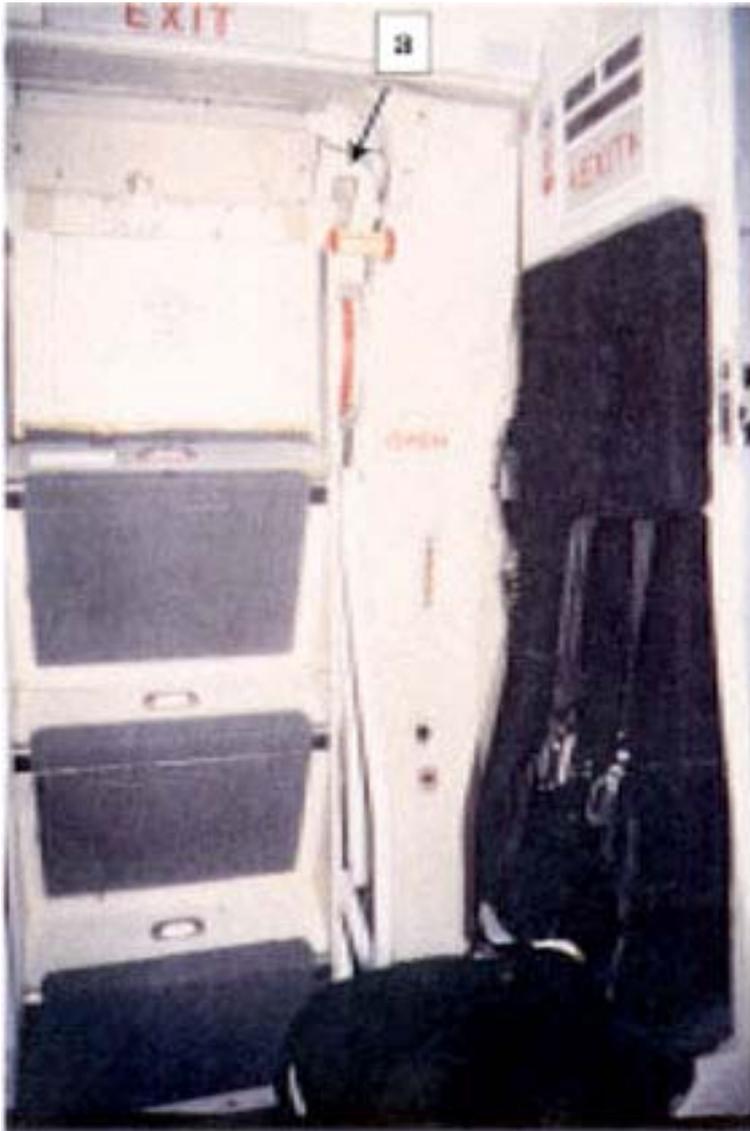
**Figure 5**  
Vestibule with door closed and locked.  
Note aft facing cabin crew seat, retracted  
air-stairs and inner door handle (a)

The vestibule, shown in Figure 5, incorporates the aft-facing, forward cabin attendant's seat; the crew member's view of the adjacent side of the fuselage being slightly obscured by the close proximity of the retracted airstairs. The cabin attendant has a full harness incorporating an inertia reel system for the shoulder straps: during the acceleration experienced on takeoff this system would not have provided significant upper body restraint.

There are two hand-holds within the reach of a seated cabin attendant which could be used to brace that person against the effects of aircraft acceleration on the upper body. The handrail of the air stair, positioned just above thigh level and to the right of the cabin attendant, could be easily grasped but would provide little upper body restraint. However, the door handle is positioned such that when the door is closed the handle is to the right of the cabin attendant's seat, just above head height, and can be readily grasped by an occupant correctly strapped into the seat. This would provide a more natural bracing mechanism for upper body restraint. Given the rear facing orientation of the seat, the high acceleration rate noted on the flight data recorder (FDR) and the lack of restraint from the inertia controlled shoulder straps, it is entirely possible that, on this occasion, the cabin attendant grabbed the handle.

It is thus concluded that the most probable way in which the recorded data and physical evidence could have been produced was if the door-handle had been grasped during the take-off run and significant downward force exerted. The ergonomic features of the cabin crew station would have contributed to the handle being inadvertently grasped during the take-off run. Under such circumstances, the natural direction of applied loading would have been similar to the normal door opening movement of the handle.

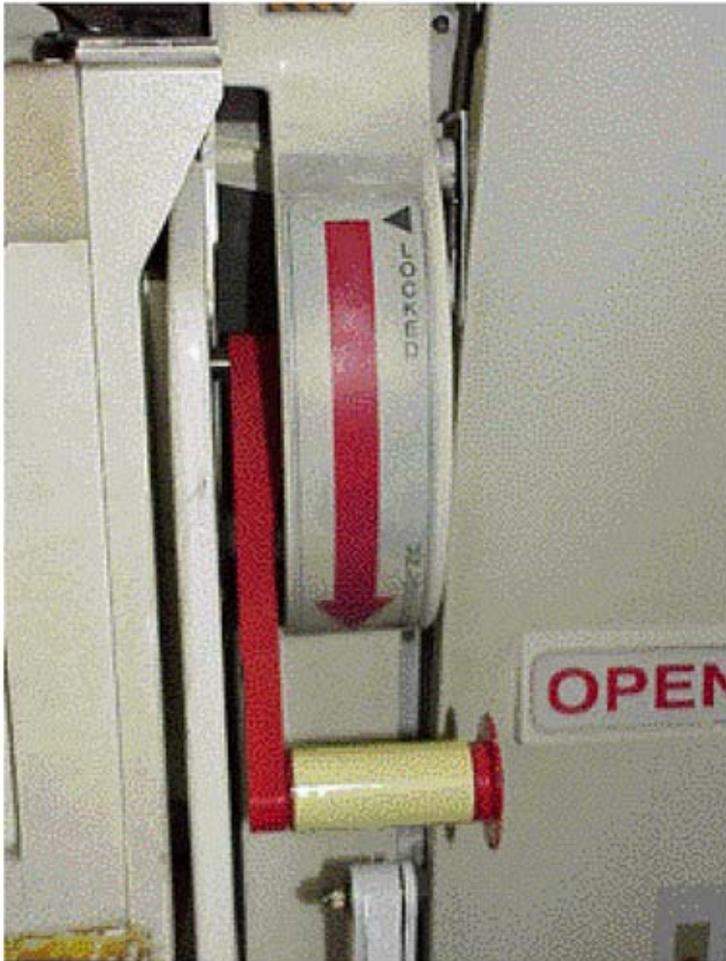
**Figure 8**  
Inner door handle in open position

The only way in which this situation could occur would be if the handle had been physically moved inwards and downwards. Although the resulting door movement is initially inwards and would be resisted by pressurisation forces, the rate at which pressure builds during the take-off run, after the outflow valve closes, is low. The precise time history of power lever angles cannot be derived from the FDR information since engine spool-up occurs progressively as the aircraft accelerates. However, it has been judged that the mechanical advantage of the door handle and its associated mechanism is such that the door could have been moved from the locked position against pressurisation forces as high as those which are likely to have been developed by the time a speed of approximately 100 kt was reached.
