INCIDENT

Aircraft Type and Registration:	Airbus A300 B4, TC-MND	
No & Type of Engines:	2 CF6-50C2 turbofan engines	
Year of Manufacture:	1982	
Date & Time (UTC):	13 April 2007 at 2314 hrs	
Location:	Manchester Airport	
Type of Flight:	Commercial Air Transport (Cargo)	
Persons on Board:	Crew - 3	Passengers - None
Injuries:	Crew - None	Passengers – N/A
Nature of Damage:	None	
Commander's Licence:	Airline Transport Pilot's Licence	
Commander's Age:	54 years	
Commander's Flying Experience:	17,640 hours (of which 7,800 were on type) Last 90 days - 172 hours Last 28 days - 43 hours	
Information Source:	Aircraft Accident Report Form submitted by the pilot

Synopsis

During its final approach to Runway 24L at Manchester, the aircraft descended below the minimum altitudes specified in the VOR/DME procedure for that runway.

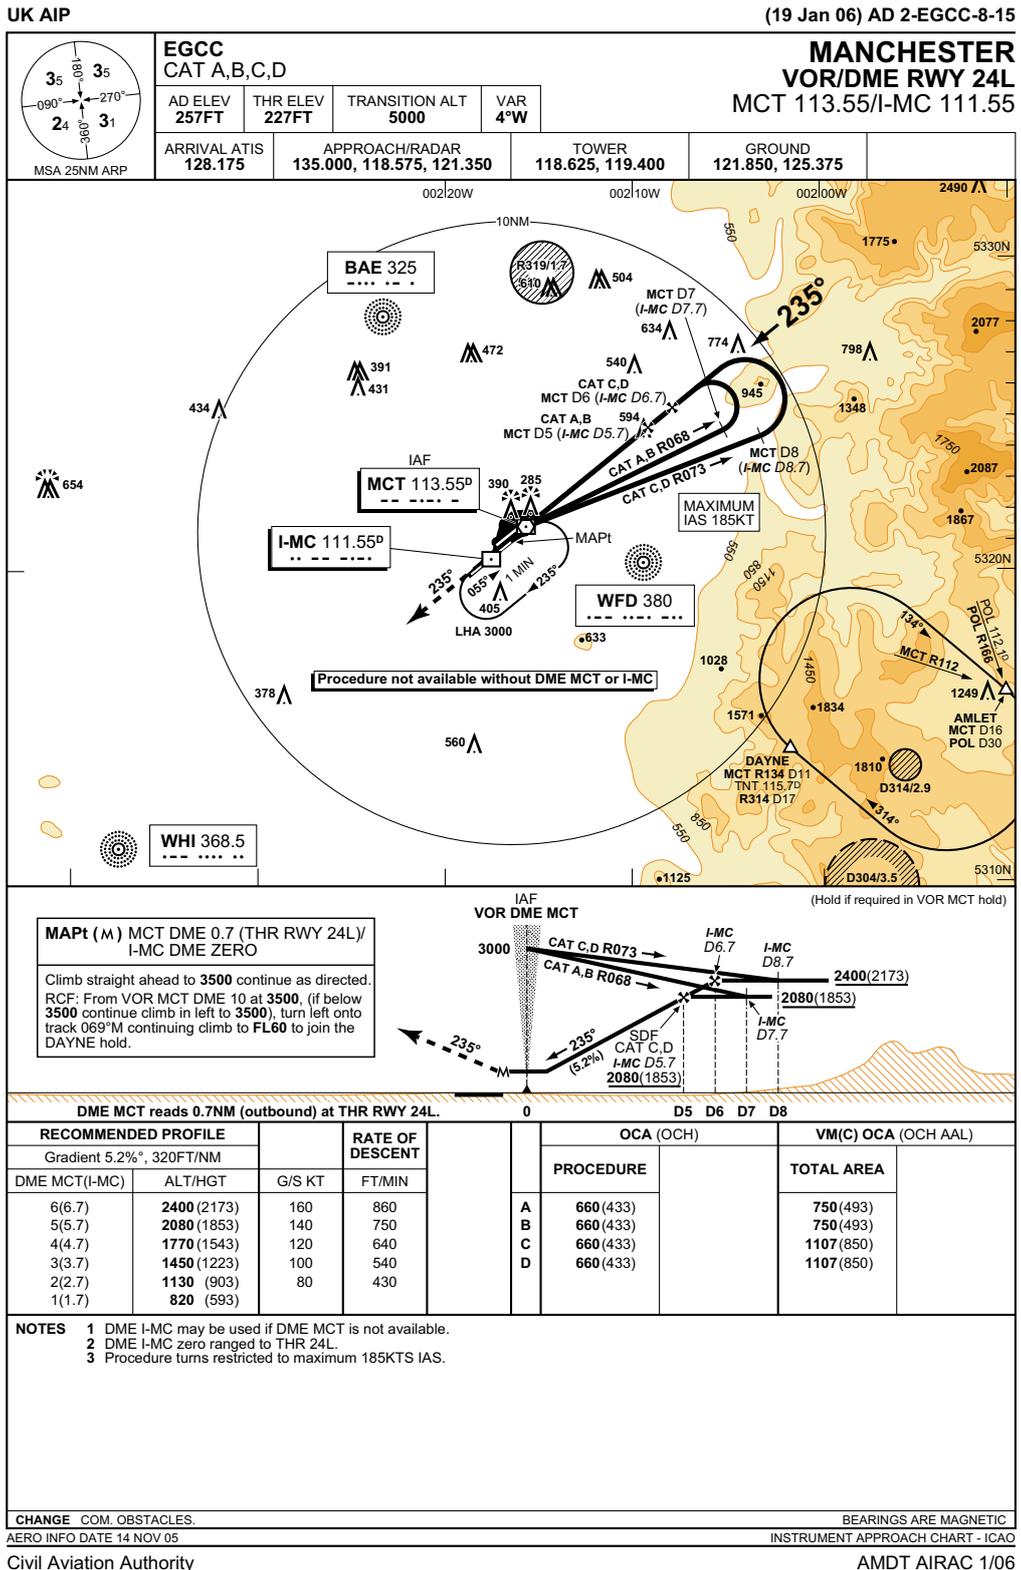
Figure 1

The VOR/DME approach procedure for Runway 24L was published in the UK Aeronautical Information Package (AIP) and is shown in Figure 1. The pilots of TC-MND used a commercially available approach chart which contained information equivalent to that shown in the UK AIP.

According to the published procedure the aircraft was required to maintain an altitude of 2,400 ft until passing the Final Approach Fix (FAF) 6 nm from the MCT. When established on the published approach track the minimum altitude until passing the Step Down Fix at 5 nm from the MCT was 2,080 ft. Thereafter there were no further published altitude restrictions until the

aircraft reached the MDA of 660 ft. The recommended vertical profile, given in the form of altitude versus distance from the MCT (and also, from the touchdown threshold) was shown in a table on the same page as the chart.

Manchester VOR/DME RWY 24L procedure
