ACCIDENT

Aircraft Type and Registration:	Enstrom 280FX, G-MHCK	
No & Type of Engines:	1 Lycoming HIO-360-F1AD piston engine	
Category:	2.3	
Year of Manufacture:	1985	
Date & Time (UTC):	21 May 2005 at 1015 hrs	
Location:	Barton Airfield, Manchester	
Type of Flight:	Trial Lesson	
Persons on Board:	Crew - 1	Passengers - 1
Injuries:	Crew - None	Passengers - None
Nature of Damage:	Fire damage to aircraft skin and engine area	
Commander's Licence:	Airline Transport Pilot's Licence	
Commander's Age:	67 years	
Commander's Flying Experience:	20,000 hours (of which 12,000 were on type) Last 90 days - 5 hours Last 28 days - 2 hours	
Information Source:	Aircraft Accident Report Form submitted by the pilot and metallurgical examination of exhaust system component

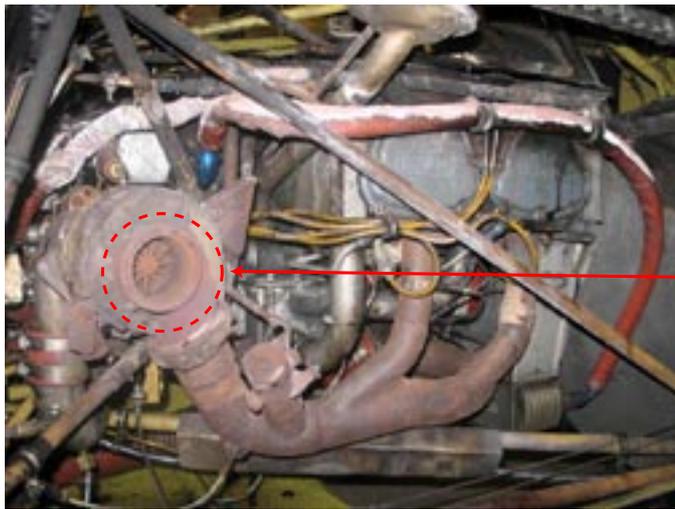
Figure 1

Subsequent examination revealed that this pipe had failed, allowing exhaust gases to heat the aircraft skin, leading to the smoke and fire. The location of the detached exhaust pipe and the damage to the engine cover is shown in Figures 1 and 2. The exhaust pipe was returned to the AAIB for examination and is shown in

Location of turbocharger exhaust (clamp and exhaust pipe flange removed)

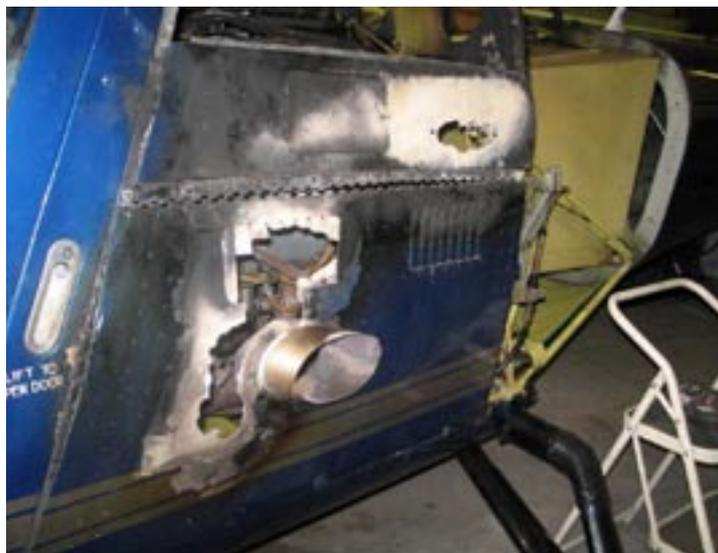
Figure 2

Fire damage to cowling and exhaust pipe outlet

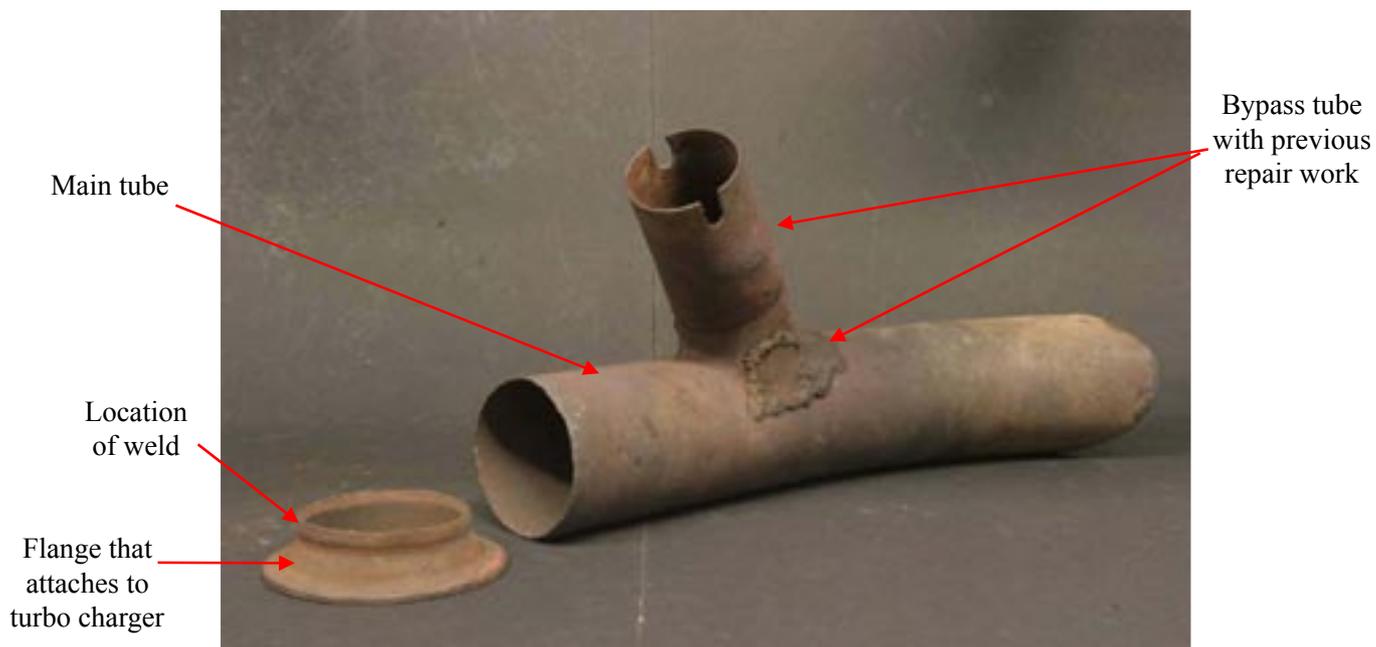
Figure 3
Exhaust pipe 'as found'

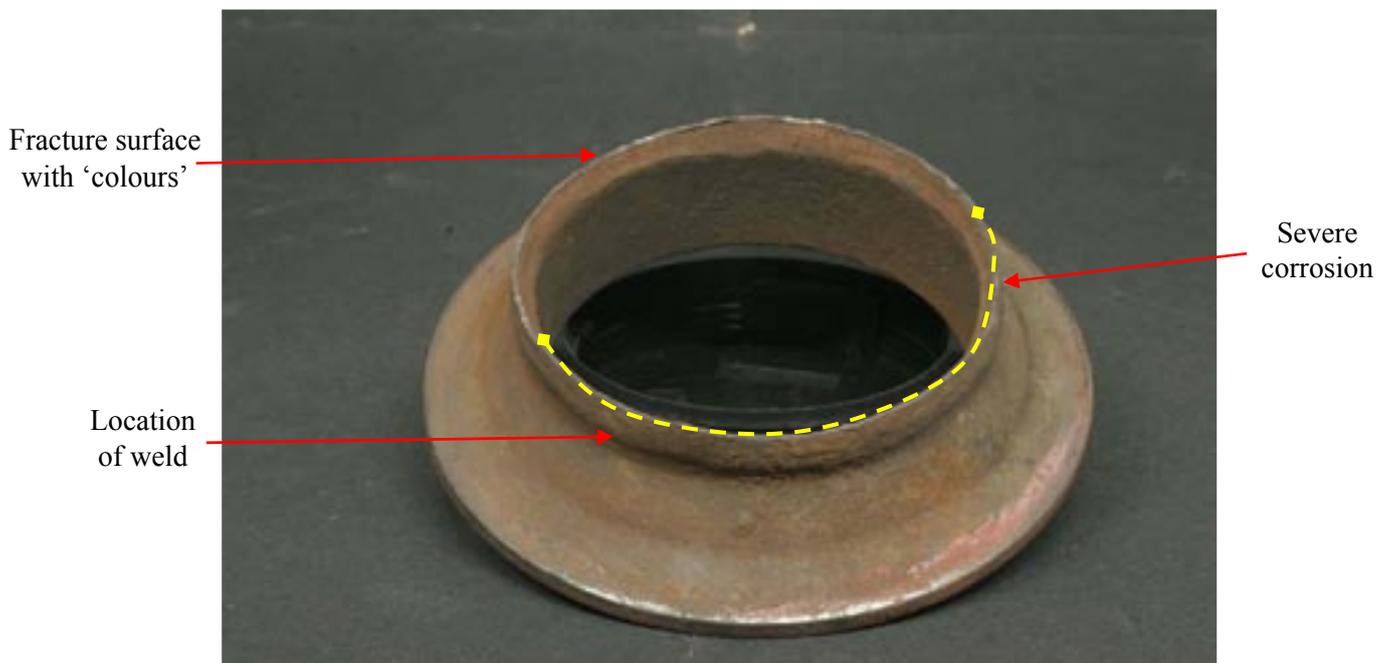
Figure 3. The pipe had failed circumferentially around the weld attaching the flange to the main tube (see Figure 4). The material of the main tube and the flange was specified to be 321 grade stainless steel and the filler weld material was specified as AMS5680 (347 grade stainless steel).

Figure 4
Exhaust pipe flange showing fracture surface and corrosion

'Visual examination of the fracture surface revealed one half to be severely corroded and the other half exhibited blue/purple colours in the fracture surface (locations shown in figure 4); these colours may be indicative of heat tinting of the component.'

'the coloured area from the visual examination exhibited intergranular cracking on the outer edges. In the centre of the intergranular cracking were areas of fatigue. Approximately 60% of the fracture surface was severely corroded, which had removed any fine detail in that area. The extent of the corrosion would indicate that the crack had been present for some length of time.'

'The Enstrom 280FX turbo charger exhaust pipe failed due to intergranular cracking around the weld connecting the flange to the main tube. It is probable that the cause of the intergranular cracking was due to sensitisation of the austenitic 321 stainless steel during welding. Sensitisation occurs in some austenitic stainless steels in the temperature range of 500 – 850°C. The formation of chromium carbides at the grain boundaries lowers the corrosion resistance and thus is susceptible to attack in an environment the steel would usually resist. Hence, a result of sensitisation is that the component becomes more vulnerable to intergranular corrosion. The fatigue

found in the fracture surface would have been a secondary failure mode initiated by cyclic loading on the reduced thickness of the tube caused by the intergranular cracking.'
