No: 11/92

Ref: EW/G92/7/3

Aircraft Type and Registration: Piper PA-34-200T Seneca II, G-BPAD

Location: Saddle Hill, Croasdale Fell, Bowland, Lancashire

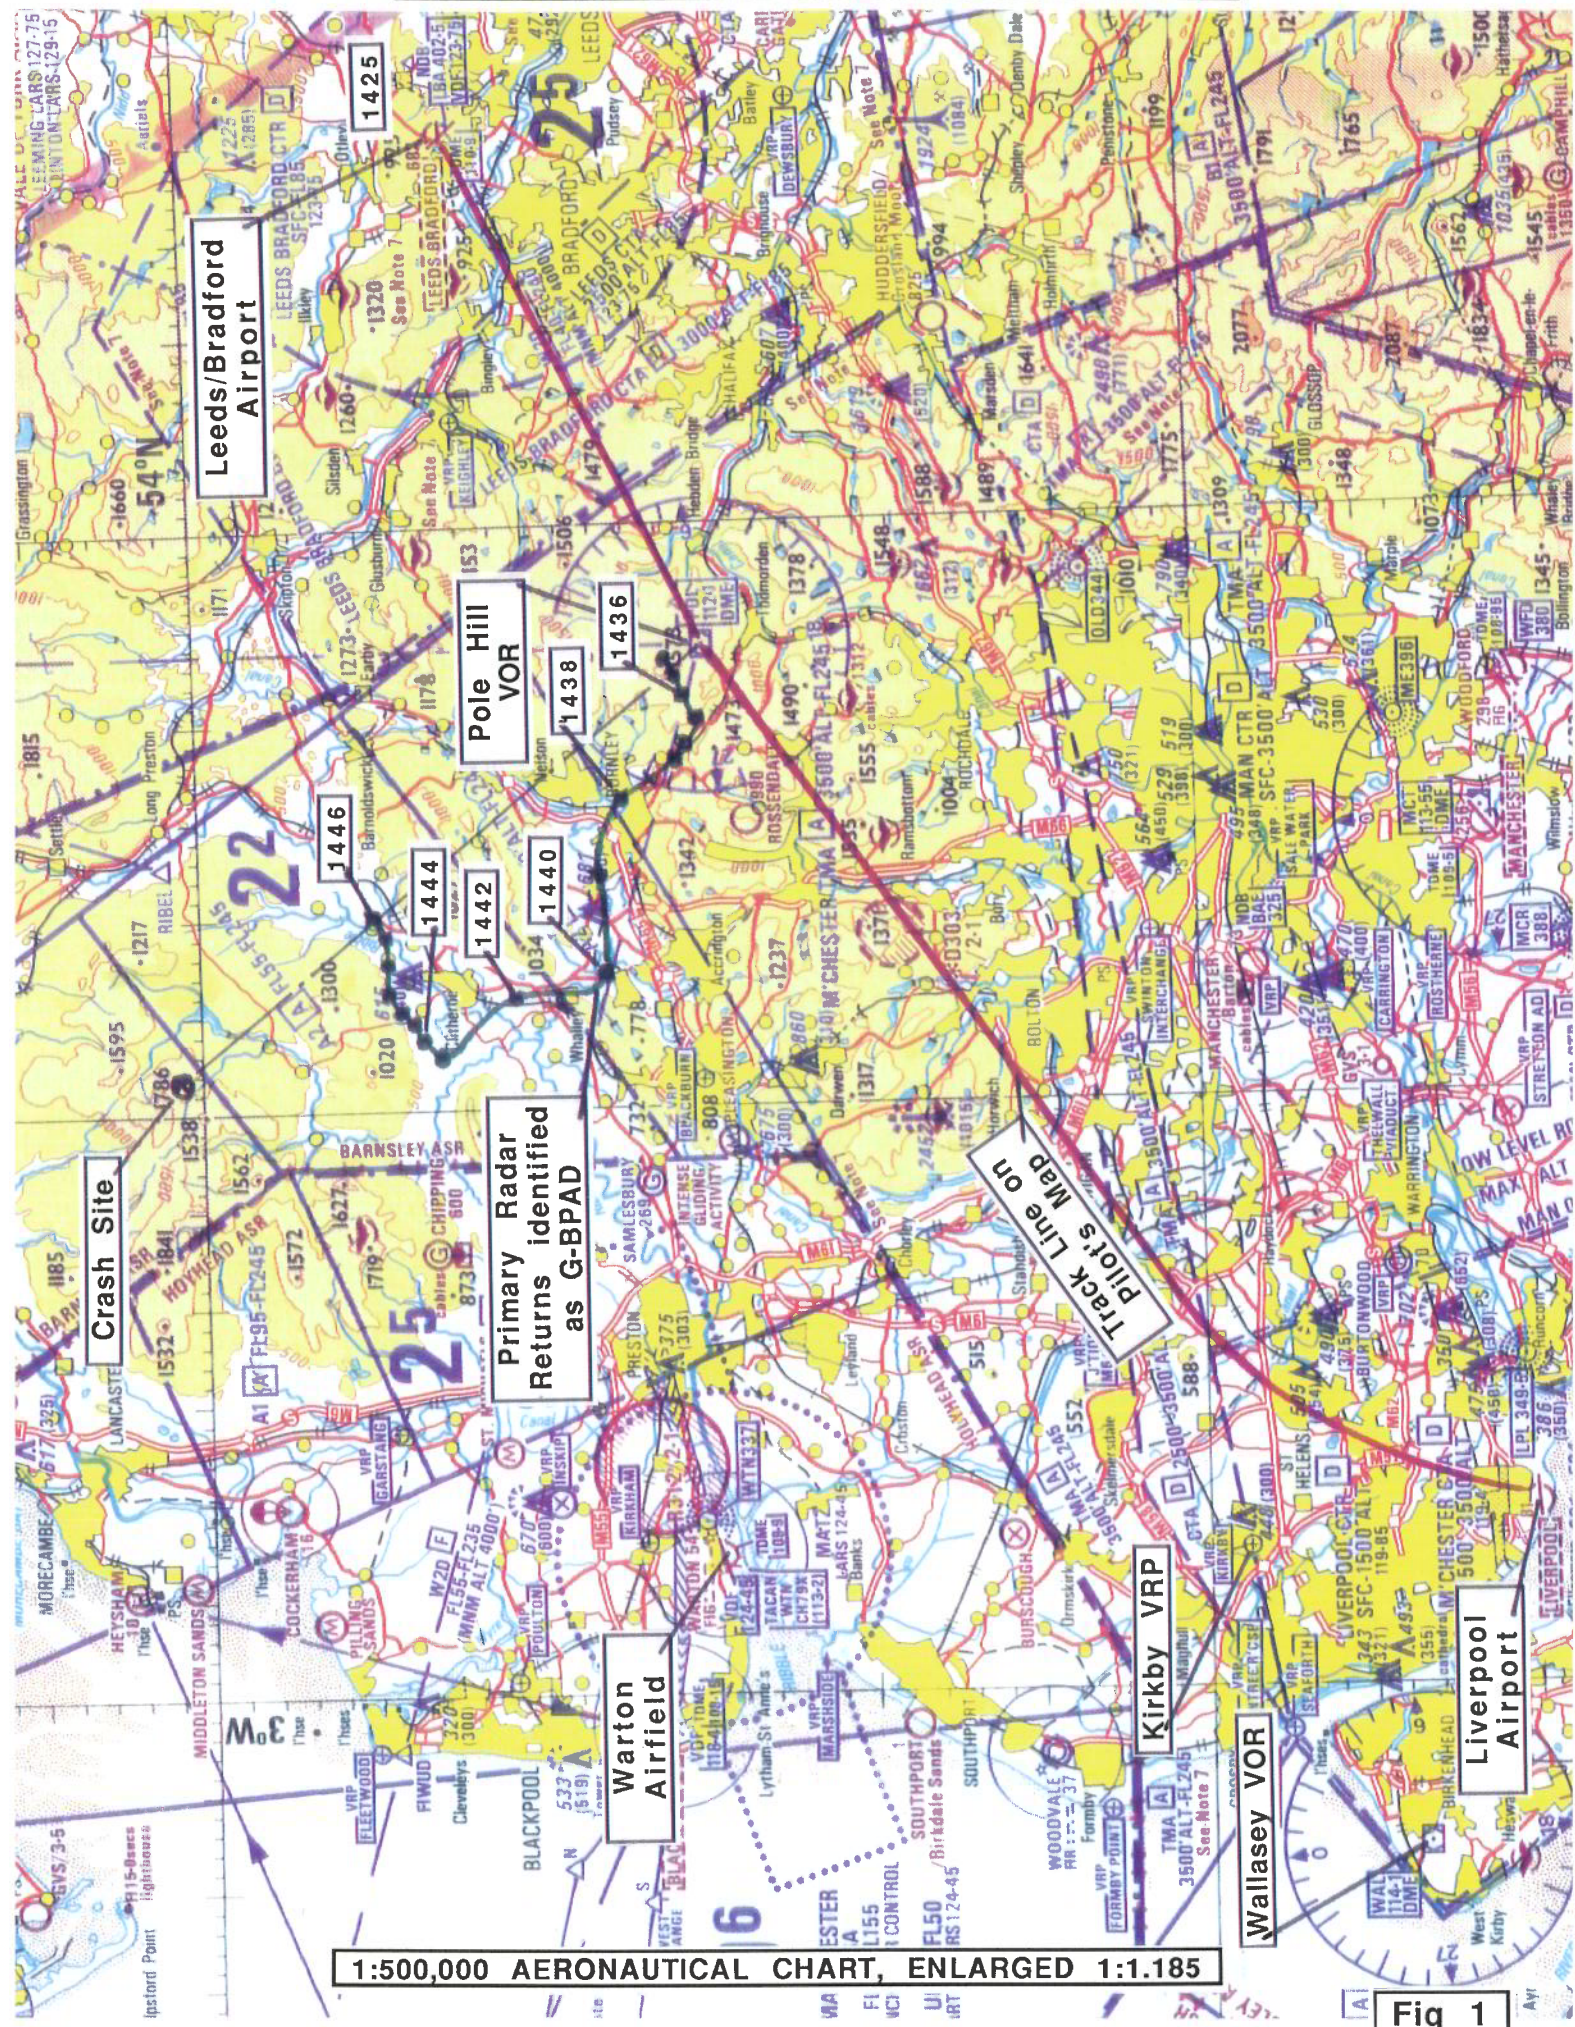
Fig 1

A radar recording, made by the ATC at the British Aerospace airfield at Warton, showed the aircraft travelling both towards and away from Pole Hill, on a somewhat erratic course and at a ground speed some 50 kt slower than that at which the aircraft normally cruised. The wind at 2,000 feet was 180°/10 kt, nearly at right angles to his intended track. When the aircraft passed within about one nautical mile north of Pole Hill, it set course on approximately the correct track for Kirkby but, after about two minutes, it turned northwest up the Calder valley towards Burnley, then into the Ribble valley at Clitheroe and from there turned northeast up that valley before disappearing from radar at around 1446 hrs, seven nautical miles southeast of the accident site.

G-BPAD TRACK FROM PRIMARY RADAR
