<b>Aircraft Type and Registration:</b>	Sikorsky S-61N, G-BDOC	
<b>No &amp; Type of Engines:</b>	2 General Electric CT58-140-2 turboshaft engines	
<b>Year of Manufacture:</b>	1976	
<b>Date &amp; Time (UTC):</b>	15 September 2004 at 0800 hrs	
<b>Location:</b>	Near Sullom Voe, Shetland	
<b>Type of Flight:</b>	Commercial Air Transport	
<b>Persons on Board:</b>	Crew - 4	Passengers - 1
<b>Injuries:</b>	Crew - None	Passengers - None
<b>Nature of Damage:</b>	Four main rotor blades damaged	
<b>Commander's Licence:</b>	Airline Transport Pilot's Licence	
<b>Commander's Age:</b>	37 years	
<b>Commander's Flying Experience:</b>	6,905 hours (of which 4,100 were on type) Last 90 days - 49 hours Last 28 days - 10 hours	
<b>Information Source:</b>	AAIB Field Investigation

During a winching operation, the rotors of G-BDOC struck the top of a mast on the deck of the receiving ship. The helicopter recovered safely to Scatsta Aerodrome. The investigation revealed some misunderstandings between the helicopter operator and the maritime operator about the winching deck markings on the ship. Accordingly, recommendations have been made to the CAA and to The International Chamber of Shipping (ICS) to ensure

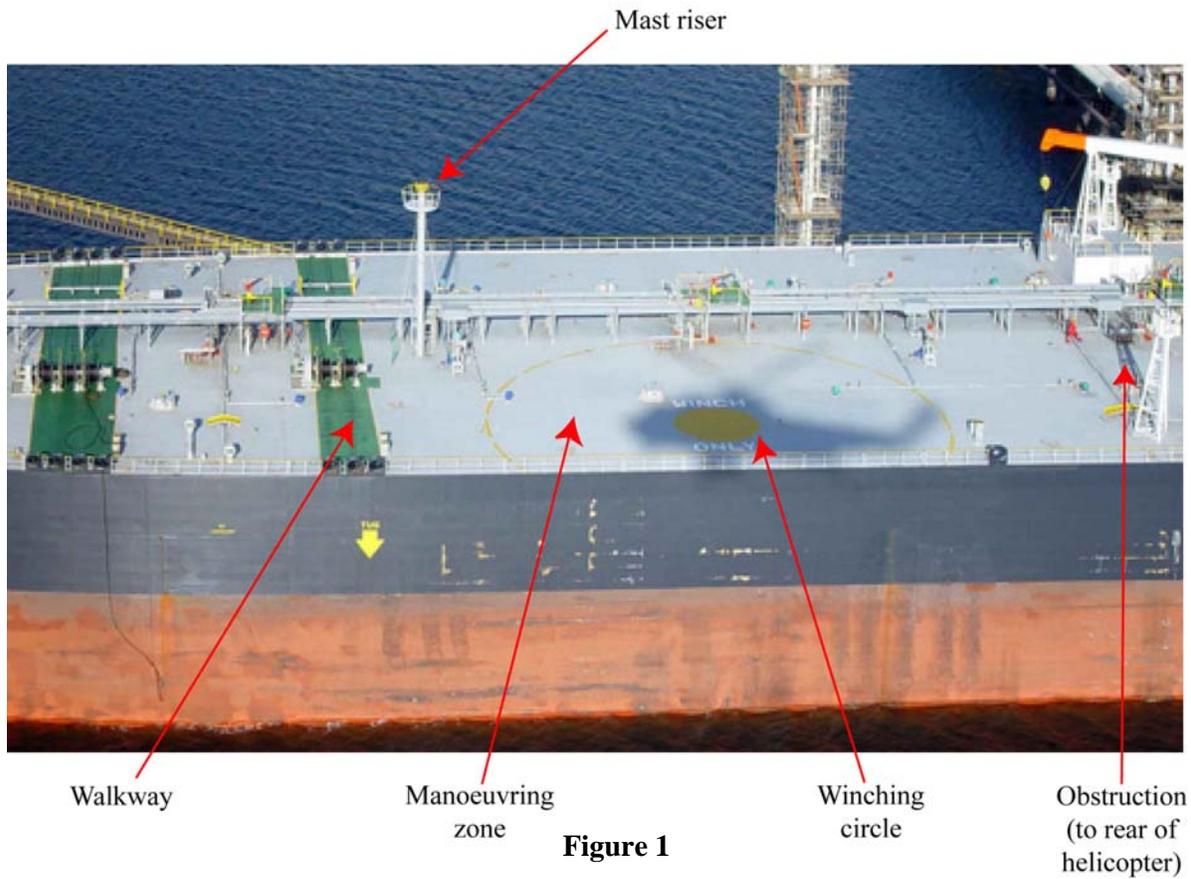
**Figure 1**  
Tanker deck

From the transit altitude of 300 feet amsl, the crew visually acquired the ship and, having established communication on FM radio, identified the winching area; this was indicated by a solid yellow circle surrounded by a broken yellow circle (Figure 1). Having completed the standard pre-winch checks and an engine power check, the helicopter was positioned on the port side of the ship. The ship was heading north at approximately 8 kt and the commander, who was the handling pilot in the right cockpit seat, assessed the surface wind as northerly 25 kt gusting to 30 kt. There was no significant cloud in the area and no turbulence. The first officer in the left cockpit seat was operating VHF communications with Scatsta and the winch operator, positioned in the opening of the cargo door on the right side, was operating FM communications with the ship.

Figure 1 shows a photograph of the tanker berthed at Sullom Voe following the accident, with the shadow of another S-61N at the winching circle. The following ship dimensions are derived from a general arrangement drawing from the tanker management company and the manufacturer's dimensions for the S-61N.

The drawing shows the diameter of the manoeuvring zone as 27 metres (radius 13.5 metres) and the winching circle as five metres. The distance from the edge of the manoeuvring zone to the obstruction to the rear was 11 metres, compared with 5.5 metres to the yellow-topped mast riser obstruction. Thus the nearer obstruction from the winching circle was the mast riser, which had a height over the tanker deck of 10 metres. The radius of the S-61N main rotor is 9.45 metres and so, with the main rotor over the centre of the winching circle, the average clearance of the main rotor disc from the mast riser would have been approximately 9.6 metres. In the same position, the average clearance of the tail rotor disc from the obstruction to the rear would have been approximately 11.8 metres.

The precise position of the helicopter's new winching position relative to the green walkway is not known. However, positioned with the centre of the main rotor directly forward of the winching circle and over the centre of the walkway, the average clearance of the main rotor disc from the mast riser would have been approximately 2.1 metres.

The roll of the ship was not significant to the crew and has been estimated as 3°. With the top of the mast riser approximately 18 metres above the ship's centre of gravity, the total arc of the top of the mast riser would be approximately two metres, bringing it very close to the main rotor disc.

- 1) Ships Masters have been instructed to ensure a proper exchange of information with the helicopter operator regarding the vessel's marking, and specifically to include the diameter of the winching area.*
- 2) Albeit that the current markings are valid they are now studying, and considering changing, the markings in order to facilitate the reception of larger helicopters if feasible.*

The International Chamber of Shipping should review the deck markings on ships involved in winching operations with the aim of including a requirement to clearly display the dimensions of the 'manoeuvring zone', such that it can be clearly seen by the helicopter crew.

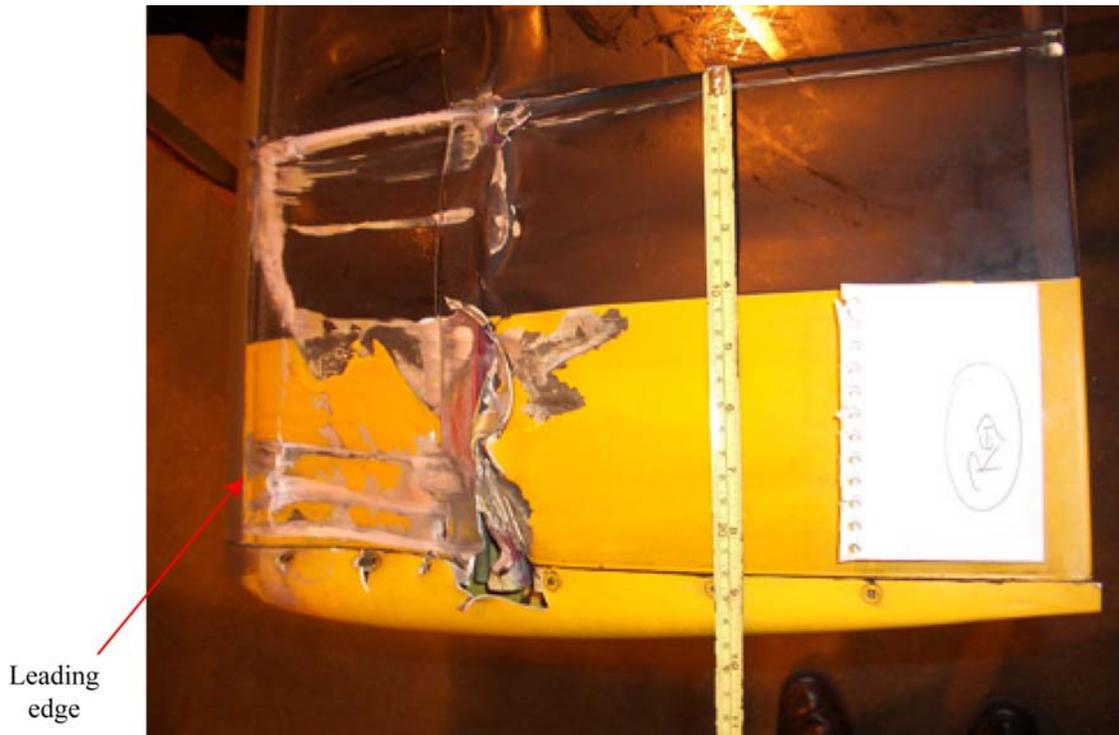
**Figure 2**  
Red blade - lower surface

Following the landing at Scatsta, the helicopter was examined for damage. Four of the five main rotor blades had extensive damage on the lower surface of the blade, starting at about 25 cm from the blade tip. Examination of the top of the yellow mast riser on the tanker showed corresponding damage to the vent, including the loss of a substantial lifting lug welded to the upper edge.

Figure 2 shows the damage to the lower surface of the Red blade. This blade showed evidence of two strikes, with the inboard marking at about 25 cm from the tip and the outboard mark at about

10 cm from the tip. The damage was similar to the Blue blade, with both blades having suffered extensive gouging of the main rotor spar and disruption of the bonded blade skin. The Black and Yellow blades had similar inboard damage but no outboard strike and there had been no visible contact with the White blade. None of the blade spars had been fully penetrated so the BIM system, which operates on pressure release, would not have been activated.

All five blades were removed from the helicopter, which was subjected to a thorough inspection. There was no evidence found of other damage and the aircraft was returned to service with replacement main rotor blades

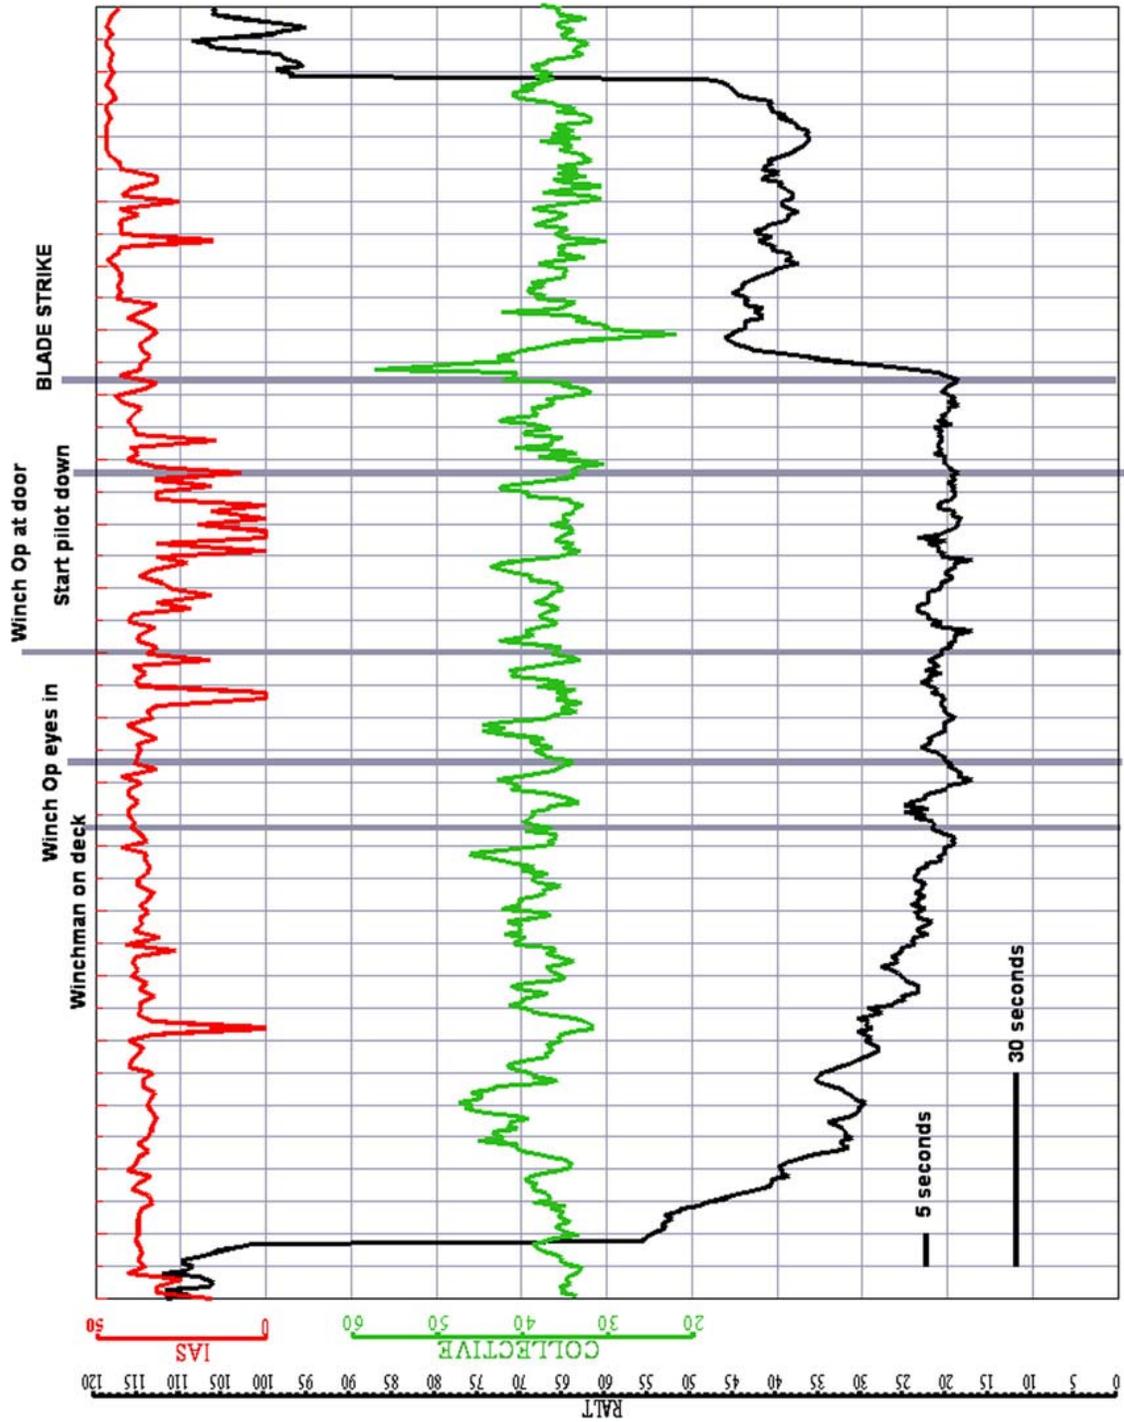
**Figure 3**  
 Relevant FDR parameters and related crew activities

Figure 3 shows relevant FDR parameters together with related crew activities. Given a lack of data pertaining to the ship's movements, the FDR data could not be used to reconstruct the motion of the helicopter relative to the ship except that the radio altitude shows when the helicopter was over the deck of the ship. The radio altitude also indicated that the peak-to-peak wave effect at the time was about five feet. The radio altitude above the deck started at 55 feet and settled to approximately 20 feet after about a minute, holding steady at 20 feet plus/minus wave action for a further minute and a quarter before the blade strike. After the blade strike, the helicopter altitude increased to approximately 45 feet above the deck. Over the next 40 seconds, the helicopter remained over the deck with a slow reduction of mean radio altitude of about five feet. Some 45 seconds after the blade strike, the helicopter was over water.
