## Boeing 737-300, G-LGTI

<b>AAIB Bulletin No: 6/2004</b>	<b>Ref: EW/C2003/07/07</b>	<b>Category: 1.1</b>
<b>INCIDENT</b>		
<b>Aircraft Type and Registration:</b>	Boeing 737-300, G-LGTI	
<b>No &amp; Type of Engines:</b>	2 CFM56-3B2 turbofan engines	
<b>Year of Manufacture:</b>	1988	
<b>Date &amp; Time (UTC):</b>	30 July 2003 at 0500 hrs	
<b>Location:</b>	Newcastle Airport, Tyne and Wear	
<b>Type of Flight:</b>	Public Transport (Passenger)	
<b>Persons on Board:</b>	Crew - 6	Passengers - None
<b>Injuries:</b>	Crew - None	Passengers - N/A
<b>Nature of Damage:</b>	Fire damage to electrical wiring and insulation material	
<b>Commander's Licence:</b>	Airline Transport Pilot's Licence	
<b>Information Source:</b>	AAIB Field Investigation

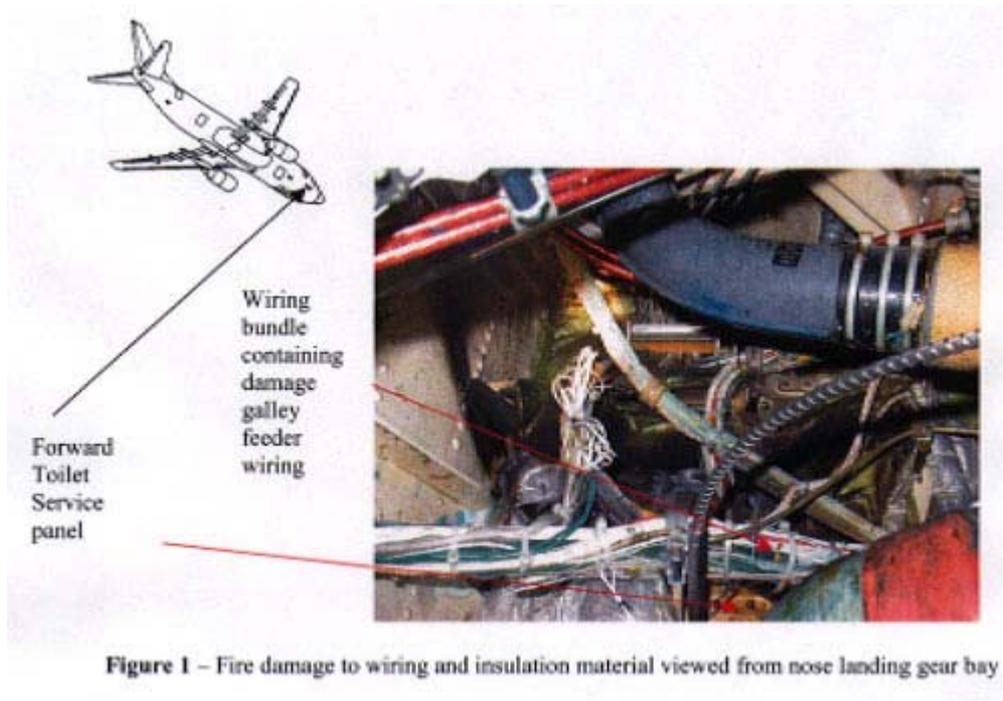
Some fire damage was observed inside the fuselage on the right side of the aircraft, in the area of the forward toilet service panel, beneath the cockpit floor and forward of the Electrical and Electronic compartment (see Figure 1). The area contains the toilet servicing ducts as well as inertial reference units and numerous wiring bundles. Included in the list of systems affected by the damage were; autothrottle system, digital stall warning system, engine idle control, engine ignition, thrust reverser control (No 2 Engine), right wing slat and flap indicating systems, altitude information from Air Data System No 2, Inertial Reference Systems, EFIS power and weather radar.

**Figure 1: Fire damage to wiring and insulation material viewed from nose landing gear bay**

Figure 1 – Fire damage to wiring and insulation material viewed from nose landing gear bay

There was evidence of dried blue fluid (toilet sanitising fluid) contamination indicating that there had been leakage from the toilet charge pipe in the area of the forward toilet service panel. The ground engineer also reported that the area has been wet from the ingress of moisture from rainfall the previous night when the integral airstairs had been used. The APU had been run for a period of 20 minutes in order to dry the underfloor area before resetting the Circuit Breakers.

A short duration flash fire had apparently occurred; there was evidence of fire having consumed some of the aircraft insulation material. The majority of the wiring bundles from this area were insulated with polyimide (Kapton). Some of these wires had separated and examination showed evidence of damage from heat and arcing but there was no evidence that the wires had been contaminated or chafed prior to the fire. Similarly, there was no evidence on the adjacent structure that chafing or arcing had occurred. However, examination of the 10 gauge Boeing Material Specification (BMS) 13-31 3-Phase 115V AC galley power feeder cables did show evidence of some pre-existing damage (see Figure 2). The insulation material for these cables is a mineral filled polytetrafluoroethylene (ie Teflon).

The operator has since carried out visual inspections of the wiring in the area above the forward toilet service panel highlighted by this incident on a sample of six other B737 aircraft. No wire damage or interference between wire bundles and aircraft structure was found.

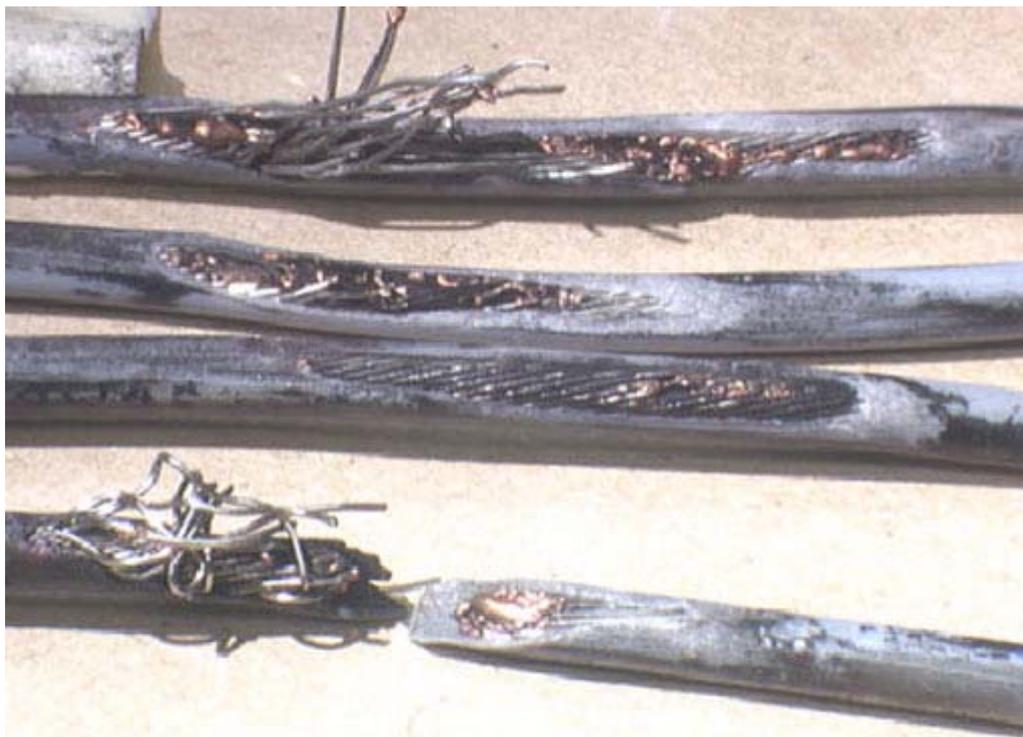
Figure 2: Damage to galley power feeder cables

Figure 2 - Damage to galley power feeder cables

Laboratory analysis of wiring segments removed from the aircraft was carried out by the aircraft manufacturer. They concluded that there was evidence that some insulation material from the galley feeder cables had been missing prior to the incident; the exposed edges of the insulation contained 'grooves' along its length and some of the wire strands appeared mechanically damaged. Tests on undamaged wires showed that damage similar to the 'grooves' could be caused by the insulation being torn away rather than cut from the wire.

The galley feeder cables carry a three phase 115V AC giving a 200V potential between the exposed wires of the damaged cables, thus providing the possibility for arcing. It is probable that the arcing between the galley feeder cables eventually started a process of arc tracking of the polyimide insulated wires, which would have continued until the circuit breakers tripped and started again when the electrical power was reapplied. It could not be determined when the damage to the galley power feeder cables occurred or why arcing sufficient to cause the fire occurred on this particular occasion.

Damage consistent with the insulation material being torn away from the wires was identified on at least two of the wires. It is probable that this damage occurred at some earlier time, possibly during

the replacement of the forward toilet service panel in November 2002. The ignition source of many previous occurrences of on-board fires has been attributed to mechanical damage to wiring as a result of aircraft maintenance.
