## BAe 146-200, G-JEAX

| <b>AAIB Bulletin No: 2/2004</b> | <b>Ref: EW/C2002/12/02/03</b> | <b>Category: 1.1</b> |

### Synopsis

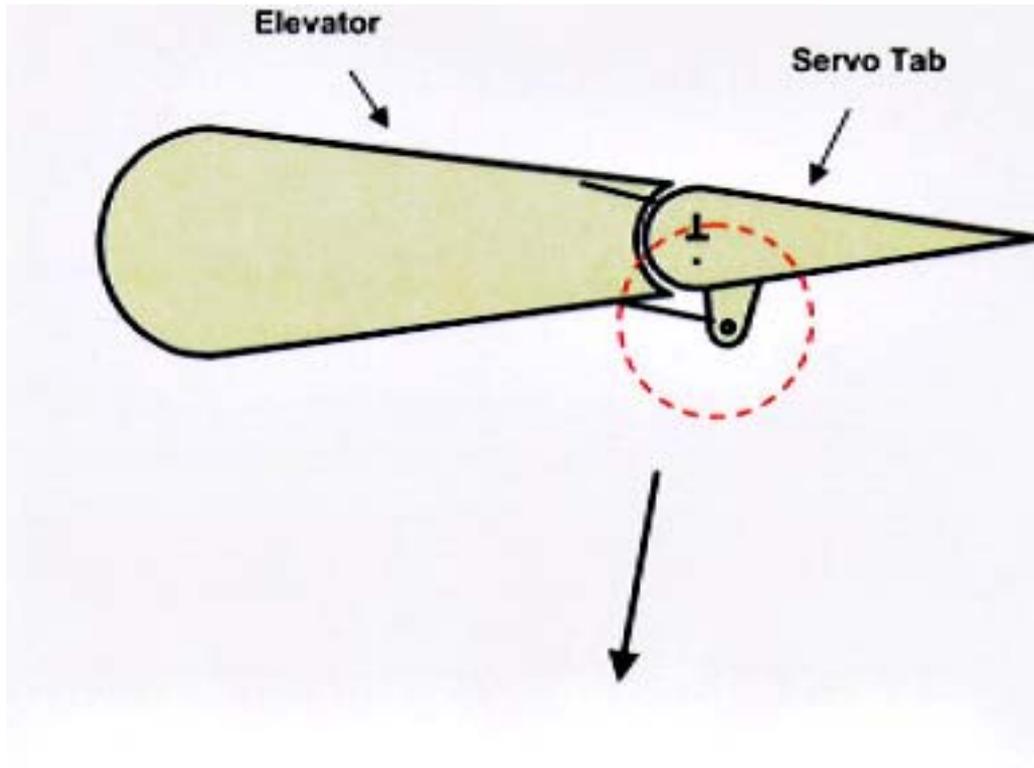
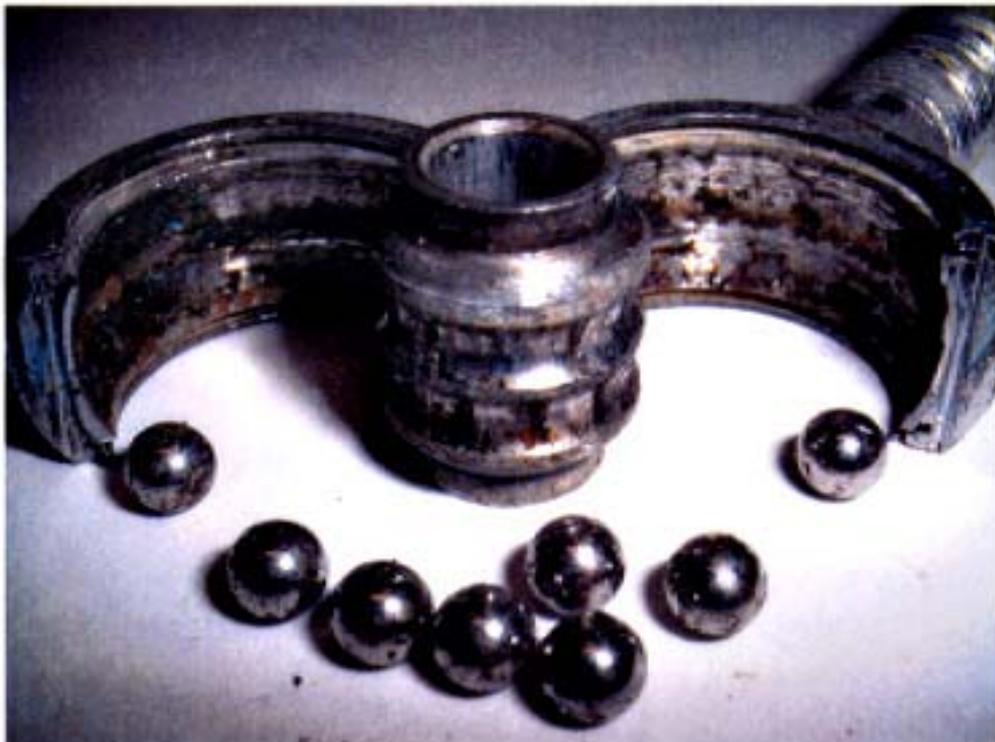
**Figure 6: Sectioned Left-Hand Servo Tab Rod End Bearing**

On preliminary examination, it was noted that the servo tab rod end bearings were stiff to rotate and felt 'notchy'. The outer race of the left-hand tab bearing was sectioned to allow the bearing to be disassembled. It was immediately evident that there was no grease present in the bearing. A brown, powdery residue was visible on the surfaces of the inner and outer races and on the ball bearings (Figure 6). The lack of grease was a matter for concern, given that the grease seals were found to be in good condition.

The grease seals on the right-hand servo tab bearing were also in good condition, but the bearing was completely lacking in grease, containing the same powdery residue as the left-hand bearing. Chemical analysis of the residue by the aircraft manufacturer showed that its properties were consistent with those of a clay-thickened grease such as Aeroshell 7.

system. This, of itself, may not have been sufficient to cause the servo tabs on G-JEAX to jam, but there remains the possibility that with the lack of grease in the bearing, moisture could accumulate in the bearing cage void and freeze in flight. This would further increase the stiffness of the system, possibly to the point where the servo tabs might seize. A previous incident of an aileron jam on a BAe 146 was attributed to moisture ingress into one of the sealed bearings in the aileron control system, which subsequently froze in flight (Report EW/C99/10/1 in AAIB Bulletin 7/2001 refers). Following this incident, the aircraft manufacturer proposed a change to the AMM (Aircraft Maintenance Manual) under All Operator Message Reference 01/001V to introduce a subjective check of the freedom of movement and smoothness of the aileron and elevator servo tabs. Consequently, no safety recommendation was made by the AAIB regarding inspection and maintenance of the bearings.

Whilst it was not possible to establish whether the absence of grease in the servo tab bearings was a contributory factor to the elevator control problems on G-JEAX, good engineering practice suggests that this condition is undesirable and that the servo tab bearings and other similar bearings need to be sampled for condition at regular intervals and replaced as necessary.

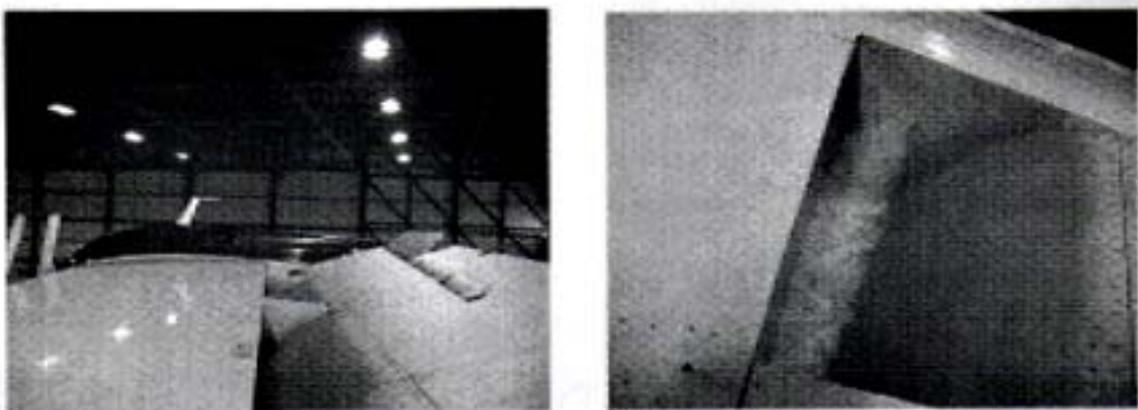
**Figure 7: Elevator in parked position and illustration of hail accumulation**

Other cases of pitch control restriction experienced by the operator were determined to have been caused by the accumulation of snow or ice in the gaps between the servo tab and the elevator. This, they believed, could occur when the aircraft was exposed to rain or snow prior to departure in near freezing conditions. On 5 February 2003 aircraft OO-DJG, that had been briefly exposed to rain prior to departure, suffered from extremely heavy elevator controls in flight. Large accumulations of ice were found in the elevator gaps after the aircraft had landed. (See Figure 7.)

The operator commented that the fact that the elevators sit trailing edge up when the aircraft is parked might encourage the accumulation of precipitation in the gaps, which can partially melt, and then re-freeze in flight, leading to pitch control problems. In their experience, the problem could also occur when the aircraft was exposed to hail prior to departure, so that the control freezing problem is not restricted to the winter period. The operator has introduced a specific inspection on the flight crew walk-round inspection. In daylight, crews check for an undisturbed line of sky within the elevator and tab gaps, on the premise that any precipitation in the gaps will refract the light, producing a visible discontinuity in the line. In darkness, one pilot moves the elevator whilst the other looks for precipitation falling through the gaps.

Although snow was not settling on the visible parts of the aircraft, it is possible that in the near freezing conditions snow or slush could have accumulated in the sheltered areas in the gaps between the elevators and the servo tabs and this would not have been visible to the crew of G -JEAX. If the aircraft was parked into wind, this process might have been aided by the fact that the elevators sit in the trailing-edge up position when the aircraft is parked. This geometry could encourage precipitation to move forwards down the elevator and to accumulate in the gaps as shown in Figure 7.

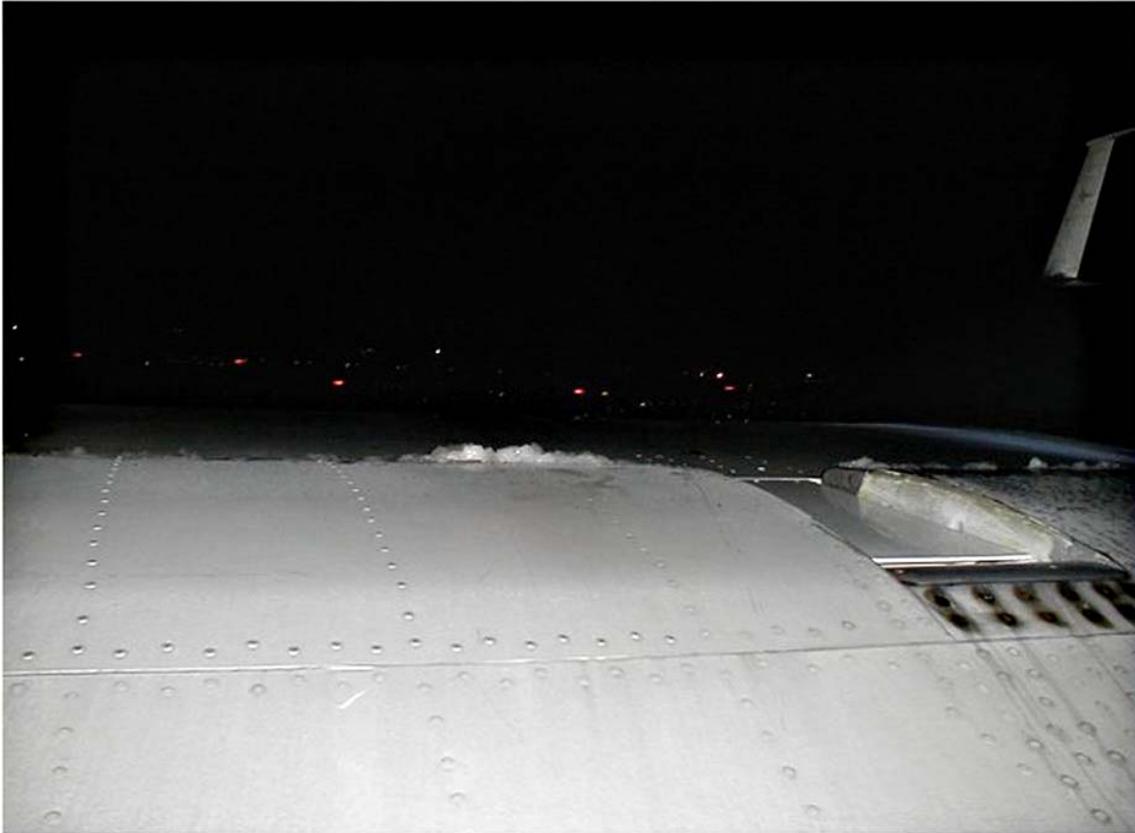
**Figure 8: OO-DJ Incident - 5/2/03**

Evidence from previous events where the aircraft was exposed to precipitation on the ground prior to takeoff in near freezing conditions without being de-iced and where the aircraft subsequently experienced pitch oscillations and/or heavy elevator forces suggests that this scenario may be one which is conducive to the accumulation of ice or slush or even hail in the elevator gaps, which can freeze in flight. Typically the ice melts as the aircraft encounters warmer air, whereupon the controls usually revert to normal, although in some cases the ice has remained and is still visible after landing, as in the OO-DJG event (see Figure 8).

**Ice Accumulation in Gaps on Top of Elevator  
(Photo taken Post Flight)**
